# Air Accident Investigation Sector

### - Preliminary Report -

AAIS Case N°: AIFN/0001/2024

# Helicopter Ground Impact During Landing

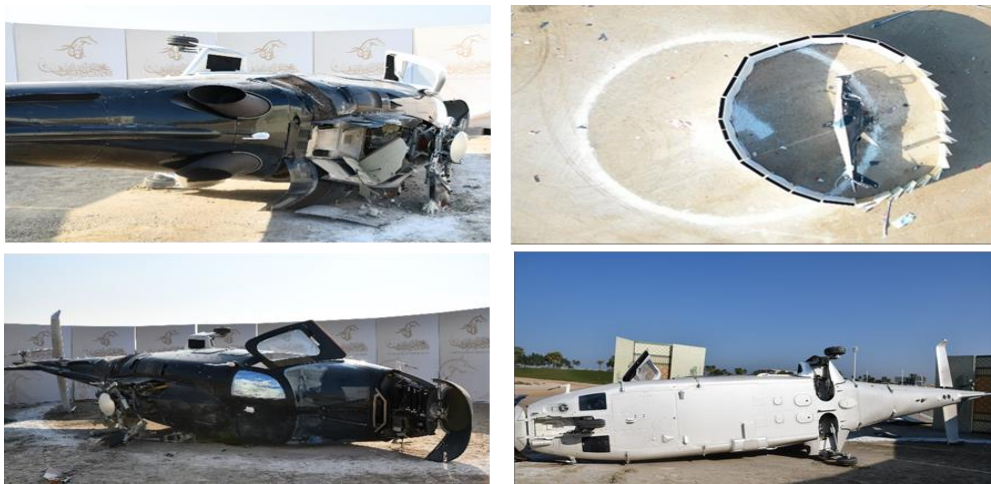
Figure 1. Structural damage

Thereafter, the Helicopter rolled over to the right, leading to the main rotor blades striking the ground and subsequently bringing the Helicopter in a resting position on the ground, tilted to the right.

The Helicopter was substantially damaged due to the ground impact of its main rotor blades and right-side structure (figure 1).

The Helicopter was substantially damaged as a result of ground impact.
