Air Accident Investigation Sector

Accident — Final Report —

AAIS Case N°: AIFN/0004/2017

Helicopter Controlled Ditching due to Failure of Main Gearbox Oil Cooler Fan Shaft and Associated Abnormal Noise

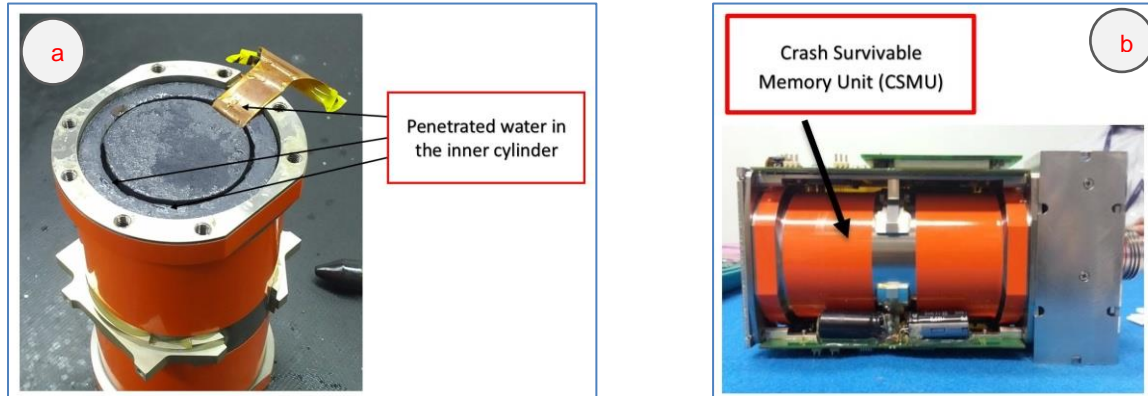
Figure 11. Evidence of moisture penetration to inner cylinder and CSMU installation

During disassembly, it was noted that water had penetrated the outer chassis and covered the electronics controls unit. A small amount of water was also found covering the CSMU inner steel cylinder that contains the data storage memory boards (figure 11a).

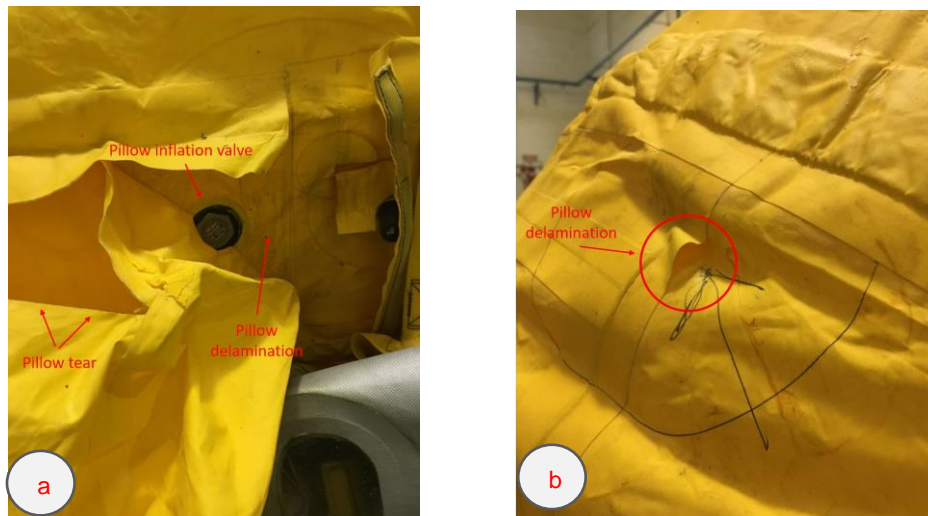
Figure 14. Left aft float damage

Images showed that all the floats, except the left rear float, were intact prior to the recovery of the Aircraft, approximately six hours after ditching. Damage, identified on these floats during the shop inspection, was most likely caused by the recovery and transport of the Aircraft.

It was identified that part of the aft pillow chamber had delaminated, releasing air from the aft flotation chamber through the pillow inflation valve (figure 14a). A second area of delamination was found at a main chamber seam which was slowly releasing air (figure 14b).

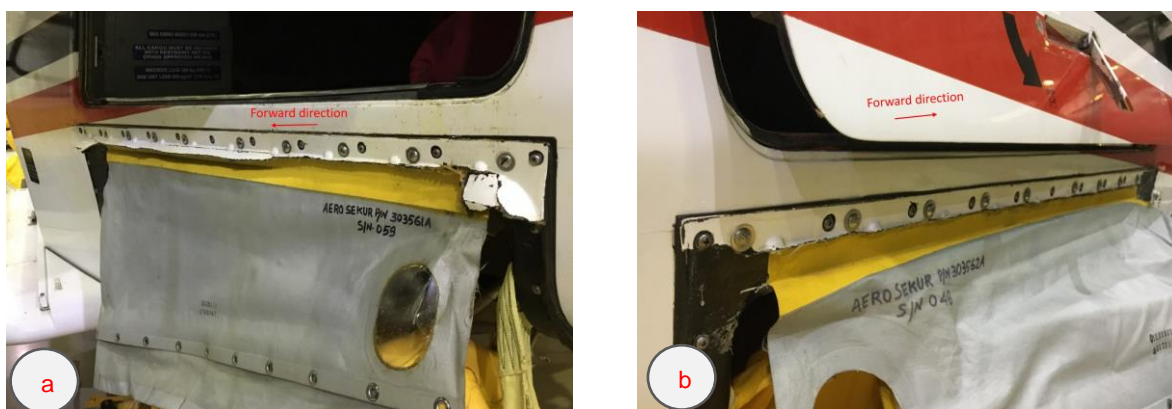
Figure 15. Left and right aft composite cover damage

An inspection of the Aircraft identified that the shear-bolts (attaching the upper edge of the float covers) had not sheared causing fracture of the composite covers leaving the remains attached to the Aircraft (figures 15a and 15b).

The Aircraft manufacturer advised that this type of failure was evident during the certification process when the floats are deployed in-flight, resulting in a downward deployment instead of a sideway deployment of the flotation bags.

This failure has the potential to cause damage in form of cuts or abrasions to the main flotation bag or the pillow bag. Aircraft manuals therefore warn of in-flight deployment.

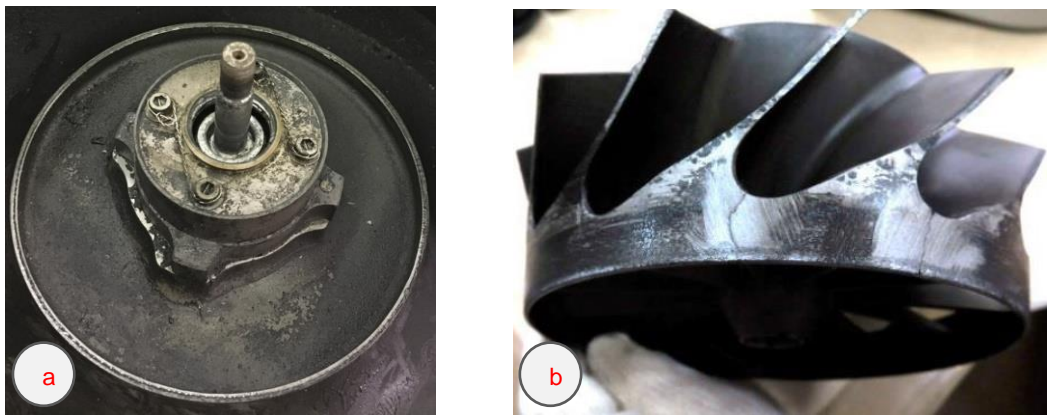
Figure 16. Fan shaft damage and cracked impeller [Source: Leonardo Helicopters]

It was found that the fan shaft had lateral play of 5.3mm (figure 16a) and was no longer connected to the impeller, which showed signs of rubbing with the outer shroud and was cracked in two places (figure 16b).

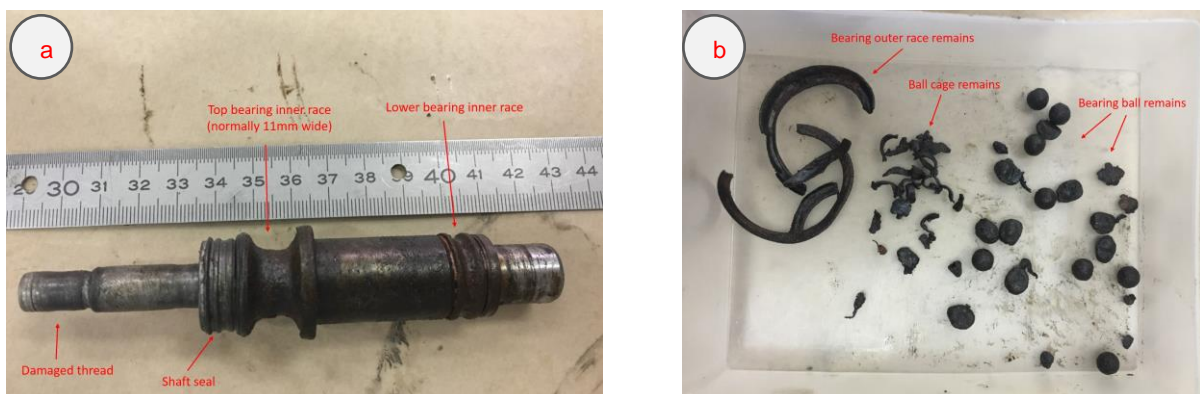
Figure 17. Cooling fan assembly shaft and bearing parts findings [Source: Leonardo Helicopters]

The top bearing was completely degraded, showing signs of overheating, with the inner bearing race physically expanding its width from 11mm to 18mm (figure 17a).

The lower bearing was destroyed and its seal package found extruded from the housing by 4.8mm. Figure 17b shows the destroyed bearing balls and ball cages from the top and lower bearings.

The fan shaft thread was stripped and showed signs of extensive heating near the lower end (figure 17a).

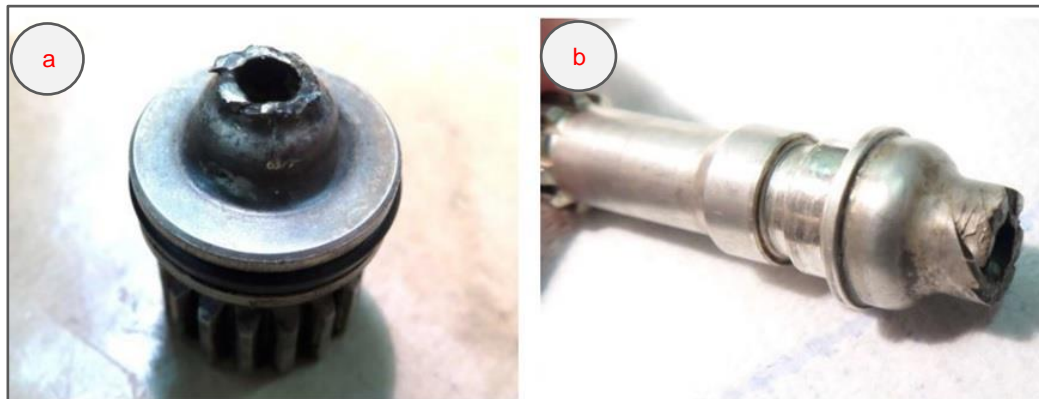
Figure 18. Cooling fan drive shaft damage [Source: Leonardo Helicopters]

The cooling fan drive shaft was recovered and forensically examined by Leonardo Helicopters in the presents of the IIC, the ANSV and representatives from Leonardo Helicopters. It was found that the shaft fractured at the nominated shear point. Both fracture surfaces showed evidence of rubbing. The splines on each end were in good condition and the lower O-ring was still present (figures 18a and 18b).
