# Air Accident Investigation Sector

### - Final Report -

AAIS Case N°: AIFN/0008/2016

# Runway Impact during Attempted Go-Around

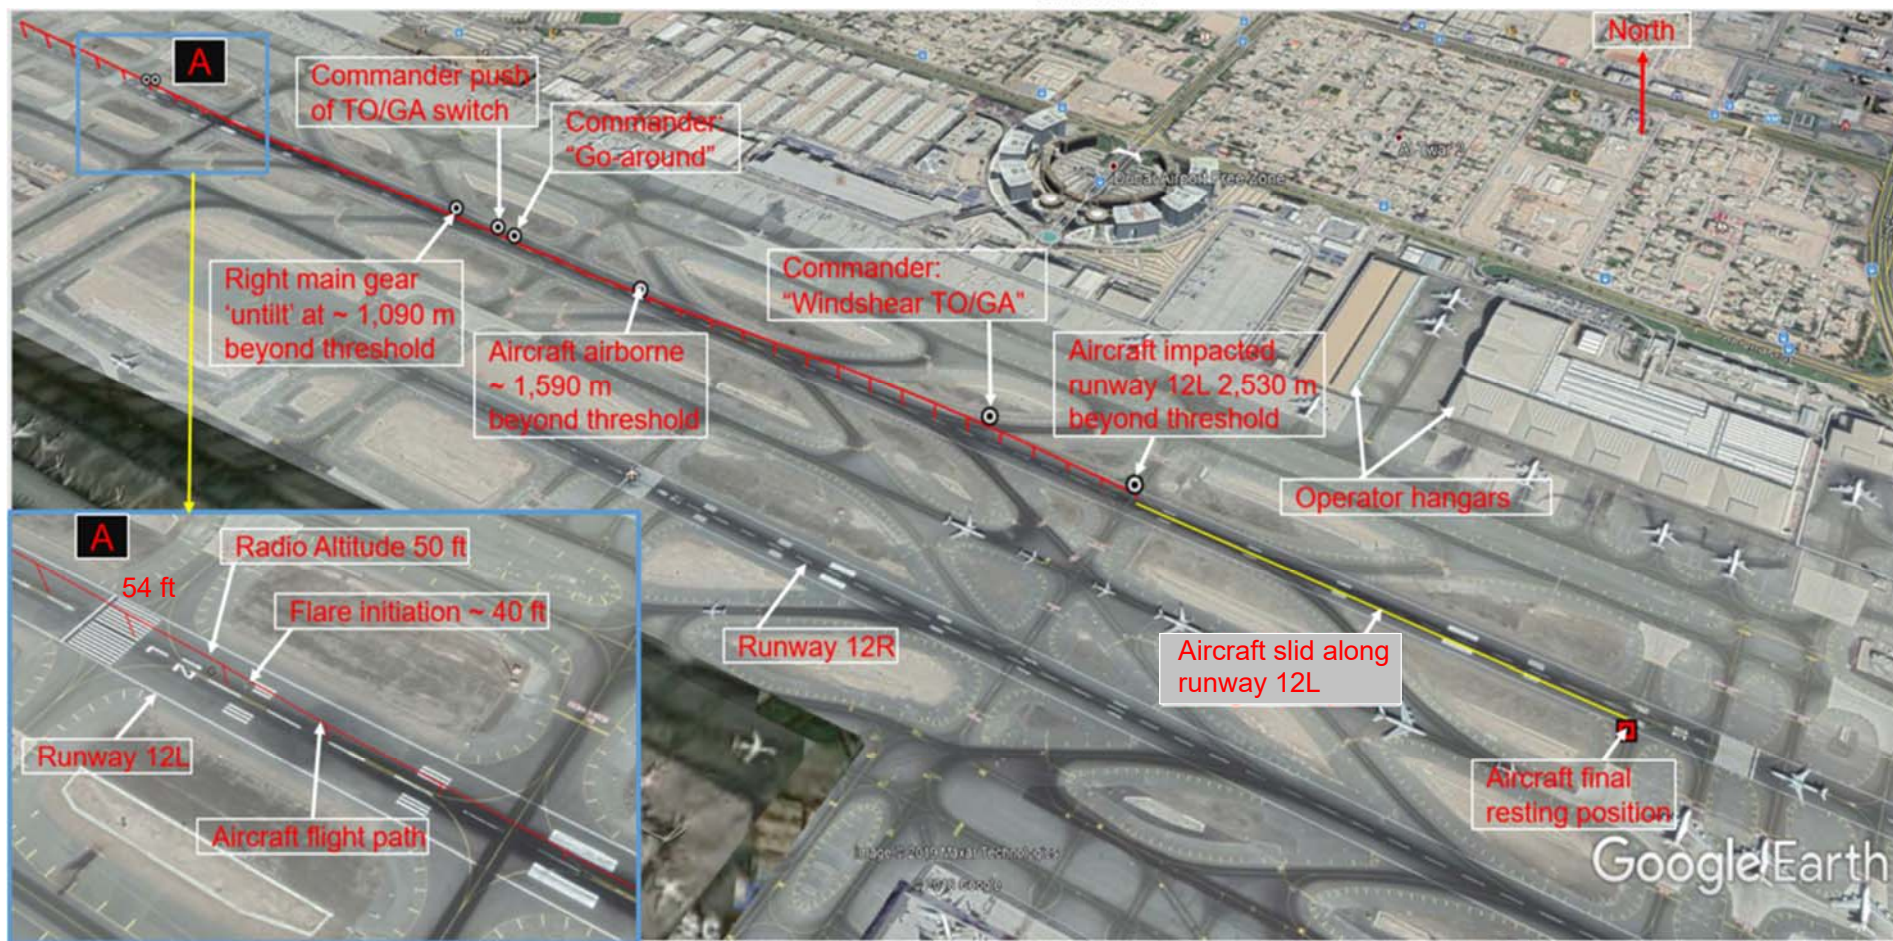
Figure 1. UAE521 flightpath and impact along runway 12L

At 0837:16, the Aircraft rolled 3 degrees to the left due to the wind effect and the Commander corrected with right control wheel input of 30 degrees. In response to this input, the resulting right bank of 7.4 degrees caused the right main landing gear to contact the runway approximately 1,090 m beyond the threshold.

Refer to figure 1 which illustrates the final flightpath of the Aircraft from before the runway threshold until the impact. Appendix A to this Report illustrates the FDR and CVR data recorded along the flightpath over runway 12L.

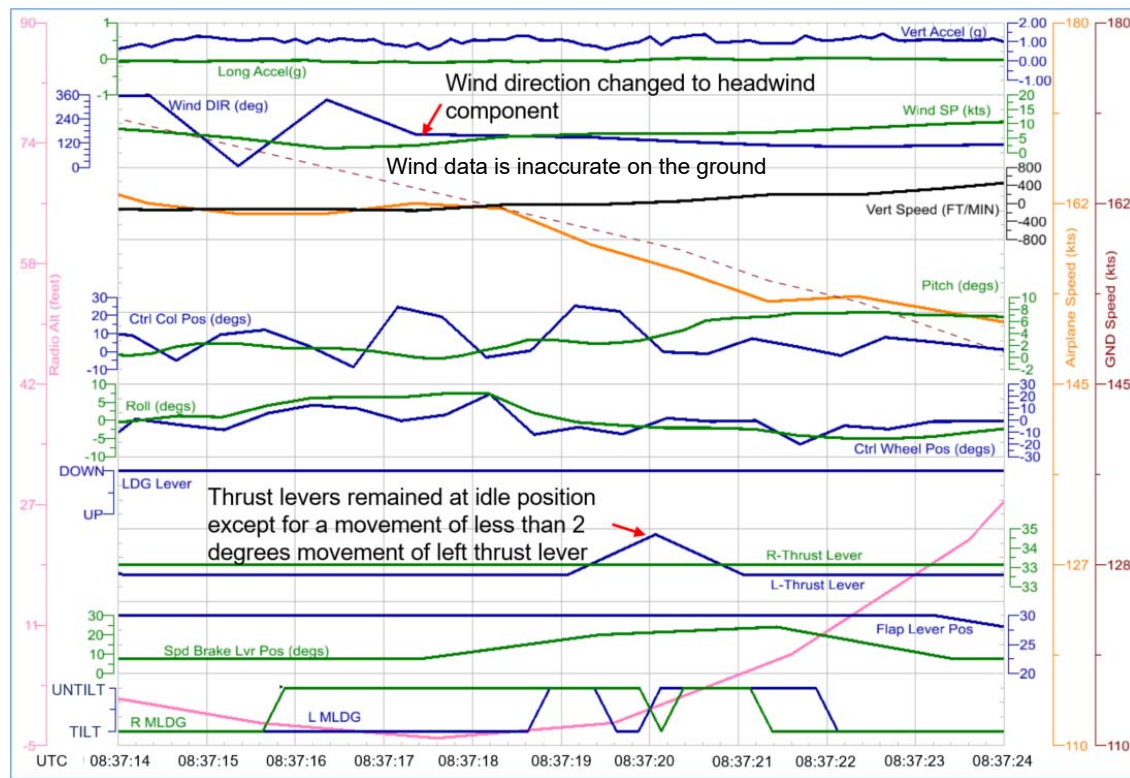
Figure 14. Main landing gear over six seconds of 'tilt' and 'untilt'

At 0837:18, the FDR indicated the pitch-up angle increasing from 0.8 to 3 degrees. The increase in pitch angle occurred shortly before the Commander called for a go-around, at about 161 kt IAS. The pitch angle oscillated between 3 and 2.3 degrees over the next one second before it continued to increase at a positive rate towards 7.4 degrees, at about 153 kt IAS, with both main landing gear being 'untilt'. The landing gear lever was selected to 'up' at 0837:29 and the Aircraft then continued in 'air' mode with the landing gear being in transit to the up position until impact.

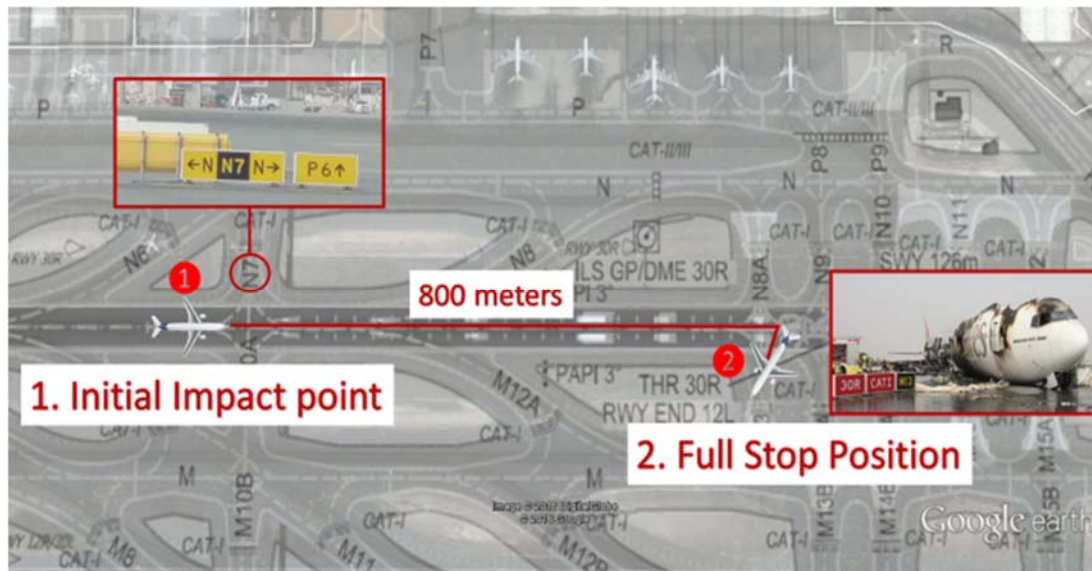
Figure 15. Aircraft Initial impact point and final position

The impact and movement of the Aircraft along the runway caused damage to the runway surface from abeam taxiway November 7 to the final resting point of the Aircraft.

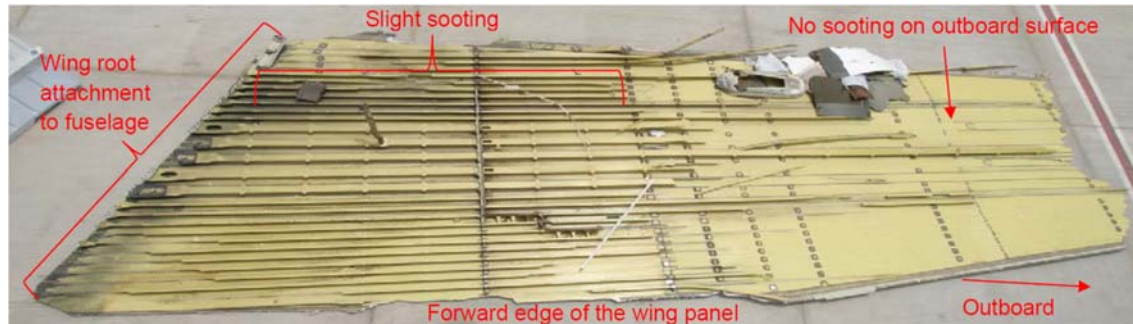
**Figure 16.** Upper skin panel from right wing

landing gear heating and causing the ignition of the approximately 100 kg of residual fuel in the center wing tank. The explosion caused the right wing upper skin panel of the center wing fuel tank to violently separate (figure 16).

The direction of the explosion pressure wave was from the center wing tank towards the right main wing tank. This resulted in a large section of the upper wing skin from the inboard right wing, approximately 15 m in length and the width of the upper wing surface, being separated with such force that it landed behind the right wing on the tarmac approximately 5 m from the wingtip. The wing skin panel separated from wing buttock line station (WB) 123.124 to wing station (WS) 732 (Rib 21). In addition, the explosion also caused the cabin floor over the center tank area to lift which provided a path for fire and smoke to enter into the passenger cabin.

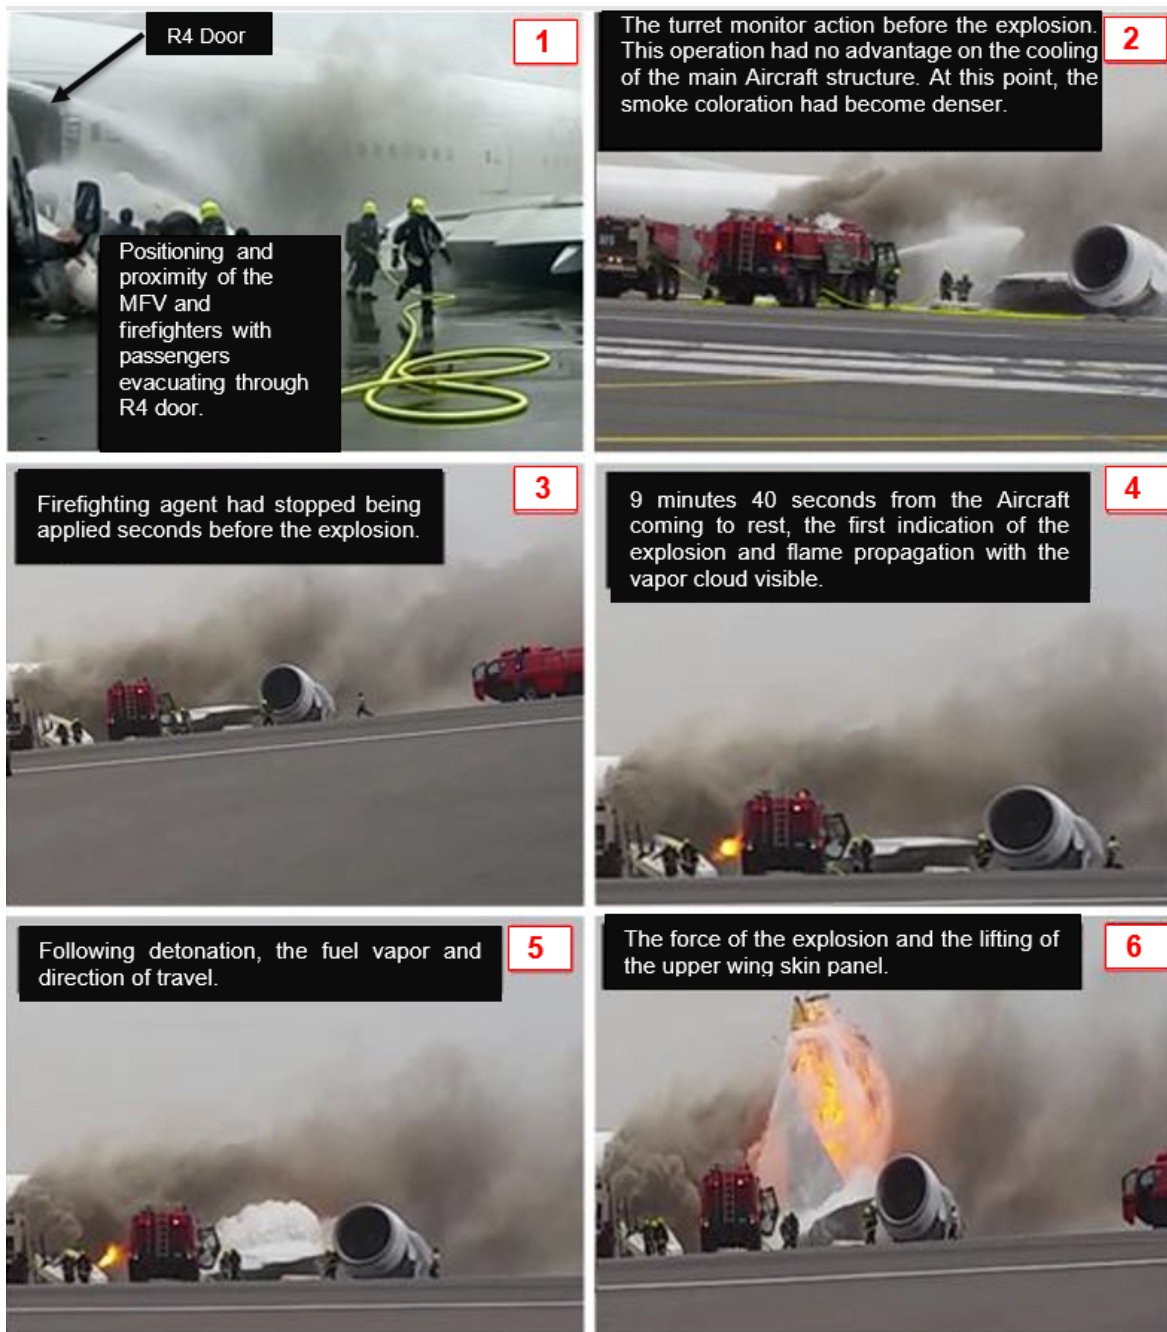
Figure 17. Center wing fuel tank explosion

Figure 17 illustrates the sequence of events before and after the explosion.

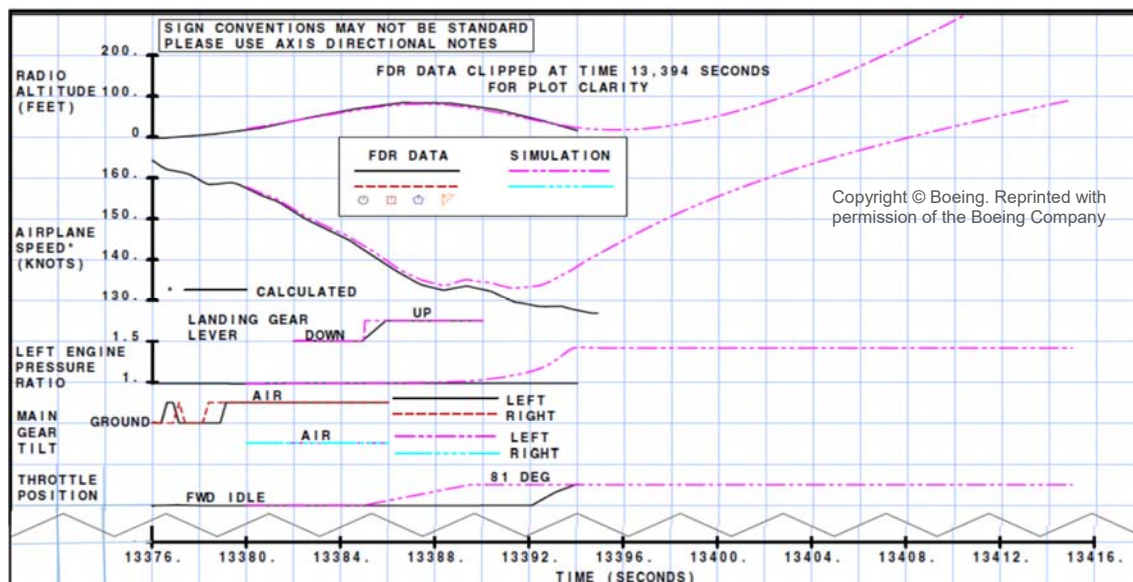
**Figure 21.** Calculated go-around after TO/GA switch push [source: Boeing]

For UAE521, the actual thrust lever increase, which was a manual advancement by the Commander at 13,392 seconds FDR time, was performed fifteen seconds after the Commander called for a 'go-around'.

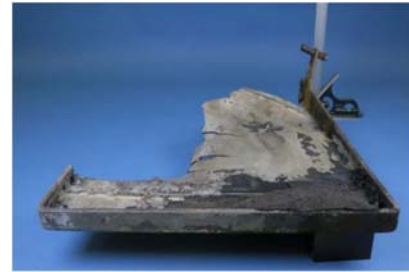
**Figure 22.** L1 cabin crew seat pan and left lever distortion [Source: NTSB]

The L1 cabin crew seat parts recovered from the Aircraft were sent to the NTSB materials laboratory in Washington, DC, the United States. The examination found that the left seat pan lever was twisted outwards at the attachment location of the seat pan lever stop and lower back pivot. The left lower back pivot stop bolt (figure 22), attached to this lever, was found bent. The lower back pivot stop bolt hole (figure 23) of the right seat pan lever was found elongated with a plastic deformation of base material.

From these findings, the Investigation concluded that the right lower back pivot stop bolt, most likely, fractured due to a force generated by the Aircraft impact. This caused the right seat pan base to be released, and the left lower back pivot stop to be extracted from its position, completely folding the seat base down.
