Air Accident Investigation Sector

- Final Report -

AAIS Case N° AIFN/0012/2017

AIRPROX (Loss of Separation)

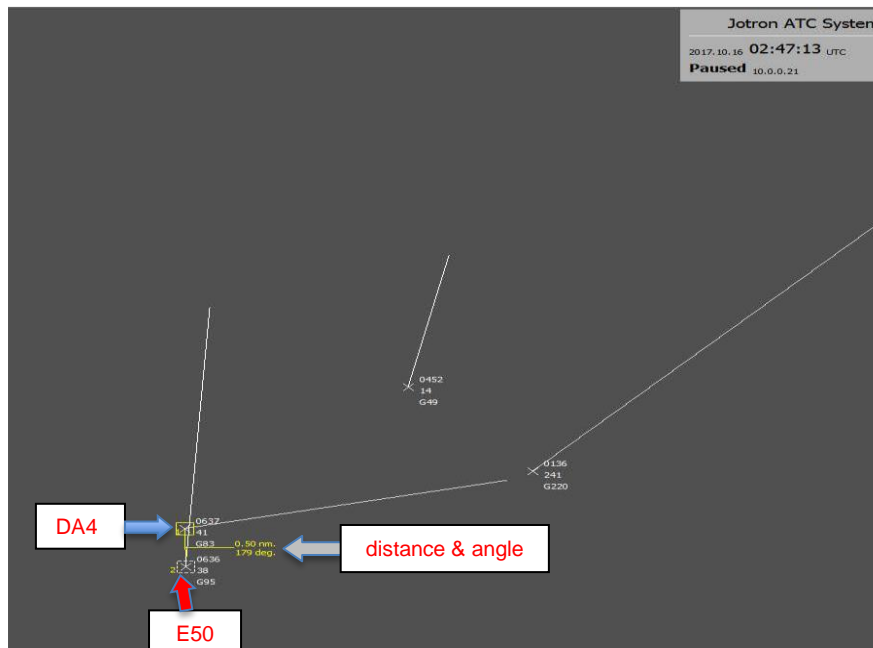
Figure 1. Radar snapshot at 02:47:13 UTC

The following snapshots were taken from the radar recording and do not accurately represent exactly what the controller saw on the radar screen at the time of the Incident. In addition, the range scale varies between snapshots. The radar snapshot illustrated in figure 1 represents the calculated closest distance (approximate 0.5 nm/300 feet) between the aircraft at 0247:13LT. At that time, the E50P started to descend, upon receiving the instructions from

APPE ATCO to stop the climb at an altitude of 3,000 feet. At that moment, the E50P was climbing through 3800 feet for 5,000 feet is illustrated in figure 1.

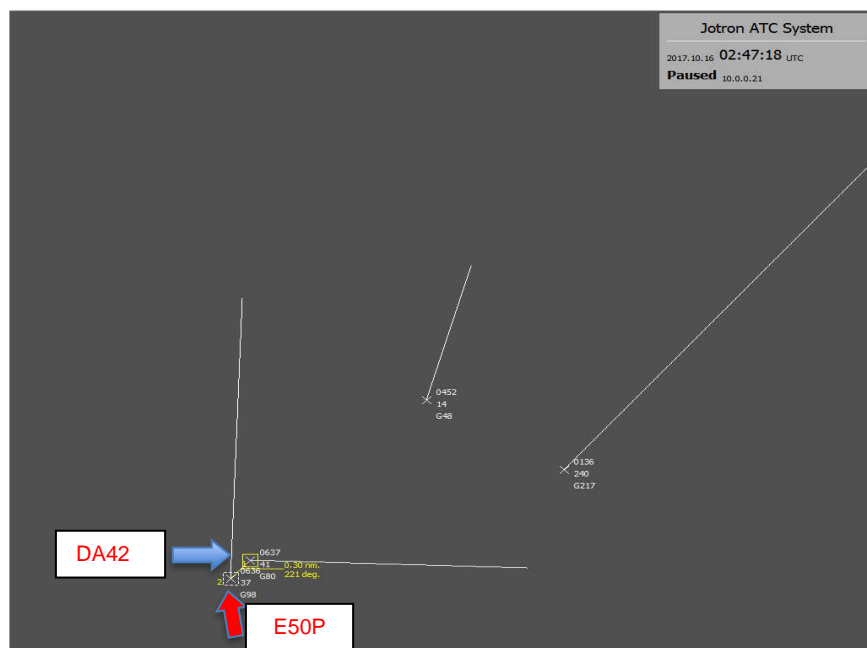
Figure 2 Radar snapshot at 02:47:18 UTC

The next radar snapshot indicates the time when the instructor pilot of the E50P reported having the DA42 visual. Approximately, at the same time the DA42 crew reported visual with the aircraft to their right hand side crossing below their aircraft. The time of the snapshot was 0247:18 and the DA42 was at 4,000 feet with the EP50 at 3,700 feet, the calculated horizontal separation was 0.30 nm and 300 feet and were crossing at the angle of 221 degrees at the right side of DA42 and 41 degrees of the E50P above the right wing (figure 2).

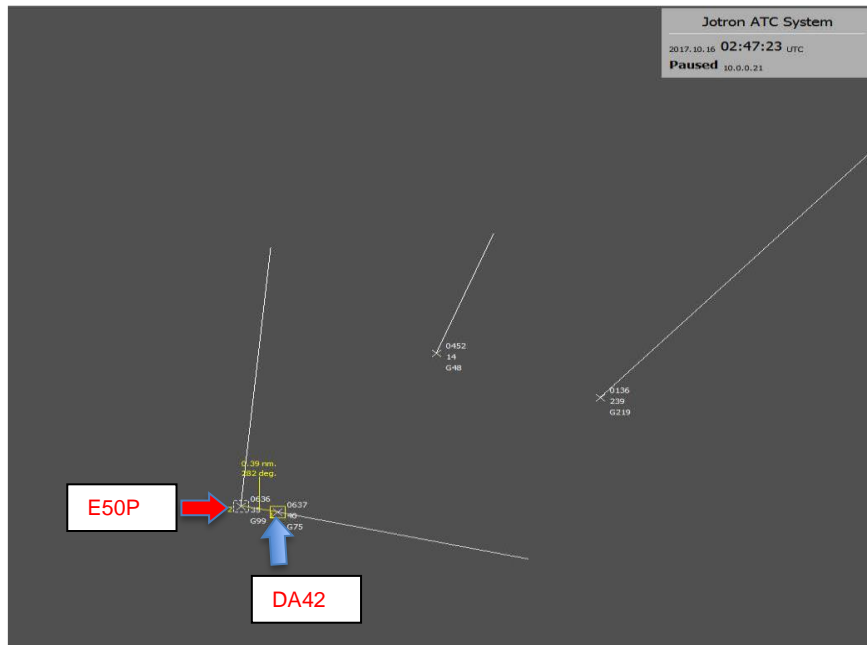
Figure 3. Radar snapshot at 02:47:23 UTC

The next radar snapshot (figure 3) represents the position of both aircraft at 0247:23 UTC indicating approximately when the E50P passed behind the DA42 with a

vertical displacement of 600 feet, and a horizontal separation of approximately 0.39 nm. The Minimum Separation Standard approved for use in the Approach East Zone was 1,000 feet vertical and 3 nm longitudinal by Radar. Both aircraft continued increasing the separation distance as the E50P continued climbing whereas the DA42 was maintaining altitude of 4,100 feet.
