AAIS Case N° AIFN/0008/2020

Nose Gear Impact During Landing

| Make and Model: | Diamond-DA-40 |
| Nationality and Registration: | The United Arab Emirates, A6-FAG |

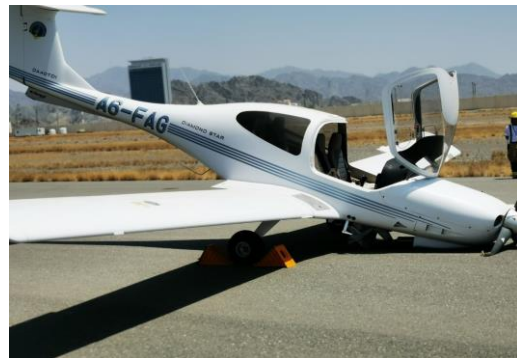
in such an attitude that the propeller had been damaged. (Figures 1 and 3)

Because of impact with the runway, the nose gear detached and was found 20 meters away from the Aircraft (figure 2). In addition, the propeller blades were bent and fractured. The propeller paint was peeled off due to the impact. The Aircraft was found in a forward leaning position.

Figure 1. Aircraft position at rest

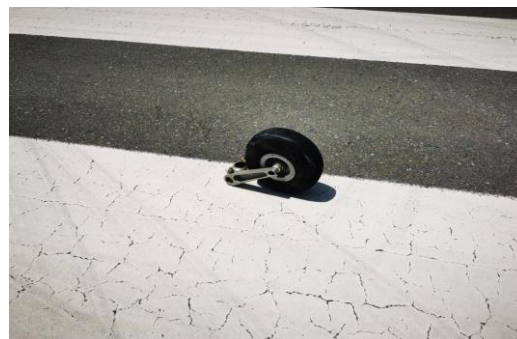
Figure 2. Detached nose gear

The Air Accident Investigation Sector determines that the cause of the Accident was the inappropriate landing technique performed by the Trainee Pilot, which led to Aircraft bounce and subsequent forced touchdown. The nose landing gear detached and the propeller contacted the runway surface causing substantial damage to the Aircraft.

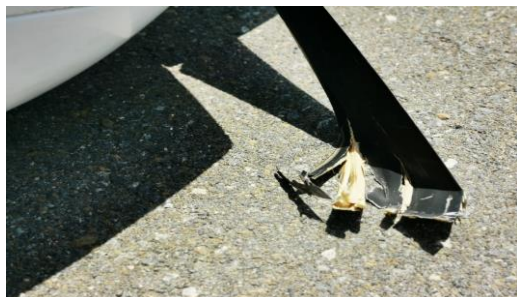
Figure 3. Damage to Aircraft propeller

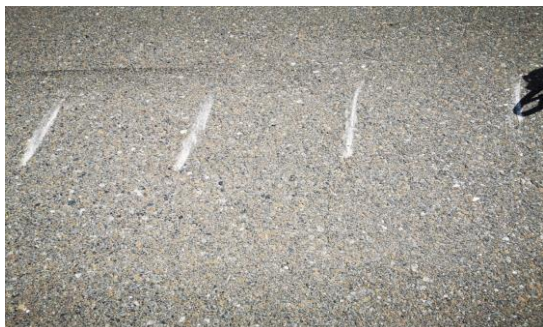
The propeller contact with the runway surface caused slashes. (Figure 4)

Figure 4. Slashes left by the propeller on the runway

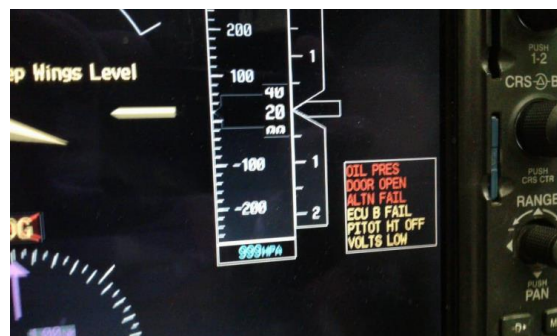
The Trainee Pilot stated that upon her return, she noticed engine control unit (ECU) B fault light illuminating on the cockpit display accompanied by a beep. She proceeded normally without declaring an emergency. The air traffic control (ATC) at Fujairah International Airport advised the Trainee Pilot about the availability of runway 29 and runway 11 for landing. The wind data as per the weather report provided to the Trainee Pilot was indicating 6 knots wind speed, blowing from 60 degrees. In her interview, the Trainee Pilot mentioned that the wind was at 90 degrees

Figure 6. ECU B failure caution

“Press the ECU Test Button for more than 2 seconds to reset the caution message.

1. If the ECU B caution re-appears, or cannot be reset:
 - Land on the nearest suitable airfield.
 - The engine must be serviced after landing.
2. If ECU B caution can be reset:
 - Continue flight.
 - The engine must be serviced after landing.”
