Air Accident Investigation Sector

Serious Incident

AAIS Case N° AIFN/0004/2019

Engine Failure after Takeoff

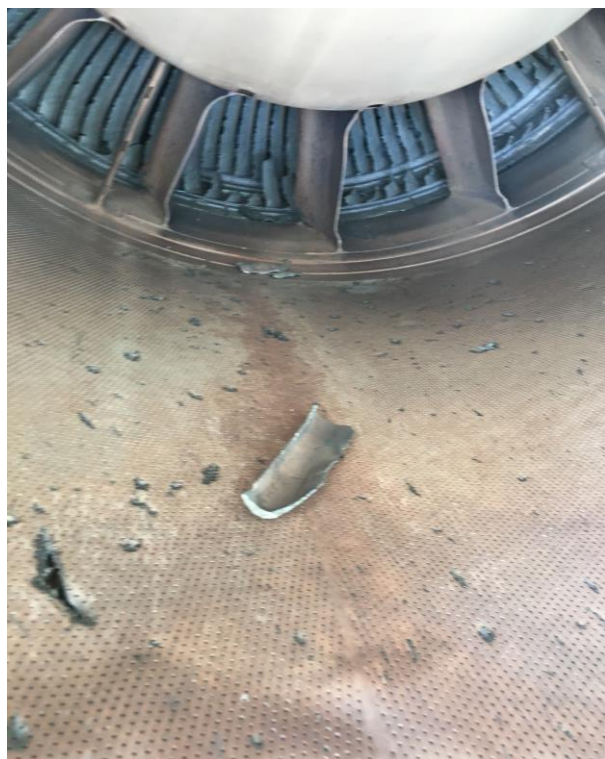
There was no visible damage to the engine cowling, engine intake or fan blades. An inspection of the engine exhaust identified that the low pressure turbine had suffered extensive damage.

Liberated engine debris exited the exhaust case and damaged the acoustic panel. (Figure 2)

Figure 2. Damage to the No.1 engine turbine and exhaust case acoustic panel, and turbine debris

- (f) The Aircraft landed after 17 minutes without further incident.
- (g) Engine turbine debris exited through the exhaust case, causing damage to the exhaust case acoustic panels.

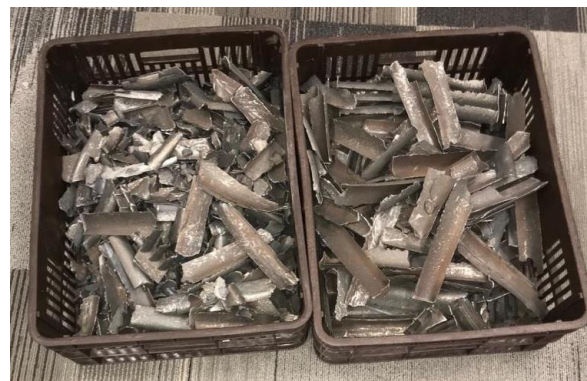
Further impact damage was observed at the left wing inboard flap-hinge fairing and the underside of the left wing outboard flap assembly outboard of wing station 486. Impact marks were evident on the

lower surfaces of the left inboard aileron and lower wing panels 541FB and 541JB. The airport ground operation services performed a runway inspection and collected numerous pieces of engine debris from the end of runway 30. No damage to property or to the environment was reported. (Figure 3)

Figure 3. Debris collected from the runway

- (h) Turbine debris impacted the left wing inboard aileron, lower wing panels 541FB and 541JB, and the flap-hinge fairing resulting in damage to these areas.

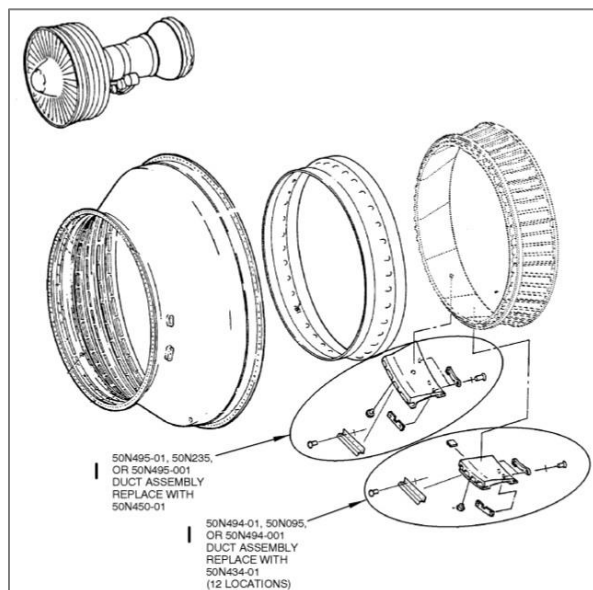
The engine manufacturer, Pratt & Whitney, identified that the riveted seal plates on the outer transition duct segments, also known as the 3rd stage low pressure turbine duct segments, may become loose and could be liberated into the low pressure turbine duct due to normal engine vibrations.

Figure 7. PW4000 3rd stage LPT duct replacement segments as per Service Bulletin [Source: Pratt & Whitney]

Airworthiness Directive AD 2012-22-16 was prompted by 16 previous reports of damaged or failed outer transition duct segments. Damage or failure of these duct segments can lead to “low pressure turbine damage, uncontained engine failures, and damage to the aircraft”.

As a result, Service Bulletin PW4ENG 72-488, initially issued on 29 October 1993, required the identification and replacement of outer transition duct segments part numbers during the next low pressure turbine disassembly.

The Airworthiness Directive compliance was specified as the next time the 3rd stage low pressure turbine was exposed during an engine shop visit, or “At the next piece-part exposure after the effective date of this AD”. For the purpose of the Airworthiness Directive, the FAA defined a “piece-part exposure” a time, when “the 3rd stage LPT duct segment is removed from the engine and completely disassembled”.

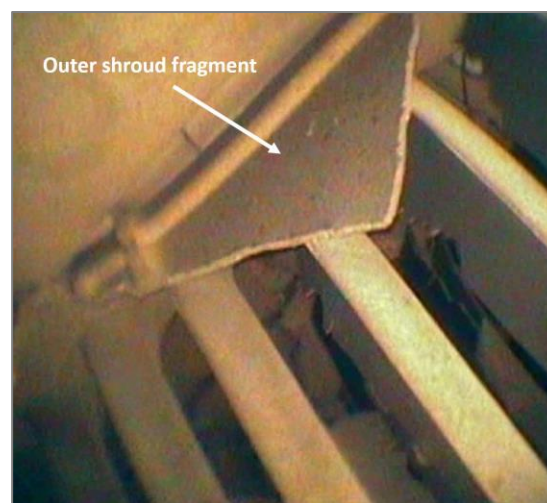
Pratt & Whitney identified a fragment of the outer transition duct segment resting on the 3rd stage low pressure turbine vanes, as depicted in figure 8, and concluded that the engine damage

Figure 8. Outer transition duct fragment resting on 3rd stage low pressure turbine vanes

was most likely initiated by a failed outer transition duct segment.

The liberated duct segment initiated secondary damage to the 3rd stage low pressure turbine and, as a consequence, blades and vanes

of subsequent stages of the low pressure turbine were damaged and/or liberated.

The fragment found resting on the 3rd stage low pressure turbine vane was identified as a piece from the outer transition duct segment.

liberation of an outer transition duct segment, located between the 2nd stage high pressure turbine blades and the 3rd stage low pressure turbine vanes, which initiated secondary engine turbine damage.
