Air Accident Investigation Sector Accident – Final Report –

AAIS Case N°: AIFN/0002/2018

Impact with Building After Takeoff

Operator:	UAL Incorporated
Make and Model:	SkyRunner MK 3.2
Nationality:	The United States of America
Registration:	N143SR
Place of Occurrence:	Sky Hub Margham, Dubai
State of Occurrence:	The United Arab Emirates
Date of Occurrence:	9 February 2018

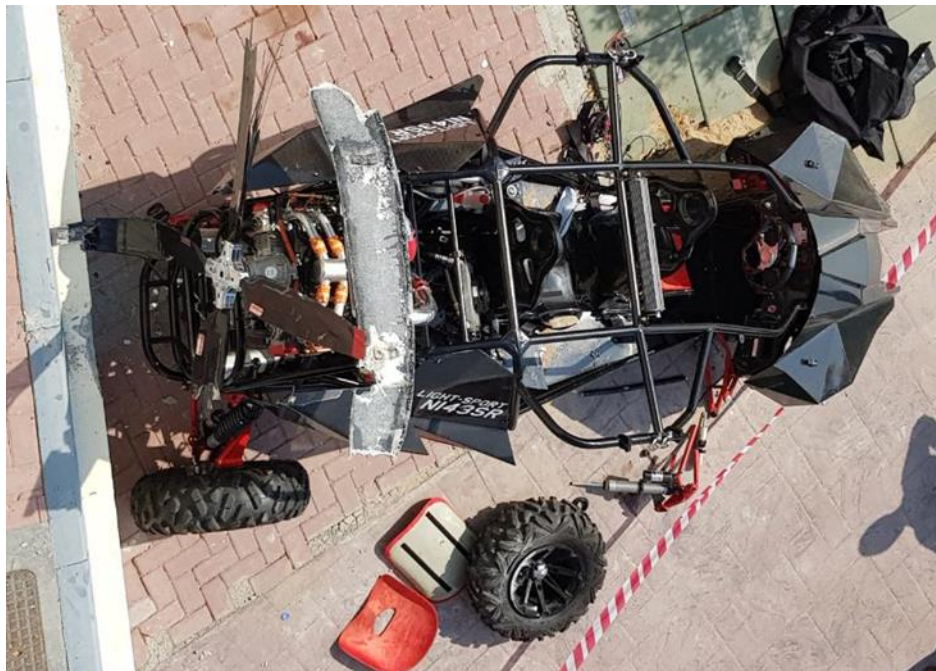
Figure 2. General view of Aircraft damage

The forward wheels of the Aircraft impacted the building, separated, and fell to the ground. The Aircraft frame structure was damaged and both left side wheel shafts were broken and detached. There was no external damage to the engine but the propeller was damaged. The Aircraft structure was damaged beyond repair (figure 2).

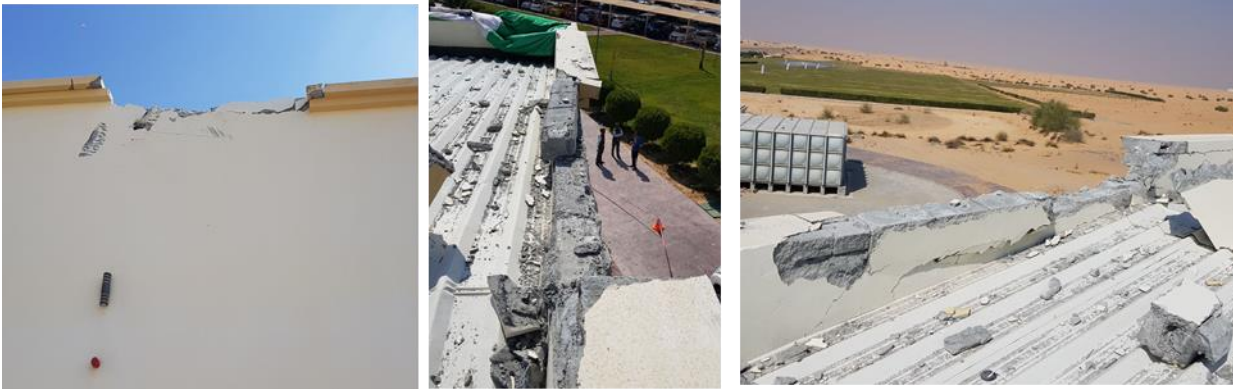
Figure 3. Damage to the building

There was damage to the building as shown in figure 3, but no other damage to the environment.

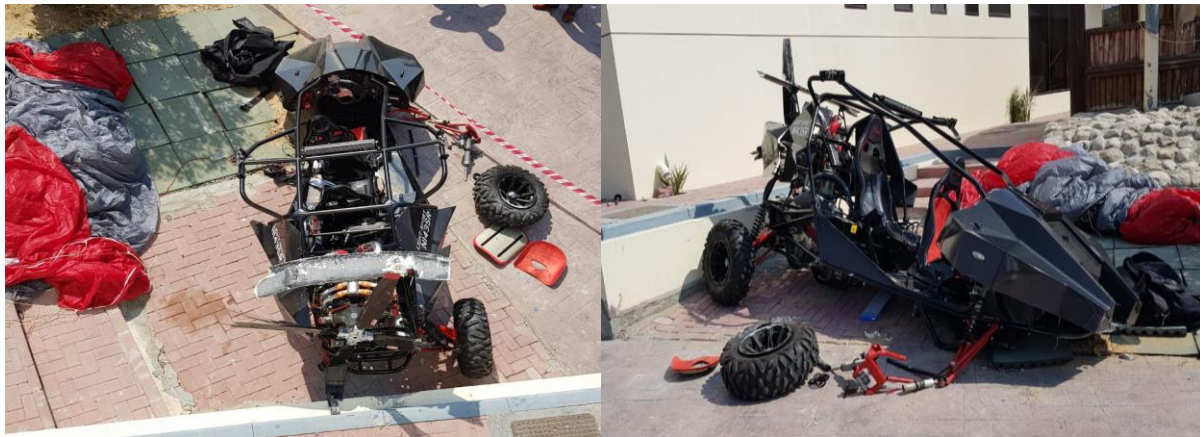
Figure 12. Aircraft wreckage

The Aircraft undercarriage impacted the edge of the building roof and then fell approximately seven meters to the ground where three wheels separated from the carriage. The Pilot and passenger seat belts were intact after the impact. The four propeller blades were fractured as projected in the figure 12.

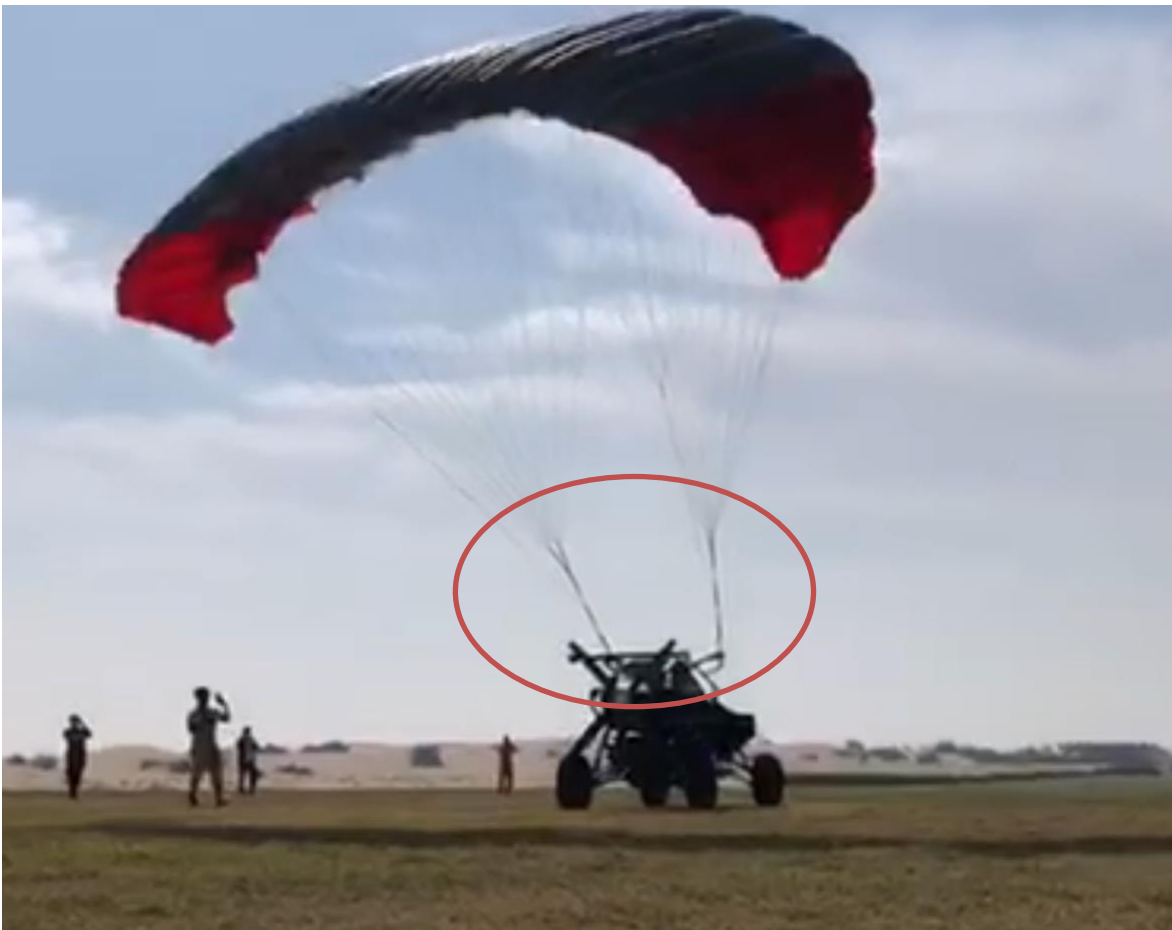
Figure 16. Wing suspension lines

As per the manufacturer's pre-flight check requirement, inspection of the wing suspension must be conducted on the ground. The Investigation confirmed that the Pilot laid out the wings on the ground as per the specification. The suspension lines are the structural skeleton of the parachute and their function is critical since twisted lines cause steering control difficulties once the machine becomes airborne and twisted lines can wrap around the parachute airfoil⁴.

The pilot shall not attempt to fly as a wing with line twists is not airworthy until the twists have been removed (Roy's Powered Parachute, page 184)

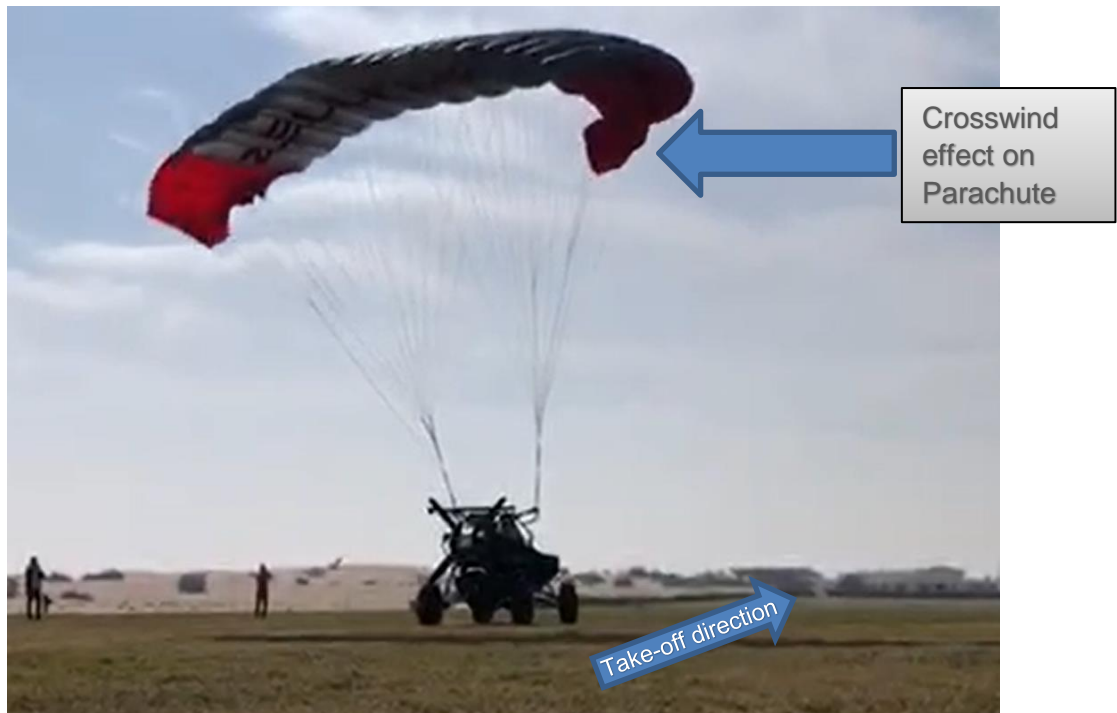
Figure 17. Crosswind effect on the parachute at the start of the takeoff roll

During the initial take-off roll, a crosswind effect was observed in the video still shown in figure 17. The crosswind direction of between 42 and 72 degrees off the take-off heading caused inadequate inflation of the right outboard section of the parachute during the early stage of the take-off roll. Subsequently, the canopy rapidly inflated and liftoff from the runway was normal.

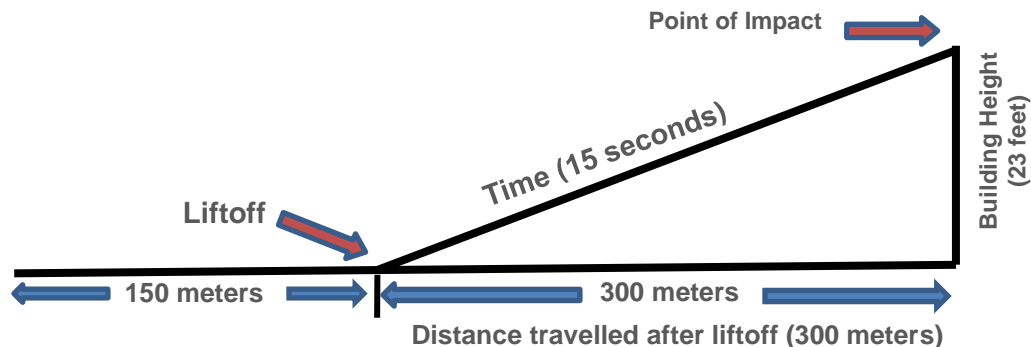
After liftoff, the Aircraft climbed to 10 ft within the first five seconds. Within eight seconds after liftoff, the Aircraft slowly reached a height of 15 ft. It maintained this height until 11 seconds after liftoff and then climbed slowly to a height of 20 ft. until 13 seconds after liftoff. At 13 seconds after liftoff, the Pilot made large control inputs. The control inputs caused a slight deviation towards the southwest to the direction of flight. The Aircraft impacted the building some 15 seconds after liftoff at a height of 23 ft. (7.1 meters)

The length of the take-off roll to liftoff was 150 meters, and from liftoff to impact with the building was approximately 300 meters. The Aircraft impacted the building at roof height, 23 ft above ground level.

The overall rate of climb and ground speed were calculated to be approximately 92 feet per minute (fpm) and 45 mile per hour (mph), respectively.⁵

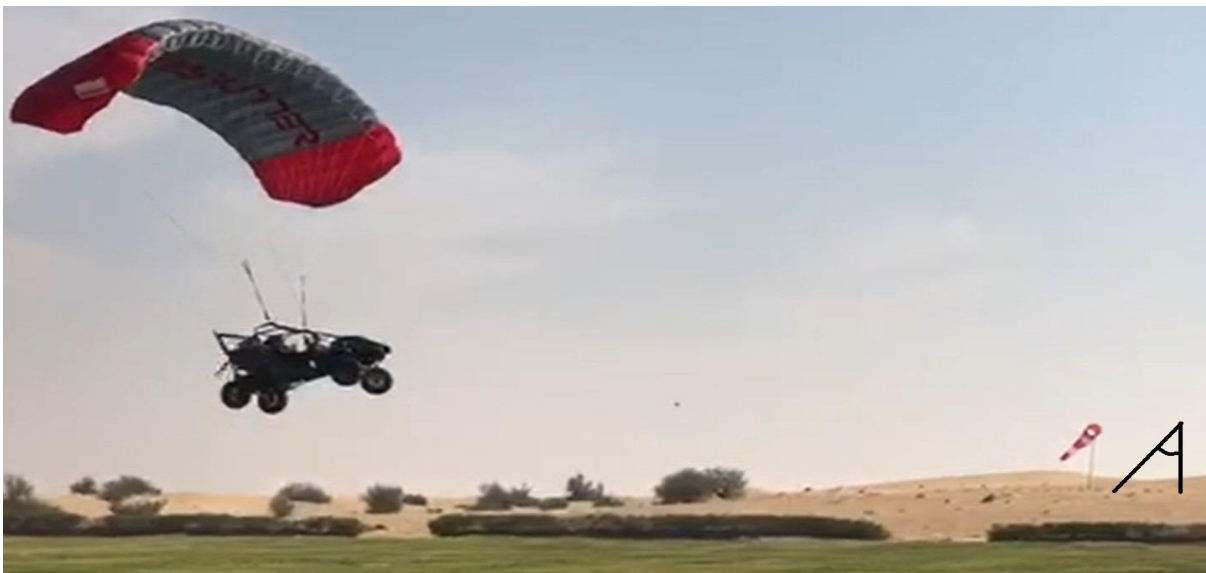
Figure 19. Windssock angle

The weather data provided showed that the wind direction on 9 February 2018, between 1000 and 1030 LT, was from the southwest between 200 and 240 degrees with a speed of 4 to 5 knots.

As per the operations manual, the crosswind during the takeoff shall not exceed more than 20 degrees off the take-off heading. The change in wind direction from 200 to 240 degrees relative to the 160-degree runway heading gave a crosswind component between 2.5 and 5 knots, which was within the limitation. However, in this case, the wind direction change was outside the wind direction limitation, which was between 40 and 80 degrees.

As per the standards, published by the Federal Aviation Administration of the United States (FAA) a windsock angle of 90 degrees to the windsock pole is 15 knots of wind speed. The Investigation observed in the video captured during the take-off and climb that the windsock located adjacent to the runway heading was at a 45-degree angle to the pole as shown in figure 19. Therefore, the wind speed is considered seven knots from the 200-240 degrees direction towards the northeast. In this case, the crosswind component was between 4.5 and 7 knots.

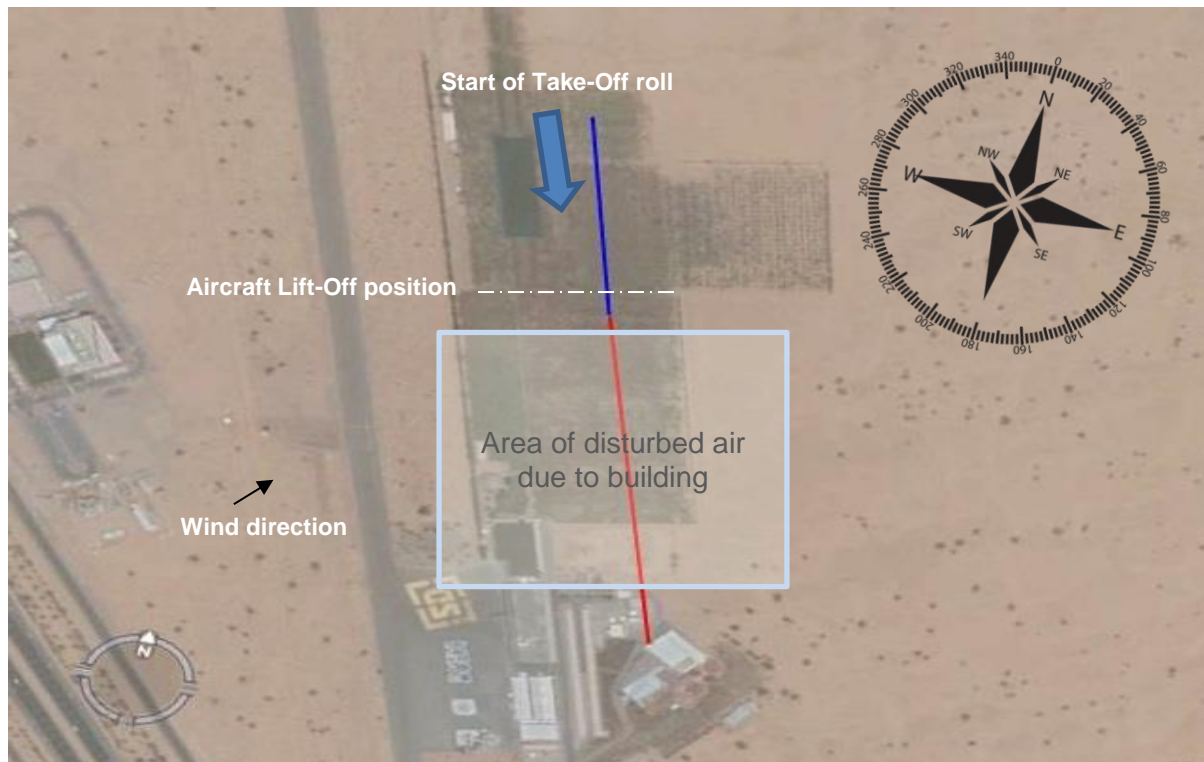
Figure 20. Take-off environment and wind effect

After lift-off, the Aircraft only achieved a slight increase in height over the runway due to the effect of the take-off crosswind limitation. As the flight continued and the Aircraft climbed slowly, it entered an area of turbulent air that caused it to descend slightly.

The Investigation believes that the area of turbulent air was due to the effect of rotors produced by the passage of the wind over and around the buildings located to the side of the runway on the take-off heading. As illustrated in figure 20, the combination of the out of limits crosswind take-off and the entry of the Aircraft into the area of turbulent air caused a reduction in lift, which prevented the Aircraft from climbing and led to the impact with the building.
