# Air Accident Investigation Sector

AAIS Case N° AIFN/0006/2019

## Balloon Hard Landing

Operator:	Balloon Adventures Emirates LLC
Make and Model:	UltraMagic N-500
Nationality and Registration:	United Arab Emirates, A6-BOY
Place of Occurrence:	Dubai
State of Occurrence:	The United Arab Emirates
Date of Occurrence:	6 April 2019, 0240 UTC

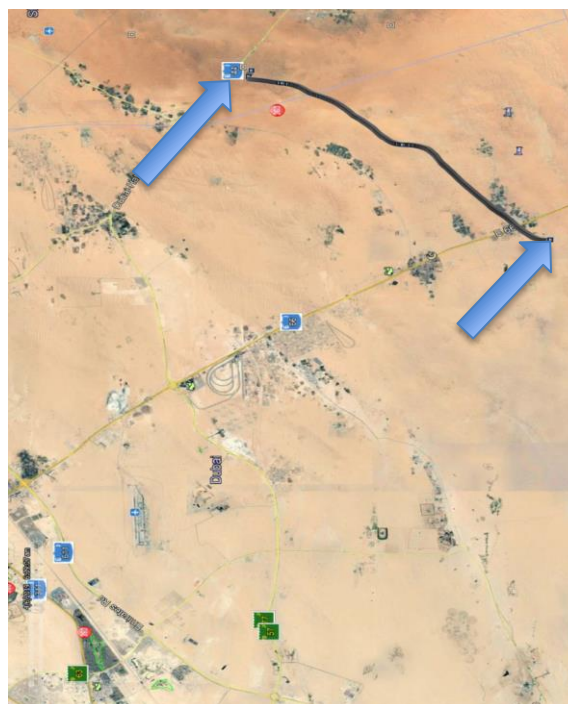
Figure 1. Balloon launch and landing location

As the Balloon commenced its approach to the landing site, the wind speed was 16 knots. During approach, the wind suddenly shifted through approximately 90 degrees and was now coming from a southeast. Four minutes before landing, the wind speed dropped to eight knots, and during the final approach, the wind speed increased again to 17 knots. The Pilot started to use the red line fast deflation system (FDS) to get the Balloon on the ground by removing the excessive hot air from the envelope. The Balloon floated over several obstacles and did not touch down in the planned flat area. Instead, it continued flying close to the ground, a corner of the basket contacted the tip of

a dune, and the basket was tipped onto its side. (Figure 1)

The basket then touched down on the uphill side of a second dune, which stopped its further movement. This abrupt contact of the basket with the dune during the touchdown phase resulted in passengers coming into sudden contact with each other, which caused injuries to three passengers. The passengers disembarked from the basket independently without assistance. The three injured passengers were transported to the nearest hospital, and following preliminary medical tests, two passengers who had experienced minor injuries were released immediately. One passenger who was seriously injured was hospitalized.
