Air Accident Investigation Sector

- Preliminary Report -

AAIS Case N° AIFN/0005/2021

Emergency Landing after Engine Failure during Approach

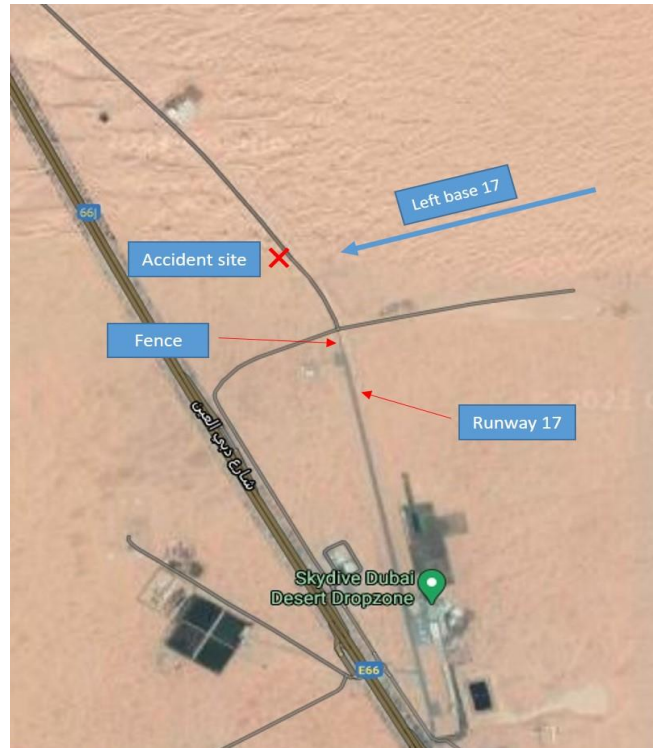
Figure 1. Aircraft flight direction on left base to runway 17

At 1530 LT, the Aircraft was on the left base to runway 17 of the Skydive Dubai airfield at an altitude of approximately 500 feet, when, during the propeller pitch change for landing, the engine stalled and shut down. The Pilot attempted to restart the engine without success. He stated that he noticed that the airbrakes were partially deployed, which he immediately retracted. He also noticed that the propeller had stopped in the 'feather' pitch position.

At this point, the Aircraft was at the end of the left base and the Pilot noticed an asphalt road leading towards the airfield on the left. However, a fence separated the road from runway 17 and he decided to turn right, into the wind, where the road continued in a long straight direction.

During the steep right-turn, the right wing touched the road and fractured. The Aircraft touched down, turned right and slid across the asphalt road into the sand on the other side and came to rest. (Figure 1)

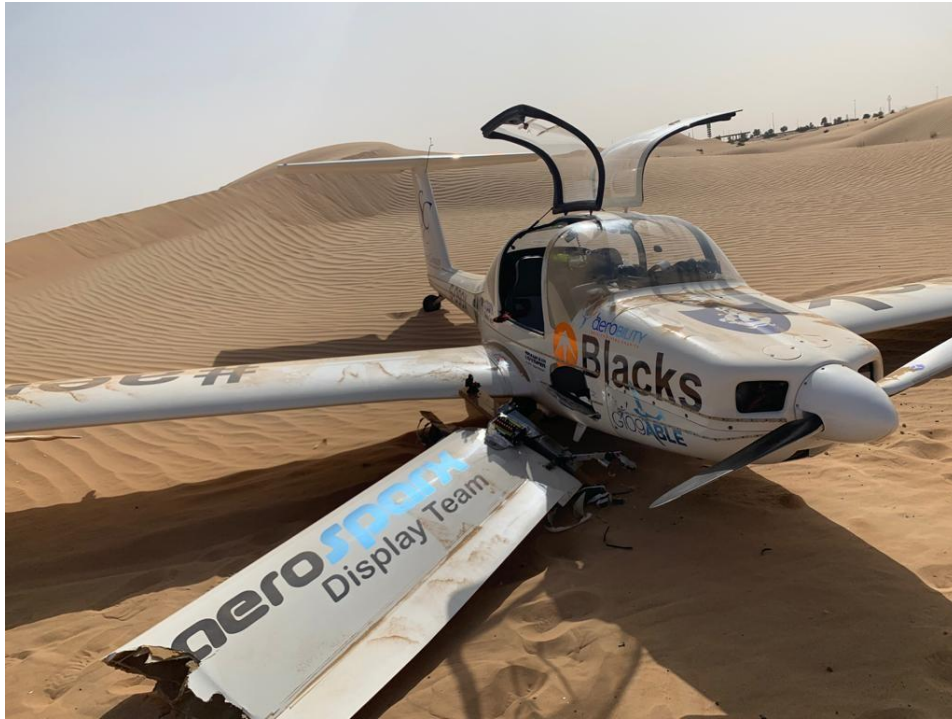
Figure 2. Damage to Aircraft

The right wing fractured and separated approximately 190 cm from the wing tip, the left main landing gear separated from the fuselage, the propeller spinner was dented, and the fuselage and engine cowling exhibited several areas of impact damage. (Figure 2)

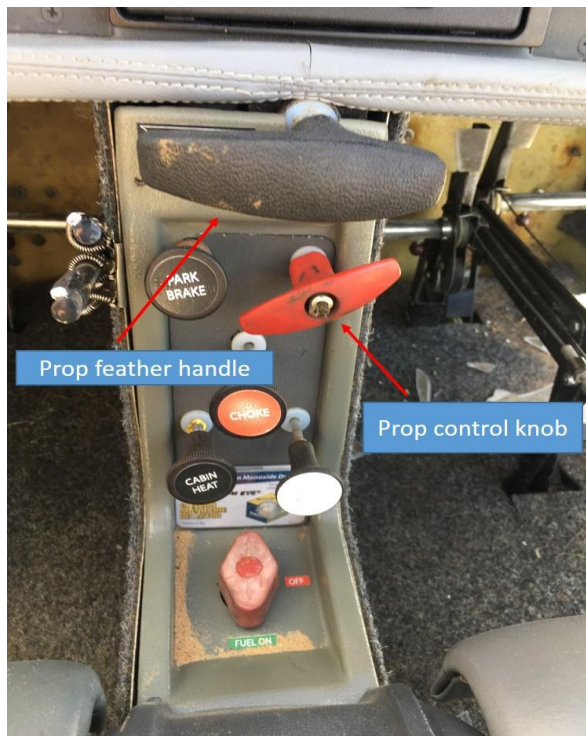
Figure 4. Propeller control on center console

A 'Prop control knob' (handle) is located on the center console and is used to change between 'fine' and 'coarse' propeller pitch. The 'fine' pitch setting allows the engine to turn at high RPM and is normally used for takeoff and climb. This setting is also used for landing in preparation for a go-around. The 'coarse' pitch setting is used for cruise flight. The change between 'fine' and 'coarse' pitch occurs while the engine is running. (Figures 4 and 5)

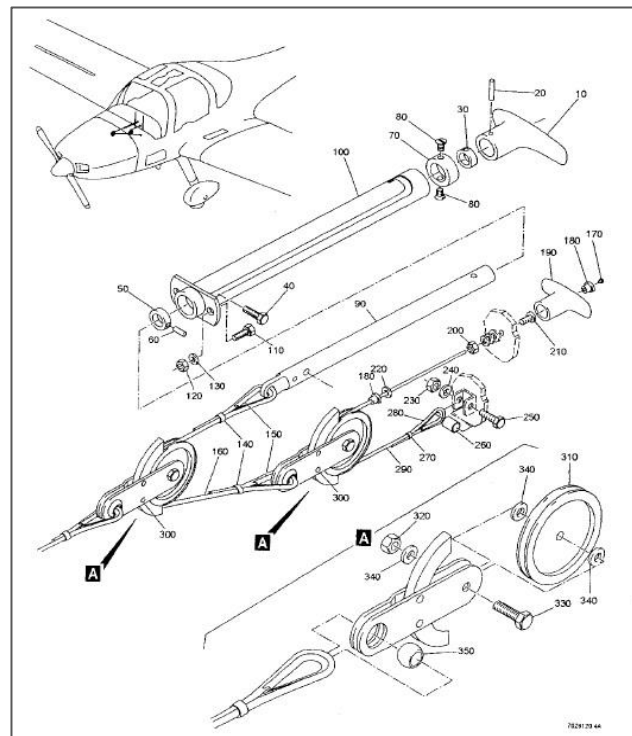
Figure 5. Propeller control mechanism [Source: Grob GmbH]

The 'feather' setting aligns the propellers into the air stream to minimize drag during gliding flight. The 'feather' selection requires the engine to be switched off first and is made by pulling and turning the 'Prop feather handle', located above the 'prop control knob'. Turning the 'Prop feather handle' will apply the propeller brake to avoid wind-milling.

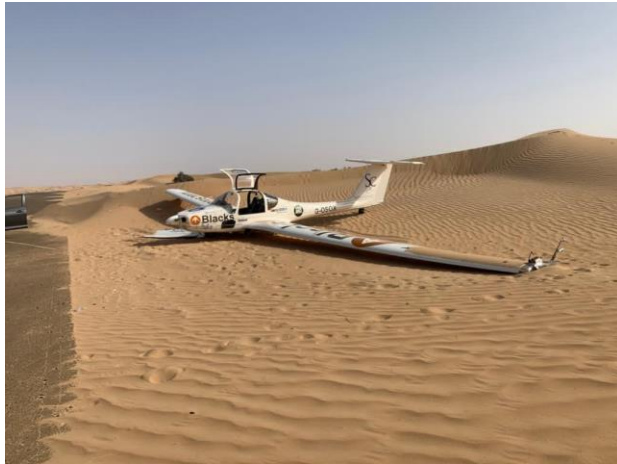
Figure 6. Aircraft location

After the Aircraft made a right-turn into the wind, the right wing impacted the asphalt road. The Aircraft impacted the asphalt road and slid sideways across, until it came to rest in the sand. (Figure 6)

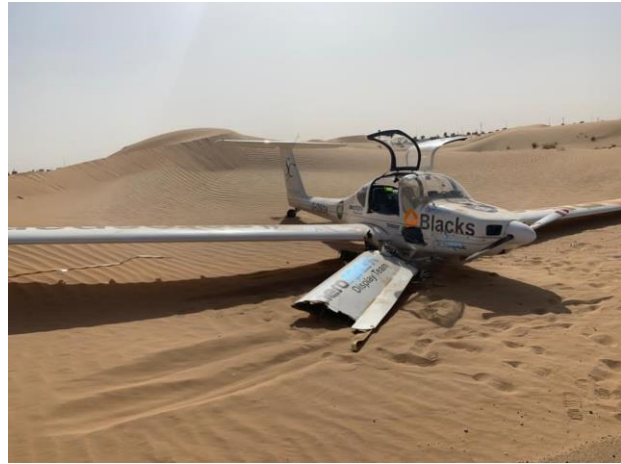
Figure 7. Aircraft damage

The left main landing gear strut detached from the fuselage, and the right wing fractured approximately 190 cm from the wingtip. Damage was also identified on the lower fuselage and the engine cowling and the propeller spinner. The propeller was found in 'feather' pitch position. (Figure 7)
