# Accident

AAIS Case N° AIFN/0015/2021

# Engine Shutdown after Takeoff

| Make and Model: | Aeroprakt A-32 |

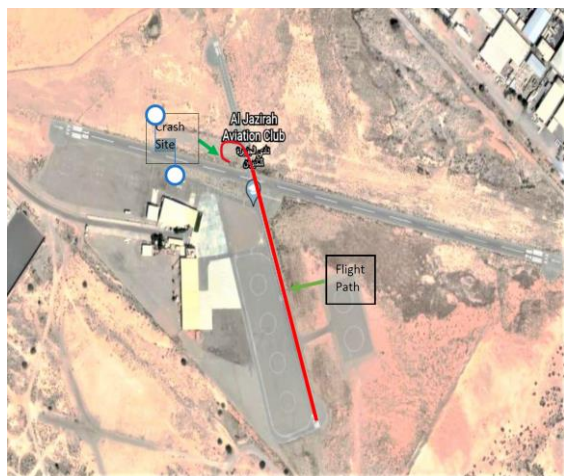
At 1118:22, the Aircraft impacted the ground on a sandy area on the left side of the runway at approximately 230 meters from the runway threshold.

Figure 1. Takeoff, flight path, and crash point

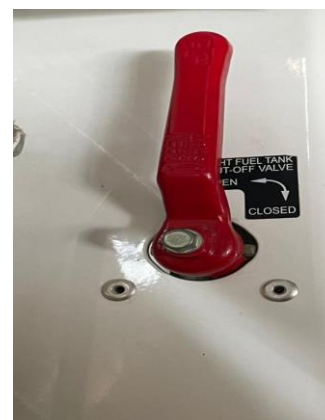
It was most likely that the engine had stopped because of fuel starvation. The field investigation revealed that the fuel shutoff valve was on the ‘closed’ position. However, the Investigation could not determine whether the valve was left at the ‘close’ position from the beginning of the flight, or it was moved to that position by a Pilot’s command or inadvertently, or it was moved during the Pilot and passenger evacuation. (Figures 5 and 6)

**Figure 5.** Fuel shutoff valve - Open position

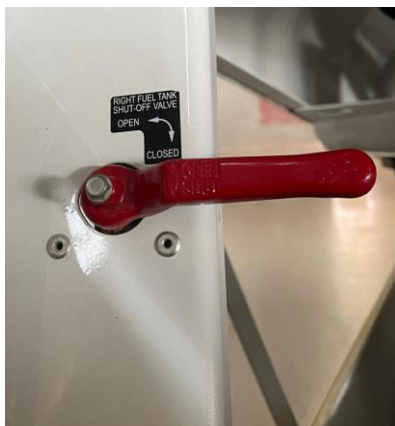
The Investigation compared the engine behavior after shutdown with the simulated engine shutdown and concluded that the engine behavior after closing the fuel shutoff valve was almost identical in both cases. The engine shutdown in both flights occurred when the aircraft was at takeoff with high power setting.

Figure 6. Fuel Shutoff valve - Closed position
