Air Accident Investigation Sector

- Summary Report -

AAIS Case N° AIFN/0010/2021

Aircraft Proximity (AIRPROX)

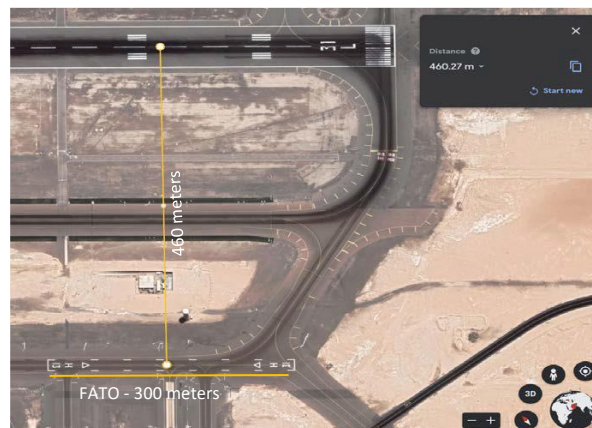
Figure 1. FATO, the runway used for helicopters operations

The FATO is the runway used for helicopter operations and is located on taxiway Foxtrot between Echo 15 and 14, also known as taxiway Foxtrot 13/31. It is offset and parallel with runway 13R/31L, by approximately 460 meters (figure 1). It is restricted to daytime operations only.

The length of FATO is 300 meters. Parallel operations from FATO and the south runway (runway 13R/31L) are allowed if traffic information has been passed to both aircraft.
