# Air Accident Investigation Sector

## Serious Incident

AAIS Case N° AIFN/0011/2022

## Runway Incursion

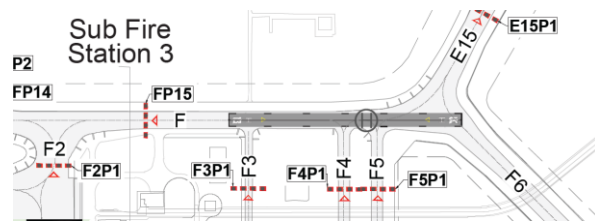
Figure 3. AIP – Stop bars and intermediate taxiway holding positions surrounding FATO

Figure 3 illustrates a screenshot of the stop bars on taxiways F3, 4, and 5, and the intermediate holding position (IHP<sup>8</sup>) locations surrounding the FATO. The chart shows the stop bars and IHPs F3P1, F4P1, and F5P1 of the taxiways.

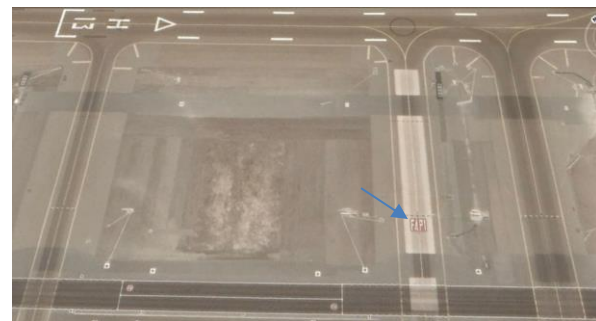
Figure 4. IHP F4P1 ground marking on taxiway F4

Among taxiways F3, 4, and 5, only taxiway F4 was marked with IHP (F4P1) (figure 4).

As shown in Figure 4, the IHP F4P1 on taxiway F4 was marked in white painted ground marking, while there were no IHP F3P1 and F5P1 markings for taxiways F3 and 5.

The Investigation recommends that Abu Dhabi Airports review the existing markings, and consider adding ground markings that indicate intermediate holding points on taxiways F3 and F5.

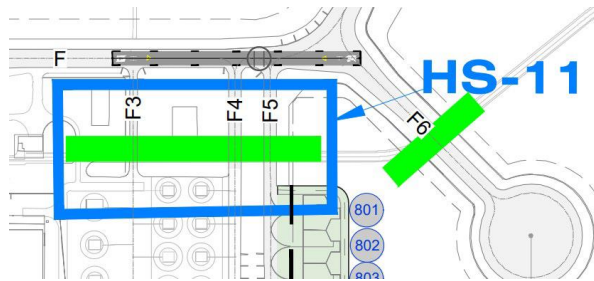
Figure 5. AIP – Hot spot HS11 area

As per the AIP, the area on taxiways F3, 4, and 5 are declared as a hotspot<sup>9</sup> HS11<sup>10</sup> area (figure 5).

<sup>10</sup> HS11: A history of incidents between aircraft and ground service equipment due to vehicle crossing on taxiways F3, 4 and 5, pilots to exercise more caution and increase situational awareness.

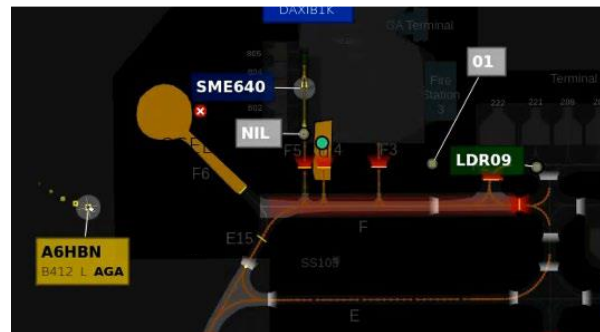
Figure 6. SME640 position when flight crew reported holding short of taxiway F to Ground Control [Source: GANS]

At 0651:27, the SME640 flight crew reported holding short of taxiway F when the Aircraft was passing abeam stand 803 (figure 6). The Ground South Control instructed the flight crew to contact Tower South Control on 119.200 MHz frequency, and the flight crew read back, "Confirm one two nine two." Subsequently, the controller repeated the Tower South Control frequency, "One one niner decimal two Abu Dhabi tower south." According to the recordings, the flight crew read back the frequency unclearly and only the last three frequency characters were clearly spelled out, "[unreadable] nine decimal two."

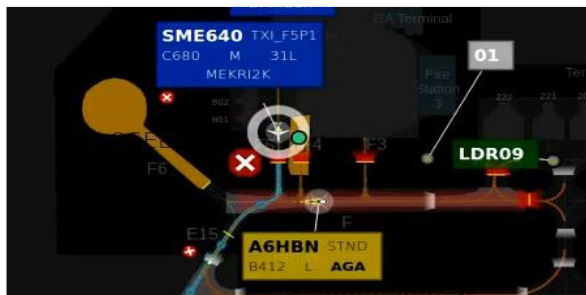
**Figure 7.** SME640 position when Tower South Control instructed the flight crew to hold short of F31 [Source: GANS]

At 0651:55, the Tower controller contacted SME640 providing instruction to hold short of F31, and informing that A6HBN helicopter was landing on F31 (SME640 Aircraft's position is shown in figure 7). The flight crew read back by stating, "Hold short foxtrot three [unreadable] land sierra mike echo six four zero."

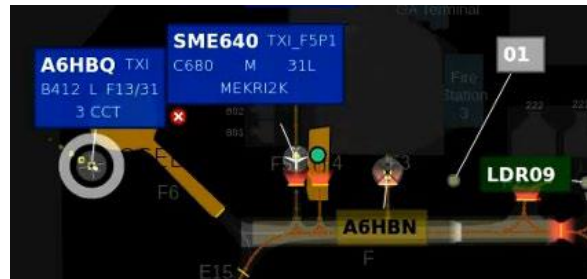
**Figure 8.** SME640 position when Tower South Control instructed A6HBQ to land [Source: GANS]

At 0652:24, the Tower controller instructed A6HBQ to land (at pilot's discretion) on F31 and informed the surface wind of 360 degrees direction at 11 knots. At this time, SME640 was moving to approach the stop bars as shown in figure 8. A6HBQ flight crew correctly read back and stated that they will report when F31 would be clear (vacating of FATO) and the Aircraft position is at taxiway F3.

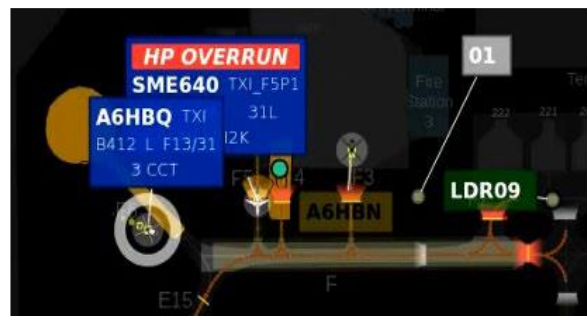
**Figure 9.** SME640 Aircraft crossing the stop bars on taxiway F5 [Source: GANS]

At 0652:35, SME640 Aircraft was crossing active stop bars on taxiway F5, which resulted in the activation of the safety net alarm "HP OVERRUN<sup>11</sup>" (figure 9). HP OVERRUN was activated since FATO was considered an active runway.

At this time, A6HBQ was on short final at approximately 200 feet above ground level and 130 meters from F31 touchdown zone.

- (g) The weather condition was not a contributing factor to the Incident, and the flight was a day flight.
- (h) The Aircraft crossed illuminated stop bars on taxiway F5 and entered the helicopter final approach/take-off (FATO) without Tower Control clearance while a helicopter traffic was on short final and approaching to land on the FATO.

Therefore, the Investigation recommends that Smart Aviation Company reinforces among their pilots to adhere to the standard operating procedures (SOP) for taxiing aircraft, especially with active stop bars.

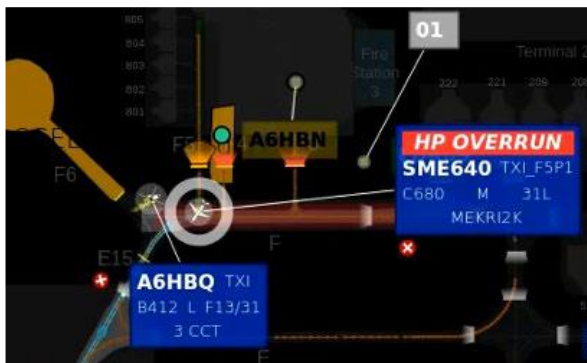
**Figure 10.** SME640 Aircraft entered taxiway F while A6HBQ initiated a go-around [Source: GANS]

The SME640 Aircraft entered taxiway F while A6HBQ was initiating a left turn go-around, and the distance was approximately 100 meters which was the closest distance between both aircraft (figure 10).
