- Preliminary Report -

AAIS Case N°: AIFN/0011/2023

Helicopter Crash Overwater

Operator: Aerogulf Services Co (L.L.C)
Make and Model: Bell B212
Nationality and Registration: The United Arab Emirates, A6-ALD
Place of Occurrence: ARAS driller rig, Umm Al Quwain
State of Occurrence: The United Arab Emirates
Date of Occurrence: 7 September 2023

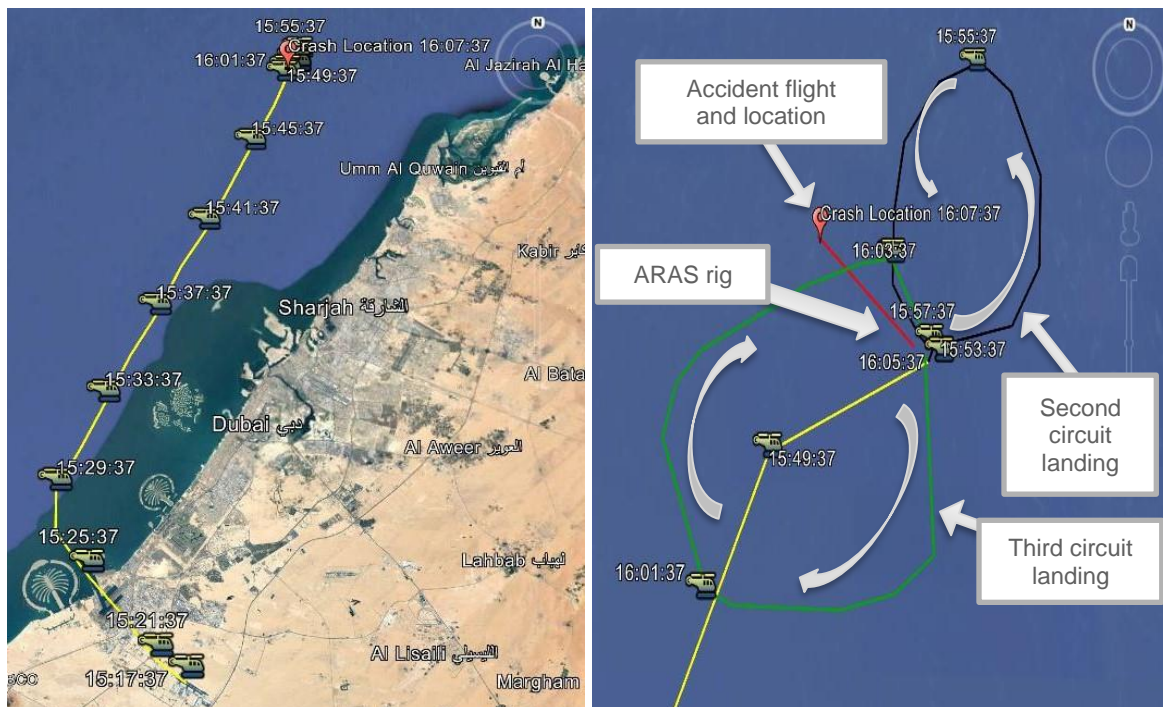
Figure 1. The Helicopter's flight path for the three landings

After the first landing, the Helicopter took off again at 1552 and started a north-eastern direction. Within three minutes, the Helicopter turned back and descended for a second landing, heading southeast similar to the previous landing. Later, at 1559, the Helicopter took off once more, and the crew performed a second circuit around the rig before landing again at 1603 for the third time, heading southeast.

At 1605, the Helicopter took off and changed heading for 180 degrees northwest and continued the flight. One minute later, at 1606, the Helideck Landing Officer (HLO) contacted the radio operator reporting that the Helicopter with the registration ALD had crashed approximately 600 meters away from the rig in the northwest direction.

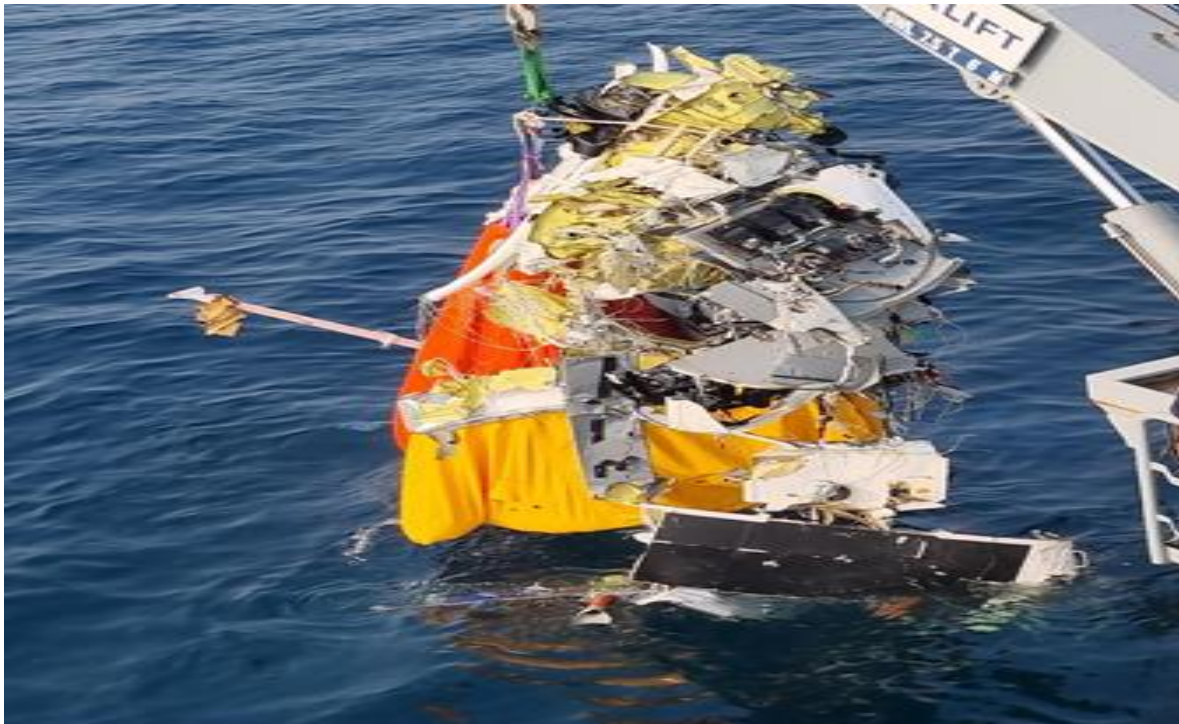
Figure 2. Underwater wreckage recovery

The following day after the Accident, the search operation resumed, but no traces of the wreckage were found. On the day after that (9 September), the SAR team discovered a significant amount of wreckage pieces that were scattered across two separate locations, approximately 100 meters apart. (Figure 2)

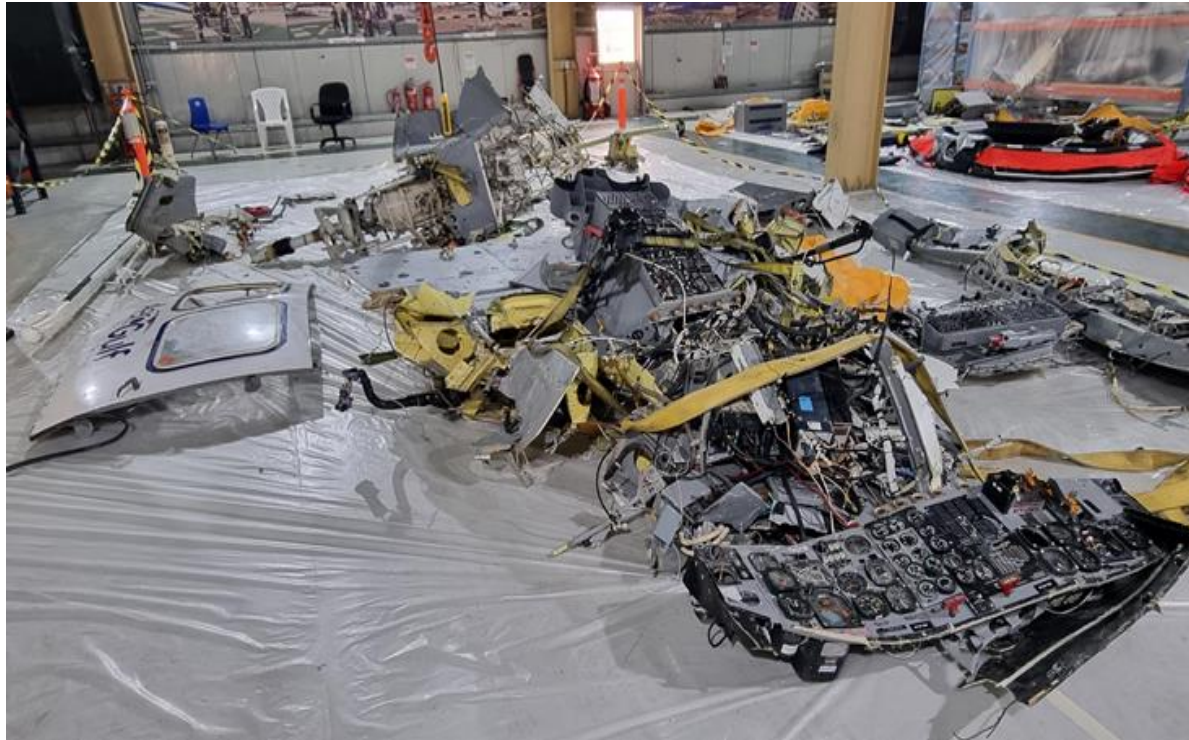
Later, the SAR team managed to successfully recover additional parts of the wreckage, including the cockpit, the main transmission gear, and various structural pieces (figure 3). The search efforts are still underway, and a detailed analysis of the relevant parts' examinations will be included in the Final Report.

Figure 3. Wreckage recovered (cockpit and main transmission gear)
