Accident

- Summary Report -

AAIS Case N° AIFN/0009/2022

Loss of Control-Inflight (LOC-I)

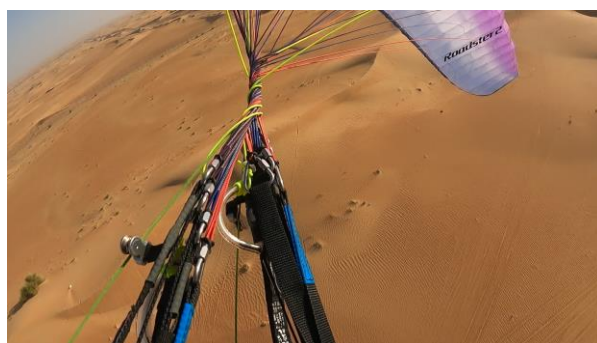
According to the video recording device attached to the Pilot, during the flight, and while the Pilot was heading southwest with a ground speed of about 23 kilometers per hour, the canopy (wing) partially collapsed to the left. The Pilot reacted by applying excessive brake to both sides of the wing leading to its stall and lagging behind the Pilot. Simultaneous to that, the Pilot was applying maximum power by pressing the hand throttle lever and excessive brakes, causing the Paramotor pilot seat to lean and turn right and create a spiral turn, which twisted the lines in the second spiral turn before impact (figure 2).

Figure 2. Spiral turn

This combined application of brakes and engine power to the maximum at this point made the Pilot tilting towards right due to the propeller torque and resulting in twisting of the wing lines and moving the wing towards the right side of the Pilot in parallel to the ground. This movement initiated a clockwise spiral turn until impact.

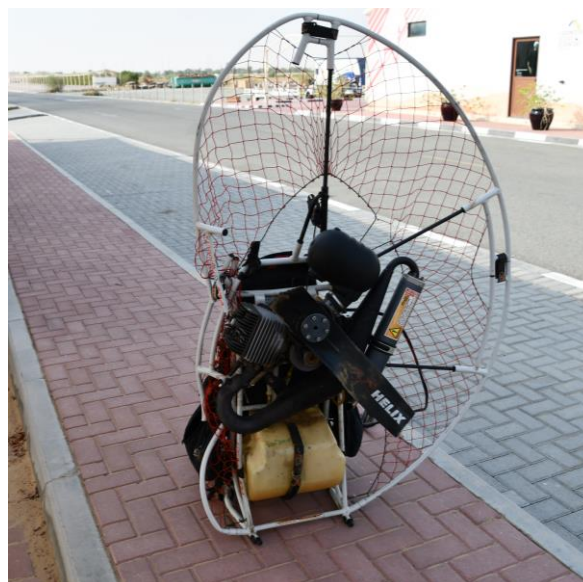
As a result of the impact, the propeller's blades broke and the cage bent (figure 4).

Figure 4. Damage to propeller's blades and cage

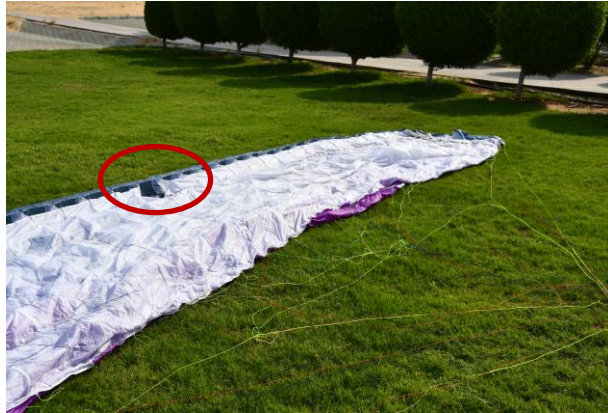
The wing torn in the middle of the leading edge as shown in figure 5.

Figure 5. Damage at the leading edge of the wing

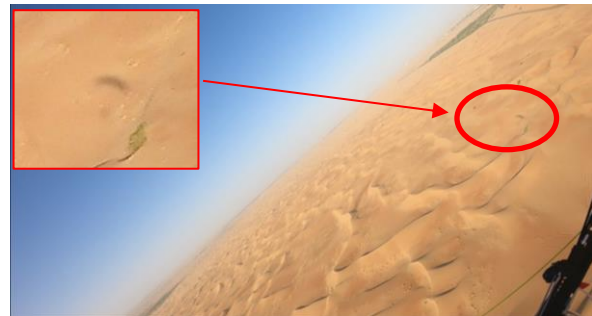
The Pilot was flying normally and then the wing turned left slightly due to partial collapse in left side of the wing. The Pilot then reacted by pulling both brakes down below his chest level.

In addition, the Pilot was seen grasping the throttle consistent with applying engine power to the maximum while pulling the right brake to a position lower than his shoulder (which was beyond the limits). At this point, the wing entered into a stall which indicated by seeing the Pilot's knees elevating up while the wing falls down behind him.

Figure 12. The shadow of the Paramotor during the stall point
