# Air Accident Investigation Sector

### - Summary Report -

AAIS Case N° AIFN/0002/2023

# Parachute Ground Impact

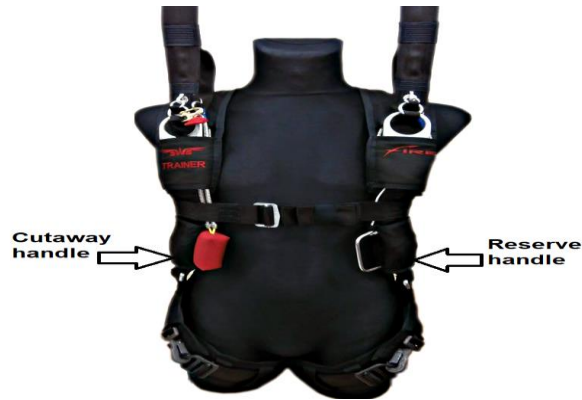
During the emergency procedure, the Skydiver grabbed the cutaway handle but he was not able to fully extend his arm to cut away the main parachute (figure 1). The Skydiver partially cut away his handle which made him hang on one riser. He grabbed the reserve handle and fully deployed the reserve handle. As a result, the reserve parachute was deployed from its container. However, he grabbed the bridle of the reserve free bag and tried to bring it back to him which caused his bridle to wrap around his arm. He tried to clear the bridle but was unable.

Figure1. Cutaway and reserve handle

It was noticed that the Skydiver did not fully pull the cutaway handle to release the main parachute. The Investigation sees that it was probable that hand force that the skydiver applied to pull the cutaway handle was not enough.

The Air Accident Investigation Sector determines that the cause of Parachute ground impact was the inability of the Skydiver to pull the cutaway handle. The force exerted on the handle was not enough. The downgraded Skydiver's situation awareness could not enable him to take the appropriate recovery actions at the right time.

Raise awareness about the complexity of line twist emergency, and include this emergency as a part of the safety briefs for the visiting skydivers.

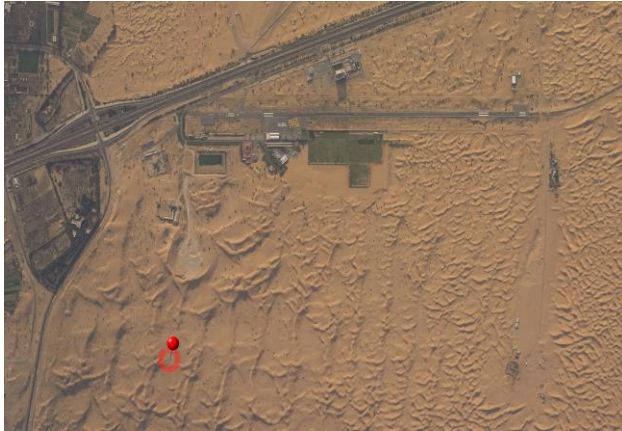
Figure 2. The Parachute impact point
