# Air Accident Investigation Sector

## Accident - Final Report -

## Runway Undershoot

| Make and Model: | Cessna 208B Grand Caravan |

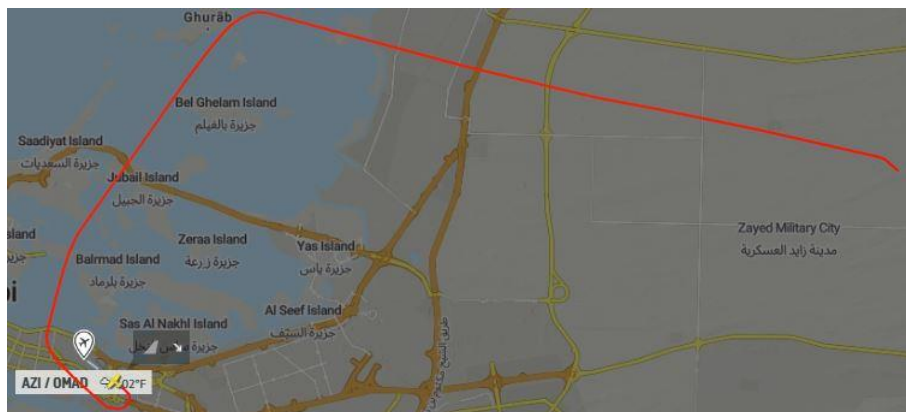
Figure 1. Aircraft flight path from OMAW to OMAD

The Aircraft followed the glidepath until reaching 700 feet, thereafter, it steepened the vertical flightpath to a low-level flight over the garden of Sheikh Zayed Grand Mosque, Abu Dhabi, the United Arab Emirates. The Aircraft impacted palm trees and continued the flight path until ground impact at 1337:31, about one kilometer (0.54 nautical miles) from the runway threshold.

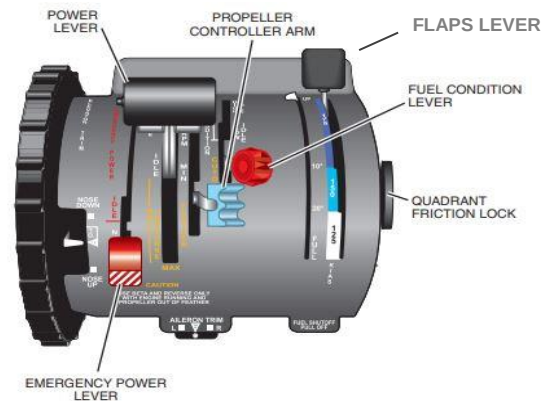
Figure 3. Example of the control pedestal of Cessna 208 Caravan

- Power lever;
- Emergency power lever;
- Propeller controller arm; and
- Fuel condition lever. (Figure 3)

The Investigation could not exactly determine why the Pilot missed to stow the flaps lever. However, since the flaps lever was located besides the fuel condition lever on the control pedestal (as shown in figure 3), and he most probably did not give particular attention when using the lever since his sight was out of the flight deck observing the aircraft (lower) vertical path.

As per the design, the power lever was not equipped with artificial force mechanism, such as detent, that may have enhanced the sensation of the Pilot when he applied in-flight prohibited commands, or that may have resisted such command. Such unfavorable commands may be repeated anytime and cause severe consequences especially if it is applied at low altitudes.

Therefore, Cessna, and in conjunction with the Federal Aviation Administration (FAA) of the United State (as being the regulatory authority of the aircraft design organization) is recommended to carry out risk assessment for a mechanism for impeding retardation of the power lever in-flight to a position beyond the IDLE, or enhance the pilot's awareness by artificial force sensation.

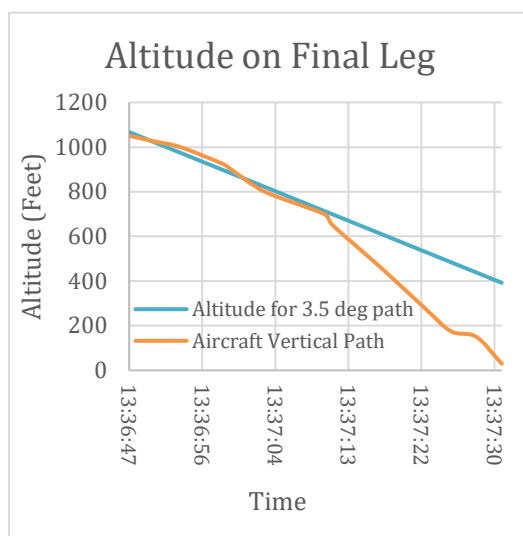
Figure 4. Vertical flight path on the final leg

Figure 4 illustrates the Aircraft's vertical path on the final leg based on the available data. A 3.5 degrees glideslope is included as per the PAPI.

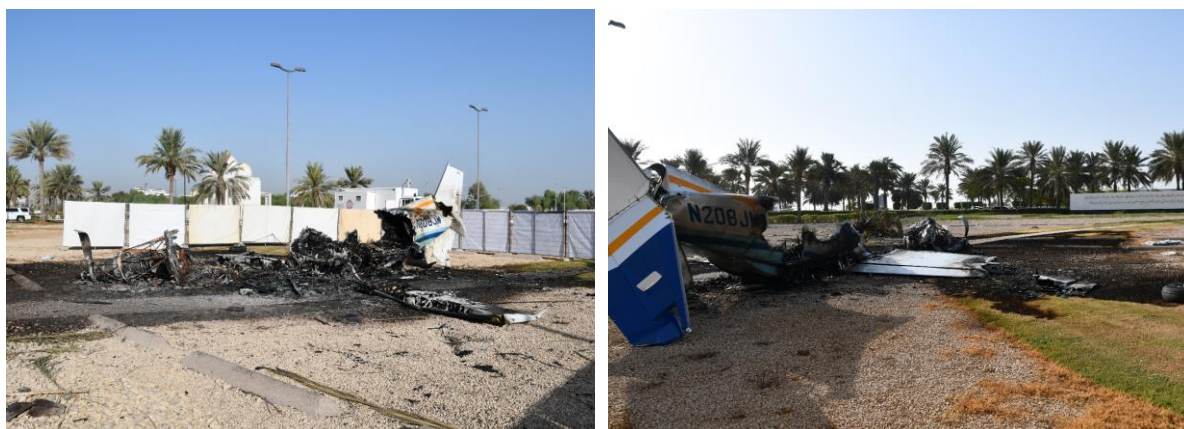
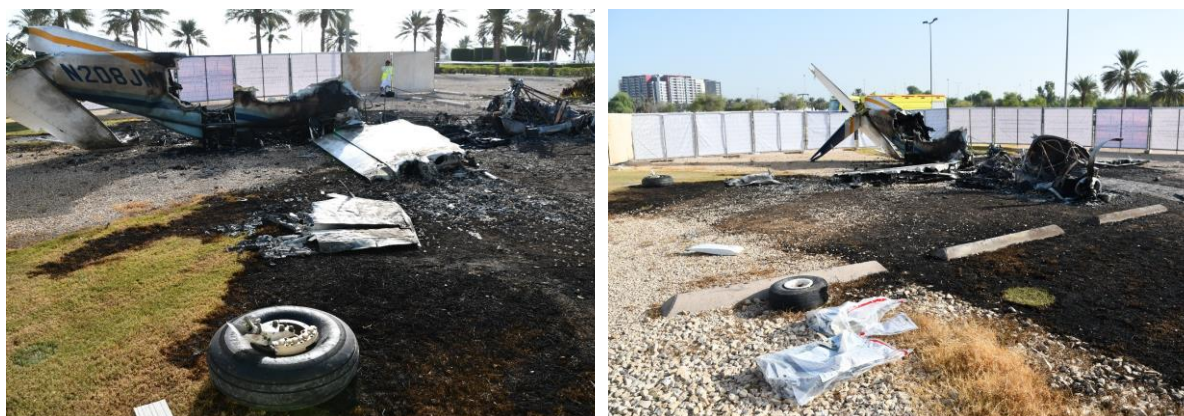
Figure 5. Wreckage distribution

The Aircraft was destroyed by the impact forces. The consequent fire consumed the majority of the aircraft's front and middle structure including the wings. The rear side exhibited damage but with less burnt composite materials.

The wing flaps were found fully retracted to clean configuration. However, the flaps handle disintegrated from the flap control panel and could not be found among the wreckage pieces. (Figure 5)

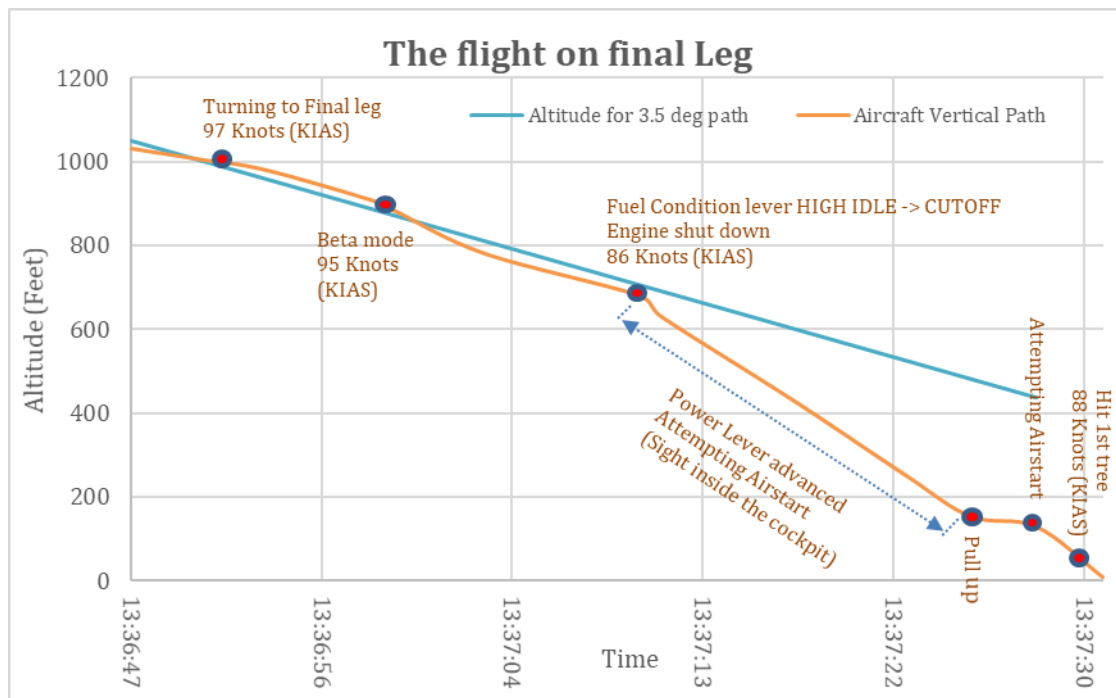
Figure 6. Events on the final leg

When the Aircraft turned to the left from the base to the final leg at 1336:53, the altitude was about 1,000 feet, while the Aircraft was on continuous descent (figure 6).

As per the Pilot's statement, he commanded the flaps to the 2<sup>nd</sup> setting (20 degrees) when the Aircraft was at the base leg, but that setting was not proven by the wreckage which exhibited the flaps fully retracted. Therefore, the Investigation determines that the flaps were not extended before the impact.
