# Air Accident Investigation Sector

AAIS Case N° AIFN/0007/2023

## Brake Fire

| Make and Model: | Boeing B777-3FXER |

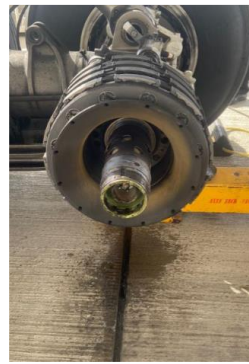
*maintenance manual (AMM) 05-51-14*. It was found that brake assembly number 2 had sustained damage with observed hydraulic fluid leakage from one of the pistons (figures 1 and 2). The brake assembly was replaced as per *AMM 32-45-07*.

**Figure 1.** Hydraulic fluid leakage

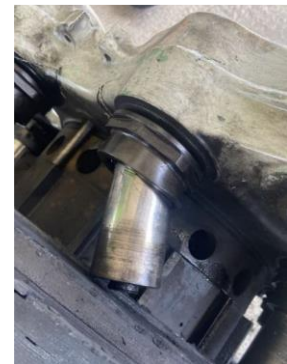
**Figure 2.** Damaged piston

The combination of the pressure plate free rotation and the increased damage to the heat sink assembly caused more uneven wear. The damage on the outboard half of stator 2 probably occurred during the last cycle after landing. This additional uneven wear condition caused one of the pistons (7 o'clock position) to fail.

The piston failure caused a hydraulic leak into the heat sink, leading to the oil heating up and reaching its flashpoint, consequently triggering the brief brake fire.

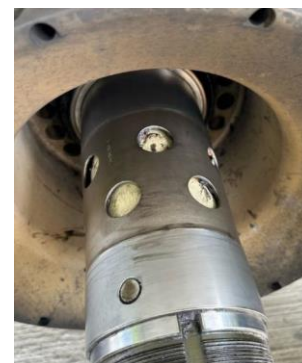
The in-depth inspection found signs of overheating damage on the axle sleeve (figure 3), and therefore, it was replaced in accordance with *AMM 32-11-28*.

**Figure 3.** Overheat damage on axle sleeve

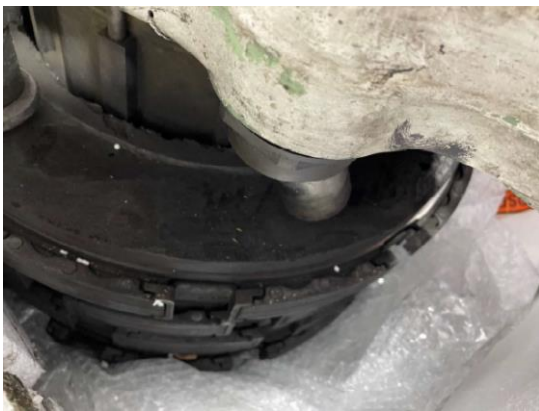
The lugs on the pressure plate had sheared (figure 4), resulting in unrestricted spinning with the rotors. This unrestricted motion led to subsequent damage at the point of contact between the pistons and the pressure plate, carving a noticeable groove into the surface of the pressure plate.

**Figure 4.** Damaged pressure plate and piston [Source: Collins Aerospace]

The examination concluded that the brake fire resulted from the failure of the pressure plate lugs, permitting unrestricted rotation of the pressure plate with the wheel assembly underneath the pistons. This condition, combined with the interaction between the heat sink assembly and dislodged stator clips, created uneven wear.

The damage to the piston was caused by unrestricted continuous rotation of the pressure plate with the wheel assembly underneath the pistons.

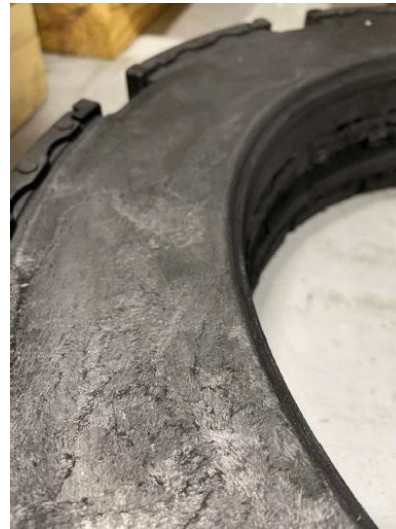
Prior to the brake fire Incident, the lugs on both stator 1 and stator 2 experienced failure. The stator clips became trapped between the heat sink and the torque plate. Damage was found on the inner diameter of the rotor assemblies (figure 5), as a consequence of contact with the dislodged stator clips. This contact-induced damage hindered the uniform distribution of clamp force through the heat sink.

**Figure 5.** Damaged rotor due to contact with stator clips [Source: Collins Aerospace]

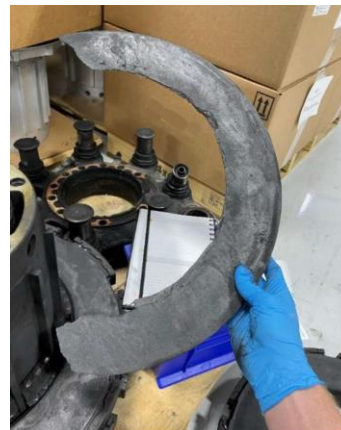
This uneven loading resulted in an unusual wear pattern, wearing entirely through part of the outboard half of stator 2. The remaining section of stator 2 is shown in figure 6.

**Figure 6.** The remaining section of stator 2 [Source: Collins Aerospace]
