# **Air Accident Investigation Sector**

### **-Final Summary Report-**

AAIS Case N° AIFN/0001/2022

## **Runway Incursion**

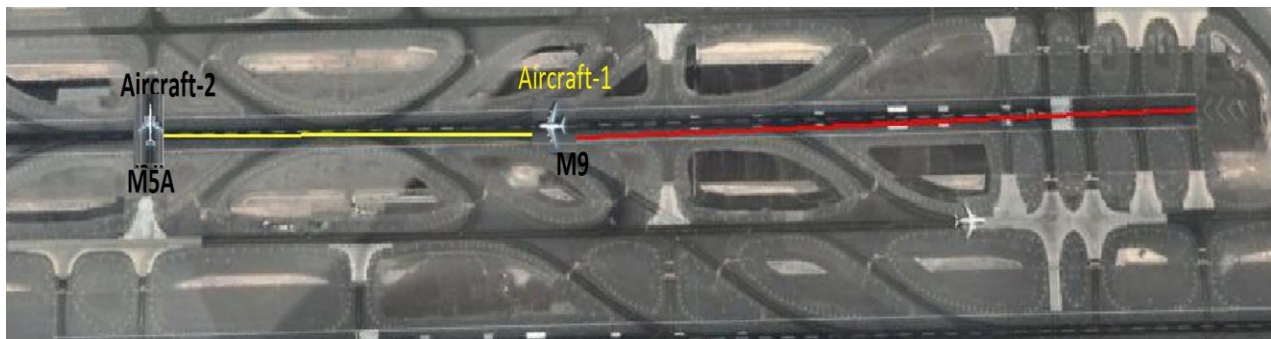
**Figure 1.** EK524 (Aircraft-1) and EK568 (Aircraft-2) on Runway 30R

At 1804:10, AIRN repeated the instruction to the flight crew to stop immediately, and the flight crew did not acknowledge the instructions, but they started to stop the Aircraft. The Aircraft stopped at a position abeam taxiway Mike 9 at 1804:26, which was 1,000 meters short of Mike 5A, after reaching a maximum ground speed of 125 knots. (Figure 1)

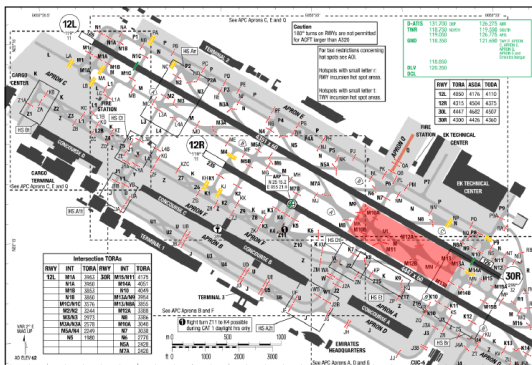
Figure 2. DXB maintenance work on taxiway Mike

As shown in figure 2 the highlight area in red, a significant area of taxiway Mike was blocked on the day of the Incident.

The aircraft taxiing for takeoff had to cross either the arrival runway 30L or the departure runway 30R, depending on which taxi route was taken, since the departure runway was 30R.

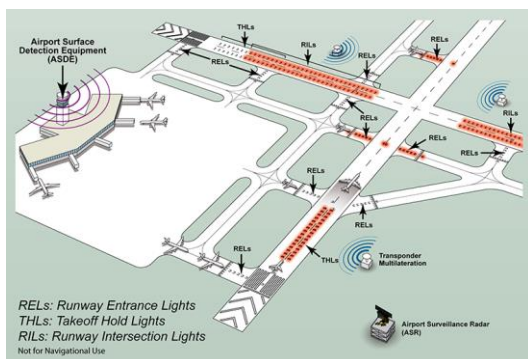
**Figure 6.** Runway Status Light

Therefore, the Investigation recommends that Dubai Airports initiates a safety case study in coordination with the GCAA, dans, and Emirates for the need of enhancing the ground based alert systems that provides warnings and alerts of detected runway incursions to ATC controllers and flight crew.
