- Preliminary Report -

AAIS Case N° AIFN/0015/2023

Severe Turbulence Encounter In-Flight

Operator: Emirates Airlines
Make and Model: Airbus A380-861
Nationality and Registration: The United Arab Emirates, A6-EEV
Place of Occurrence: Male Airspace
State of Occurrence: Republic of Maldives
Date of Occurrence: 4 December 2023

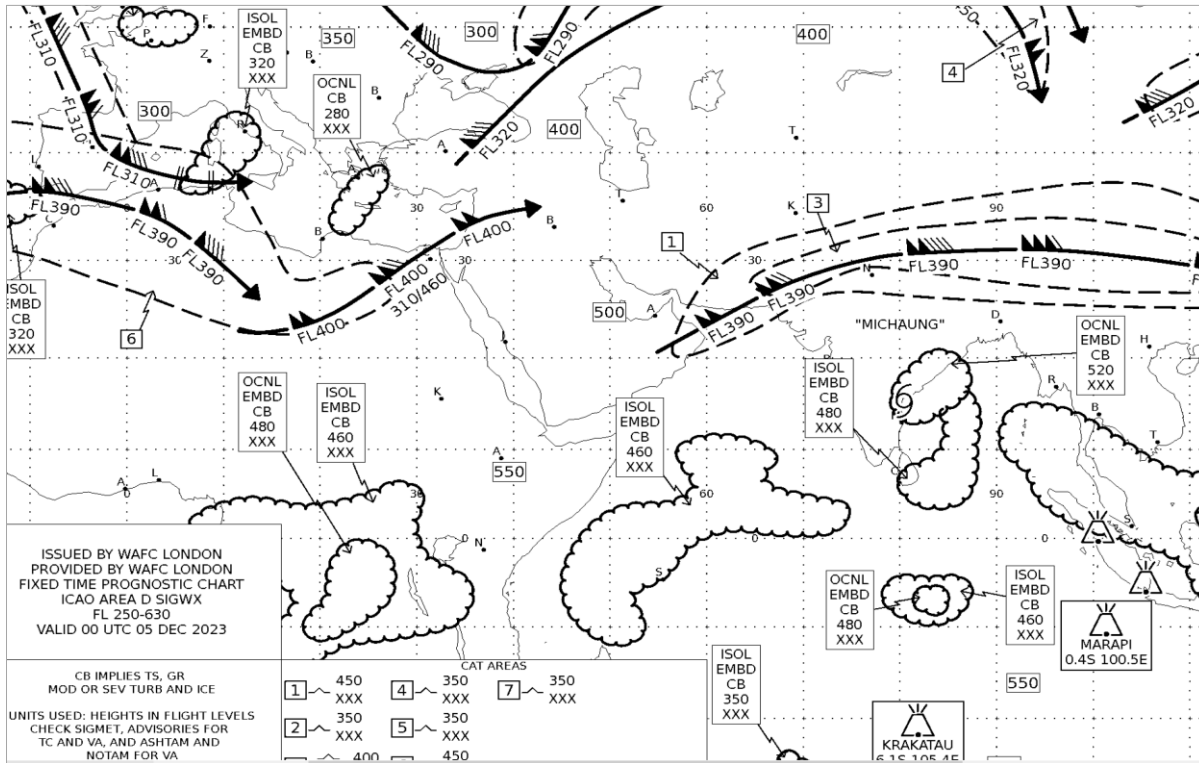
The Investigation examined the weather information provided to the flight crew on the day of the Accident⁴. The forecast for the flight segment over Male FIR indicated the presence of **Cumulonimbus** (CB) cells which were expected to be associated with moderate/severe turbulence and with icing. Additionally, the eastern part of India was impacted by the active cyclone "Michaung," leading to heavy rainfall and flooding⁵.

Figure 3. Weather information forecasting CB formation over and around Male's FIR which was provided to the flight crew

The Commander and augmenting captain stated that they took note of the CB formation at their 10 to 11 o'clock position. In addition, the augmenting captain stated, "there was a layer of clouds that is significantly under the aircraft."
