Serious Incident

AAIS Case N° AIFN/0006/2022

Aircraft Belly Structural Fairing Fracture due to Tire Burst During Flight

Operator:	Emirates
Make and Model:	Airbus A380-842
Nationality and Registration:	The United Arab Emirates, A6-EVK
Place of Occurrence:	During Cruise
State of Occurrence:	The United Arab Emirates
Date of Occurrence:	1 July 2022

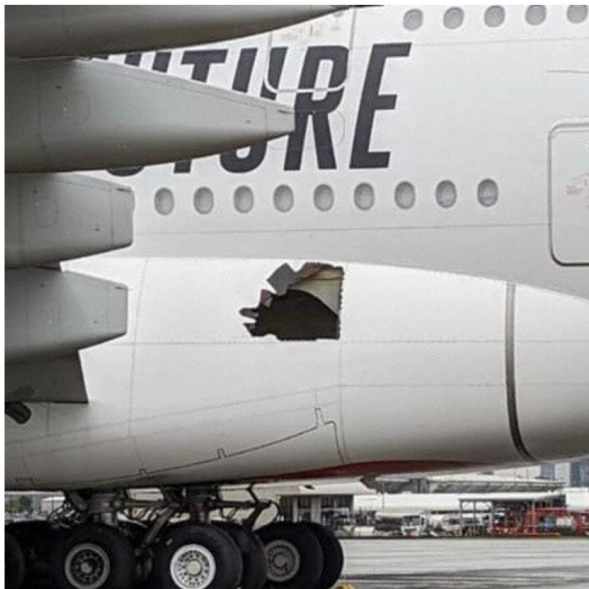
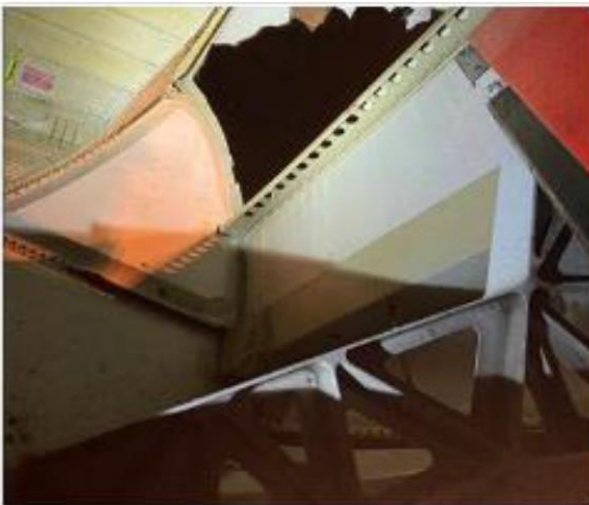
Figure 1. Fairing damage

The defragmented tire chunk impact structural panel (197ET) which was liberated and was not found. This panel was an access panel with standard fasteners. It spans Frames 67 to 72 on the fuselage and was located in the upper belly fairing area. It was supported by 110 screws and washers. The damage was observed between frames 69 and 72. The Aircraft maintenance records review did not reveal any previous damage or repair to this panel. (Figures 1, 2, and 3)

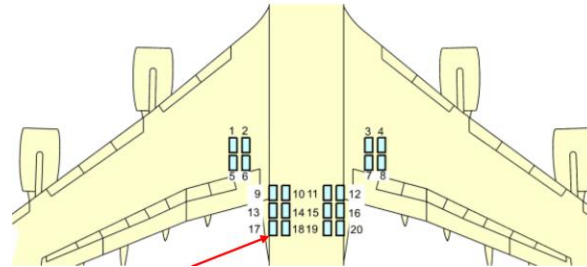
Figure 2. BLG Wheel 17

After landing, an inspection was performed and revealed wheel assembly 17 tire burst and belly fairing panel damage. There was no damage found on the other wheels.

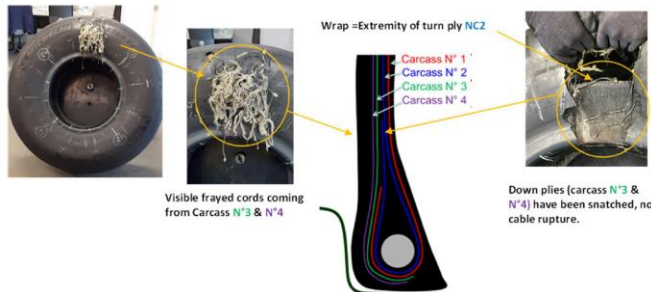
Figure 10. Visual inspection of burst zone

The inspection of the burst zone demonstrated frayed cords coming from carcasses NC3 and 4, indicating damage by tire rolling after the burst event (figure 10). Pulling up the cables of NC3 and 4 carcass plies exposes the wraps of No. 1 and 2 carcass plies. The absence of cables of the down plies (NC3 and NC4 carcasses) under the bead core evidence that down plies were snatched when the burst occurred.

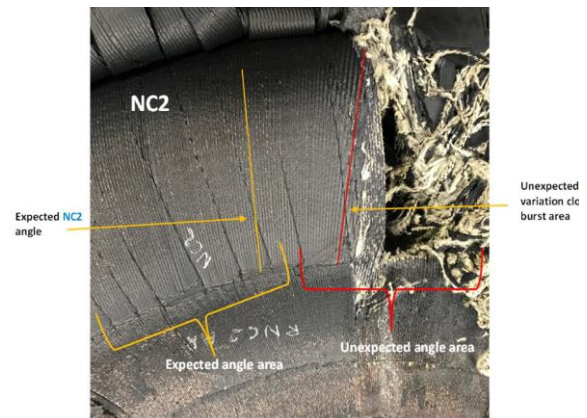
Figure 11. Local cable orientation gap between carcass plies

The separation between the bead flange rubber (BJ) and the outermost casing ply (NC4) in figure 11 is possibly due to a high level of heat or stress coming from the internal structure of the tire (NC2 turn-up).

This stress and heat generated gas have moved towards the outer surface of the tire and created this separation. This separation may have been visible from the outside of the tire before the blow-out.

During the inspection, there was an observation of an unexpected angle variation between carcass cables. When observed, NC2 carcass cables present a significantly lower angle than the theoretical one (figure 11). Outside this region, cable orientation was consistent with the expected value and no cable damage was noticed.

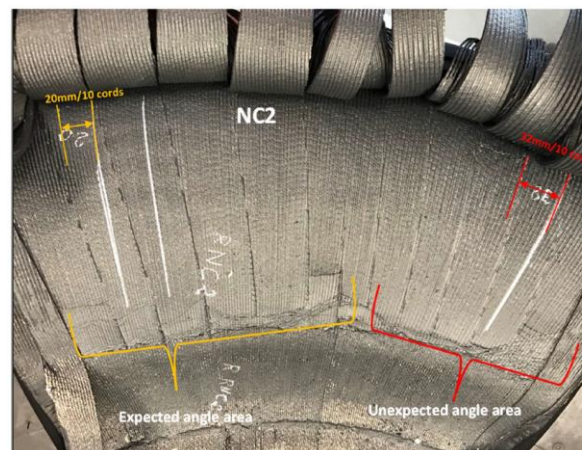
Figure 12. Cable gap on the opposite side of the burst area

The unanticipated angle change was concentrated in the vicinity of the rupture and along the NC2 carcass cable (burst side and opposite side). The space between NC2 textile cords widens as a result of this angle variation. This widening of the space between the NC2 cloth cords was used to detect the angle variation. On the side opposite the burst location, where this gap between NC2 textile cords was more noticeable (figure 12).

In the unexpected angle variation area, the gap was measured, that is 32 mm for 10 textile

cords, as opposed to 20 mm for 10 textile cords in an area without unexpected angle variation (figure 12), which reflects the target density to reach the point of measurement.

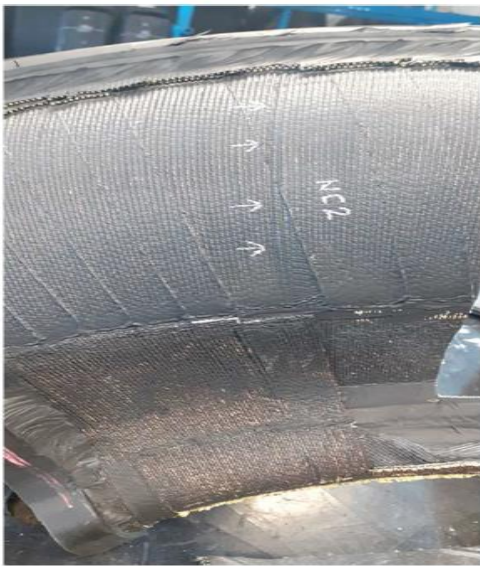
Figure 13. Joint on NC2 carcass

Additional testing was conducted on the joint to identify its type (figure 13). It is most likely that the observed joint corresponds to a casing joint that happened during the step of depositing the NC2 carcass on the drum of the tire-building machine after the reel's end, based on Michelin's industrial experience and industrial records of reel changes.

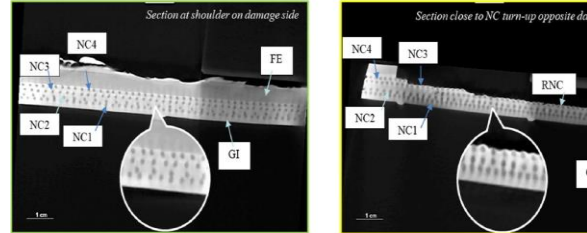
Figure 15. Casing cord gap difference between NC2 and NC1

- Close to damage [burst] area, NC2 carcass shows a cord gap (distance between the threads) twice as large as cord gap on NC1 carcass as (figure 15).

- This gap gradually slightly decreases down to NC turn-up on opposite damage side.

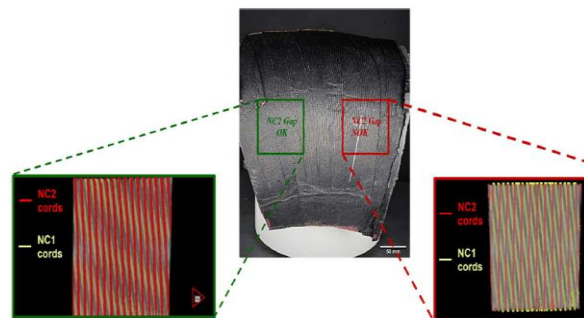
Figure 16. Location of cord gap spacing comparative measurement between NC1 & NC2

Comparative measurements of casing cord gap/spacing between NC2 and NC1 carcasses were taken on two zones on the opposite side of the burst (figure 16).

- Zone 1: area without cord spacing variation on NC2
- Zone 2: area with cord spacing variation on NC2, in the continuation of the damage [burst] area along the carcass profile on the opposite side of the burst.

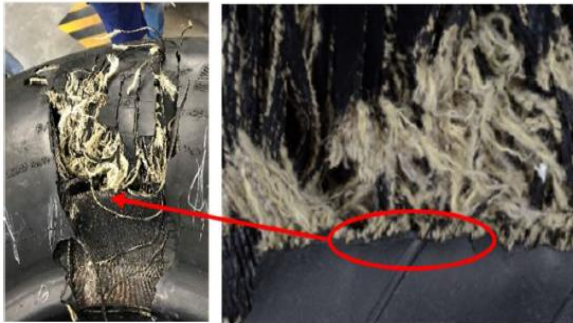
Figure 17. NC2 cord edge scanning location

Electron microscope scanning of NC2 carcass cord edge was implemented on cord samples located in the burst area (figure 17).

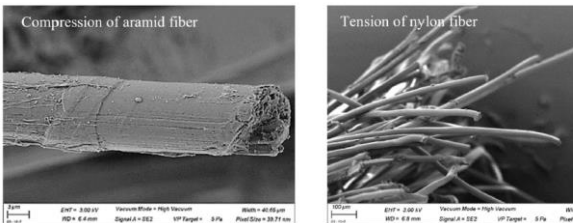
Figure 18. Aspect of aramid and nylon fibers

The rupture aspect of both fiber types (figure 18) was compared to those coming from laboratory testing and the tire manufacturer's experience, in order to determine the rupture mode of the fibers.

In conclusion to the test results based on this comparison, the rupture mode of the aramid fibers was due to fiber compression whereas the rupture mode of nylon fibers was due to tension. The hybrid combination of aramid/nylon was then exposed to alternating tension-compression solicitation, which was consistent with the fatigue failure mode observed on NC2 casing at the tire burst area.

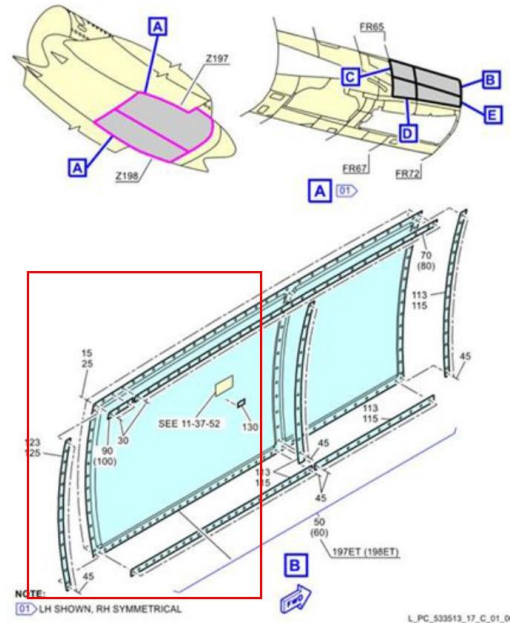
Figure 19. Belly fairing panel 197ET

Belly fairing damaged: 197ET (P/N L53383818000800)

Panel lower attached stringer 10 rear bracket found cracked (length 75mm)

- The damages on 197ET are consistent with a blast due to the wheel 17 tire burst.

The belly fairing panel 197ET is not a structural part but an aerodynamic fairing (Category C structure). This panel is not designed to sustain tire blast load.
