AAIS Case N° AIFN/0006/2024

# Parachute Collapse and Ground Impact Due to Canopy Suspension Line Breakage

Operator:	Skydive Dubai POA
Make and Model:	Fluid Wings, AirWolf2
Place of Occurrence:	Margham, Dubai
State of Occurrence:	The United Arab Emirates
Date of Occurrence:	8 March 2024

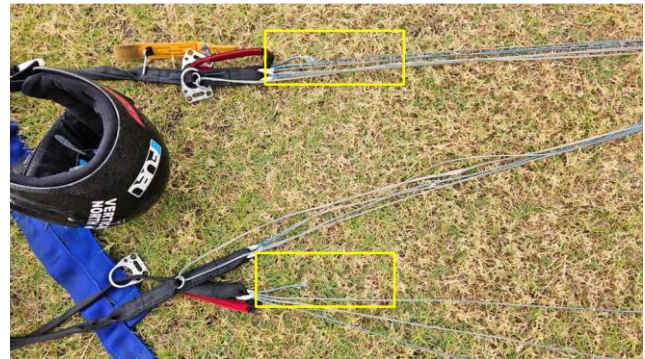
Figure 1. The involved parachute with broken lines

After completing one 360-degree left spiral turn, the parachute canopy A2-lines<sup>2</sup> at both sides disintegrated from the container<sup>3</sup> (figure 1), resulting in a freefall and

The parachute's damage included the canopy's A2 lines being broken on both sides (as shown in figure 1).

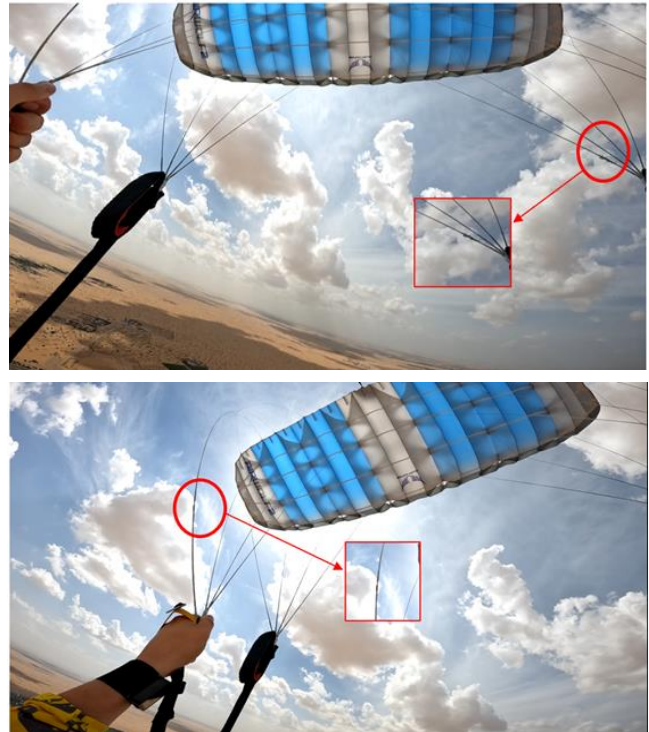
Figure 5. Right side (upper) and left side (lower) canopy suspension lines

As captured by the GoPro camera, the main canopy suspension lines exhibited deterioration marks on both sides (figures 5).

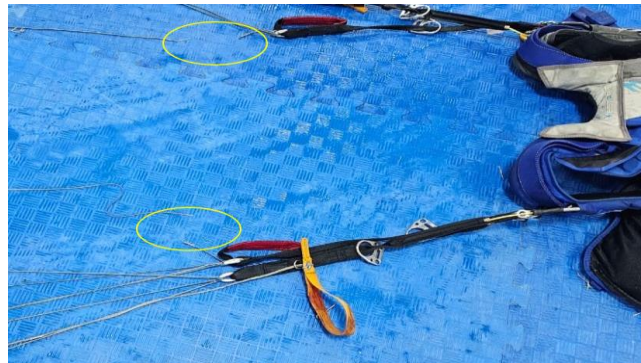
**Figure 9.** Canopy broken lines

The Investigation determines that the canopy collapse was caused by broken A lines, as evidenced by the findings at the Accident site. The wreckage

inspection revealed that several lines were severed, which likely led to the malfunction and subsequent collapse of the canopy during the descent (figure 9).

Comprehensive testing and inspection revealed severe abrasion and wear on the lower A8 and upper D5 lines<sup>14</sup>. The parachute lines, originally rated to handle 400 lb, showed significant weakening over time. When tested, their tensile strengths ranged from only 247 to 321 lb, indicating substantial degradation due to extensive use in harsh conditions.

Inspection revealed that the lines had suffered from visible wear and tear, including fraying and other signs of deterioration. This damage compromised their strength, rendering them unsafe for continued use. The wear was most pronounced in areas where the lines

made contact with components like the slider grommets or RDS rings, ultimately leading to their failure.

The Investigation concluded that the canopy collapse was caused by severely worn and unairworthy lines. This degradation was a result of excessive use and exposure to adverse conditions, which accelerated their wear and tear. The rigger's inspections in thoroughly checking the lines were not carried out properly, due to the assumption that the Parachutist's expertise as an instructor ensured the parachute reliability. No material or manufacturing deficiencies were identified. The observed wear and subsequent failure were consistent with the expected failure modes for parachute lines subjected to prolonged and harsh usage.

The manufacturer has mandated an immediate maintenance inspection for all parachutes equipped with 400 lb. suspension lines to ensure their airworthiness and safety. The action was determined due to concerns about the durability of these lines, particularly those in the 300-400 lb range, which were susceptible to reduced lifespan when exposed to harsh conditions like sand and abrasive materials.

The new inspection protocol requires that suspension lines be evaluated before every jump and undergo a detailed inspection every 20-30 jumps or every two weeks. This inspection should be conducted using magnification (1.5x to 2x) with a bright light to detect any damage accurately. Lines with visible broken carriers or filaments must be immediately removed from service and replaced. Special attention should be given to critical areas, such as the lower portion of the A-line groups, to prevent severe consequences in case of failure. A cautious and proactive approach is advised, with a strong emphasis on safety.

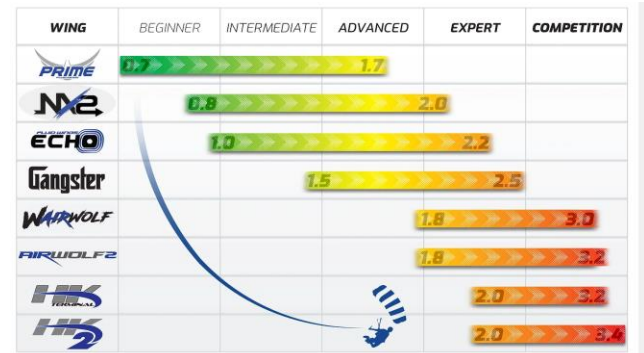
Figure 10. Wing loading chart

The Parachutist's weight with the gear of 223.416 lb exceeds the AirWolf2 parachute's maximum weight capacity, resulting in a wing loading of 2.8 lb/sq. ft compared to the maximum designed wing loading of 2.4 lb/sq. Ft.

On the other hand, according to the Fluid Wings wing loading chart (figure 10), the maximum wing loading for the AirWolf2 is 3.2 lb/sq. ft, which

The parachute label specifies a maximum weight of 190 lb (86.18 kg), while the Fluid Wings wing loading chart suggests a maximum weight of 250 lb (114 kg) for the AirWolf2 with a 79 sq. ft canopy. In this Accident, the Parachutist's weight was 198 lb, slightly exceeding the labelled maximum weight. During the recovery from a high-speed dive close to the ground, which resembled a low-level aerobatic manoeuvre, the change in flight direction likely generated a load factor higher than 1g. The already worn A2-lines were likely unable to withstand this increased load, resulting in their failure (broken lines).
