# Air Accident Investigation Sector

## Accident - Preliminary Report -

AAIS Case N°: AIFN/0014/2024

# Cessna 172R Crash During Training Flight

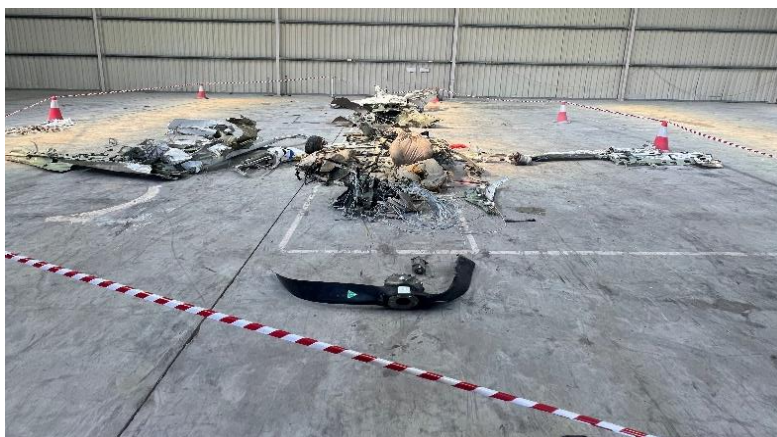
Figure 3. Recovered wreckage

The Aircraft was destroyed because of the impact forces with the sea. Part of the wreckage on the seabed at a depth of about 50 metres, about 5 nautical miles north Khorfakkan. The located wreckage was recovered and transported to FUJAA facilities (figure 3).

There were no signs of fire found on the recovered wreckage.

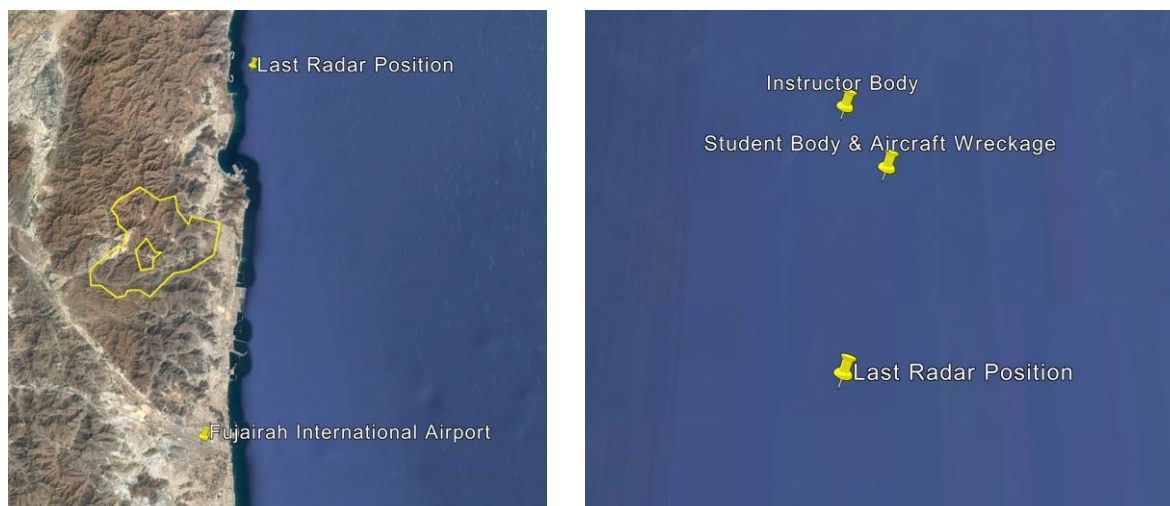
Figure 4. Bodies and wreckage distribution

The locations of the wreckage, as well as the bodies of the Instructor and Student, are shown in Figure 4. However, the engine and the cockpit remain on the seabed, with their estimated positions indicated in figure 4.
