# Air Accident Investigation Sector

## Serious Incident

### - Final Report -

## Runway Incursion

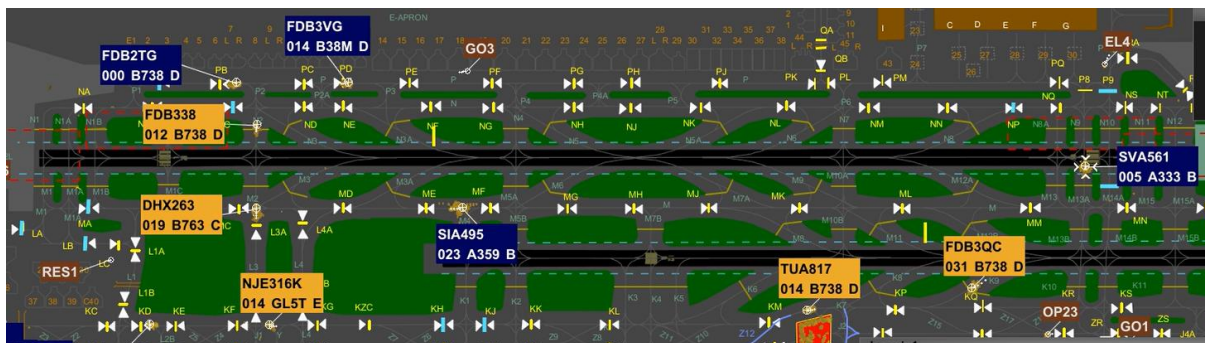
Figure 1. Ground movement radar (GMR) screenshot at 1652:44

At 1652:44, NJE316K commenced turning to the right to continue taxiing through taxiway Lima 3 (figure 1).

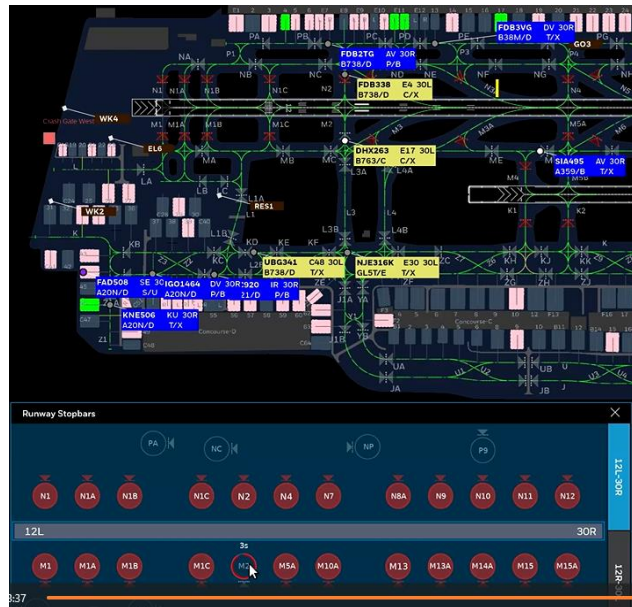
**Figure 2.** AFLCMS screenshot at 1652:52, indicating the controller interactions with the stop bar

At 1652:52, DHX263 was taxiing on taxiway Mike 2 in front of NJE316K and approaching the holding point, with the countdown timer indicating 3 seconds remaining, as displayed on the airfield lighting control and monitoring system (AFLCMS) (figure 2). While NJE316K was turning right from taxiway Kilo to taxiway Lima 3.

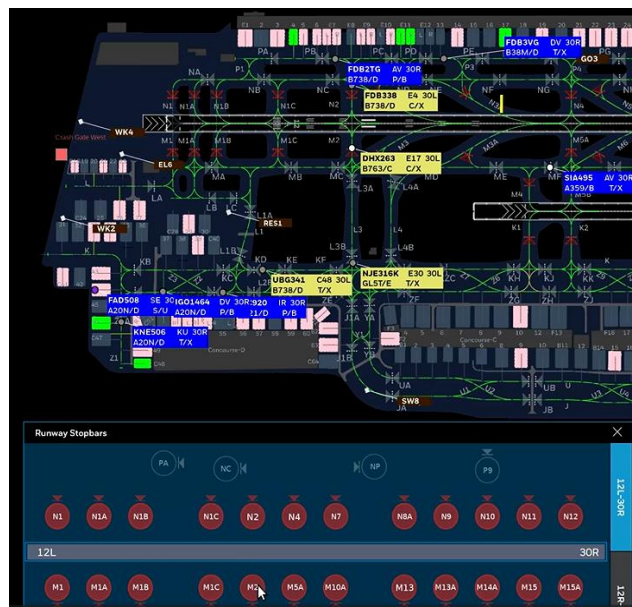
**Figure 3.** AFLCMS screenshot at 1652:54, stop bar on Mike 2 reactivated

At 1652:54, the stop bar on Mike 2 reactivated (turned ON) after a 60-second interval was due, while DHX263 just crossed the stop bar (figure 3). The NJE316K was taxiing on taxiway Lima 3 after completing the turn and the Commander noticed the stop bar activation for a few seconds.

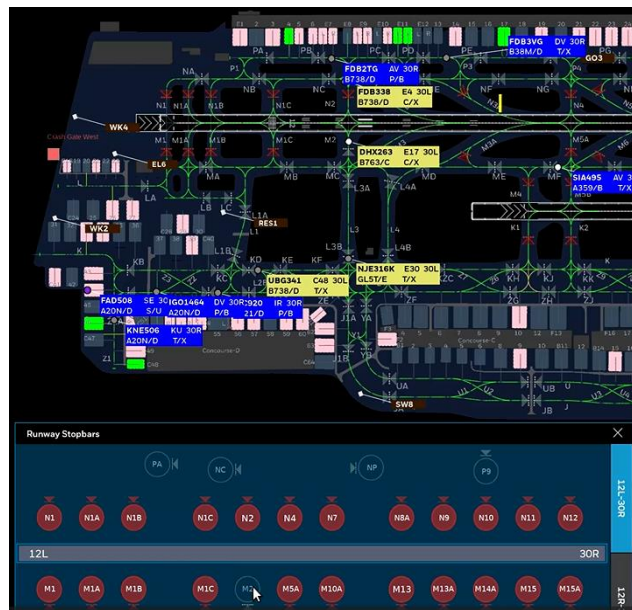
**Figure 4.** AFLCMS screenshot at 1652:57, stop bar on Mike 2 deselected

At 1652:57, the controller deactivated the stop bar on Mike 2, which reset the 60-second timer (figure 4).

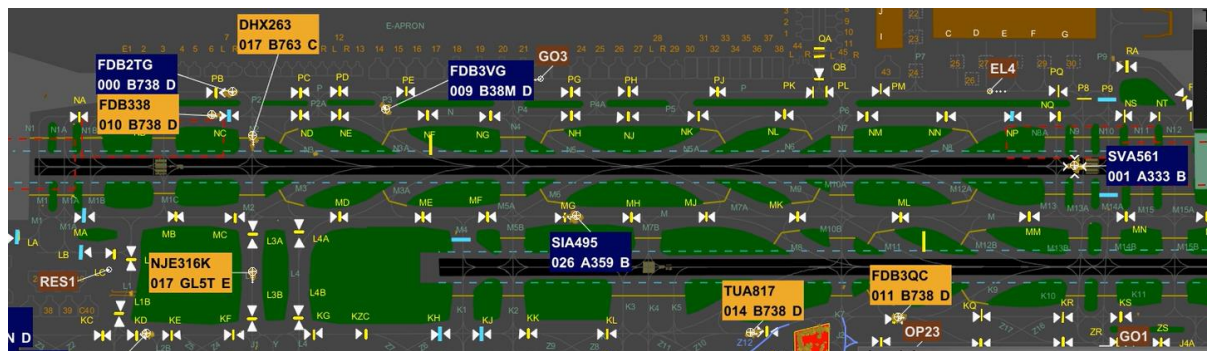
**Figure 5.** GMR screenshot at 1653:19

At 1653:19, a Saudi Arabian Airlines Airbus A330-343 aircraft, operating flight number SVA561, was lining up on the threshold of runway 30R, and the Tower controller cleared it for takeoff. At this time, NJE316K was taxiing on taxiway Lima 3 (perpendicular to runway 30R), at about 370 meters from the runway centerline intersection (figure 5).

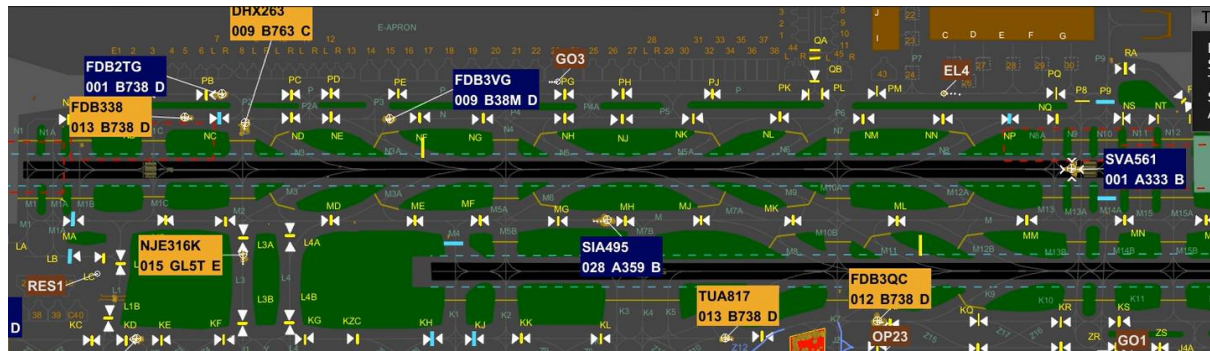
Figure 6. GMR screenshot at 1653:28

At 1653:28, the NJE316K flight crew contacted the Tower control for the first time after changing the frequency from Ground control to Tower control and reported holding at Lima 3 Alpha (figure 6).

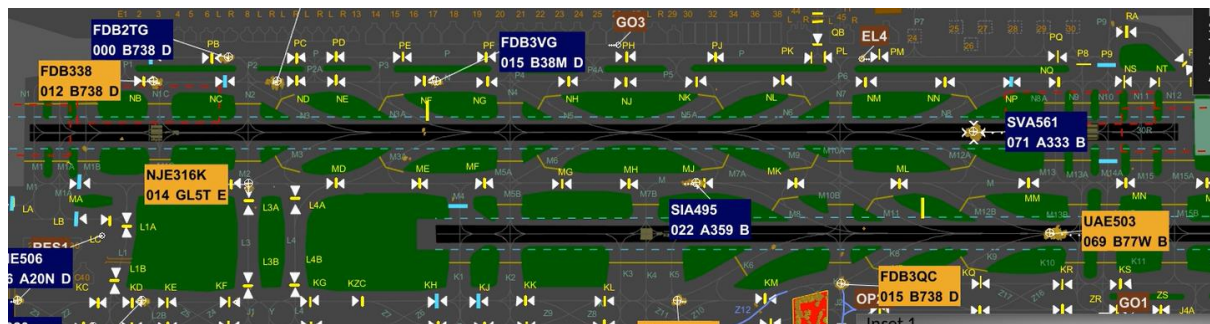
Figure 7. GMR screenshot at 1653:51

At 1653:51, NJE316K crossed the middle of the taxiway Mike and continued taxiing through taxiway Mike 2 (figure 7).

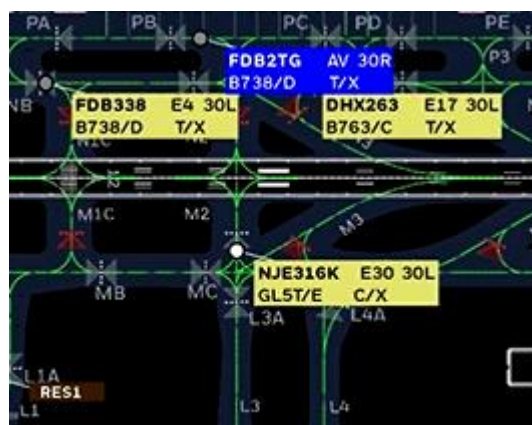
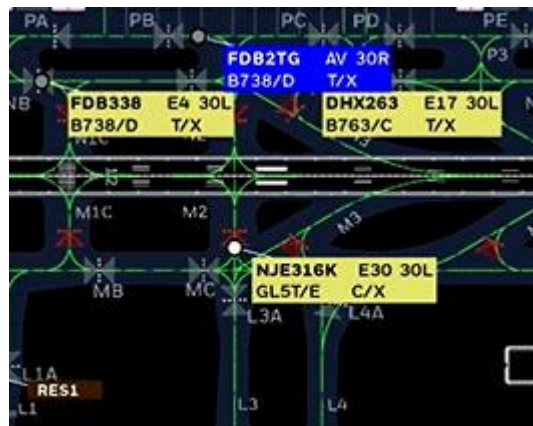
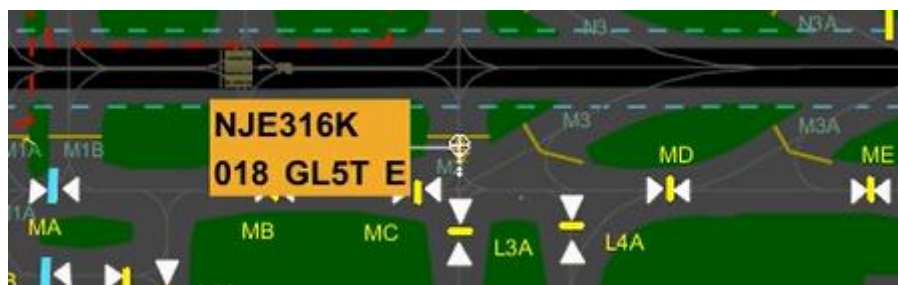
At 1653:58, the stop bar lights illuminated (figure 8.b. and 8.c.), before NJE316K crossing the holding point of taxiway Mike 2. Figure 8.a. shows the AFLCMS screenshot one second before the stop bar became active.

According to ATC recordings, the stop bar automatically reactivated as the 60-second countdown expired (figures 8.a, 8.b, and 8.c). NJE316K Aircraft was about one second away from the Mike 2 holding point, though it is likely that the actual time may have been less than one second due to system update delays and radar refresh rates. Furthermore, considering the cockpit position and 20 knots taxi speed, it is probable that the front of the Aircraft had already passed the stop bar, which was now behind the crew resulting in the crew’s peripheral view being inadequate to recognize the stop bar reactivation.

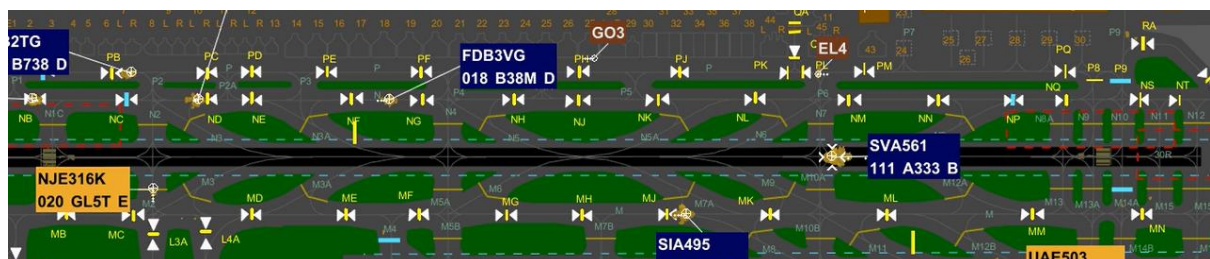
Figure 9. GMR screenshot at 1654:00

At 1654:00, NJE316K reached holding point Mike 2 crossing the stop bars, while SVA561 was rolling on runway 30R (figure 9).

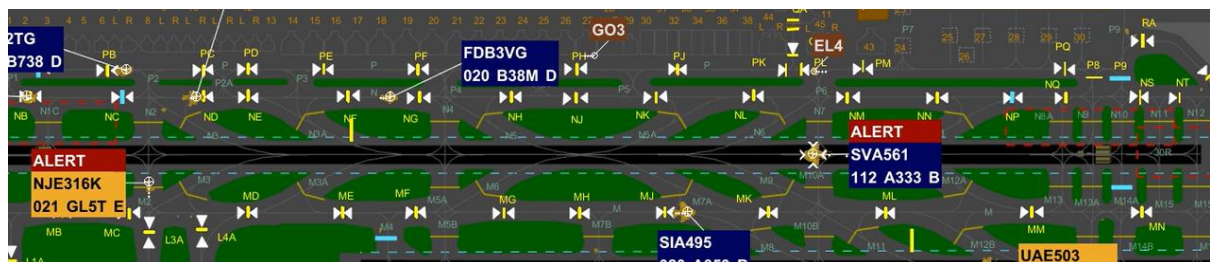
Figure 10. GMR screenshot at 1654:01

At 1654:01, the runway incursion monitoring and collision avoidance system (RIMCAS) Stage 2 alert appeared since there was a conflict between SVA561 and NJE316K with a visual and audible alarm on the Controller's display (figure 10).

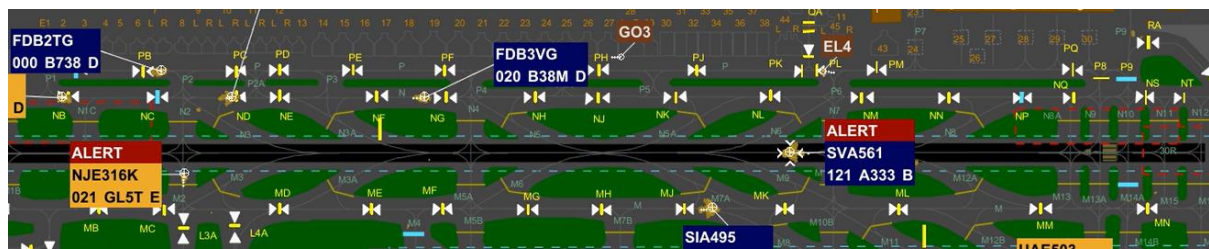
Figure 11. GMR screenshot at 1654:03

At 1654:03, the Tower controller instructed SVA561 to stop immediately, while the indicated airspeed was about 132 knots while accelerating (figure 11). There was no reply received from SVA561.

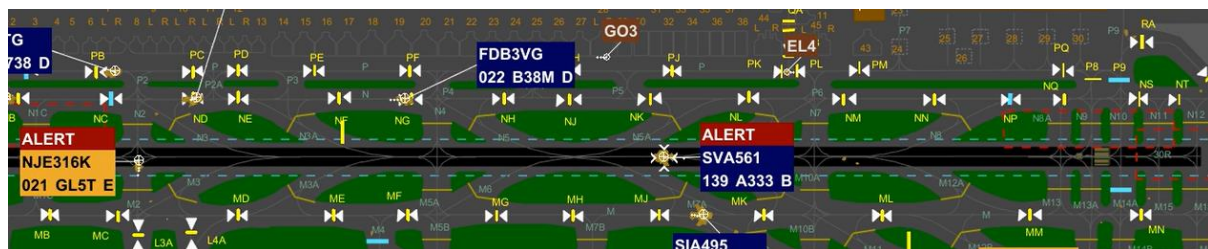
Figure 12. GMR screenshot at 1654:08

At 1654:08, while NJE316K was crossing the runway, the Tower controller instructed NJE316K flight crew to expedite the crossing. SVA561 rotated at 149 knots indicated airspeed (figure 12). Subsequently, an unidentified calling “Expediting” was heard by the Tower.

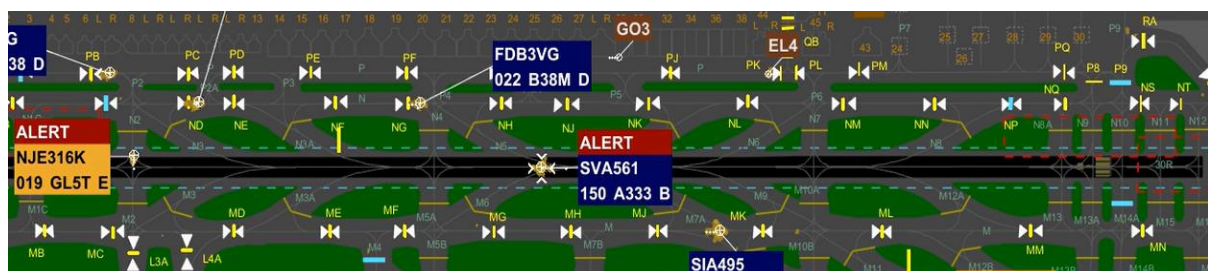
Figure 13. GMR screenshot at 1654:13

At 1654:13, SVA561 lifted off at 161 knots indicated airspeed. NJE316K was taxiing along the edge of the runway, vacating the runway after crossing it (figure 13).

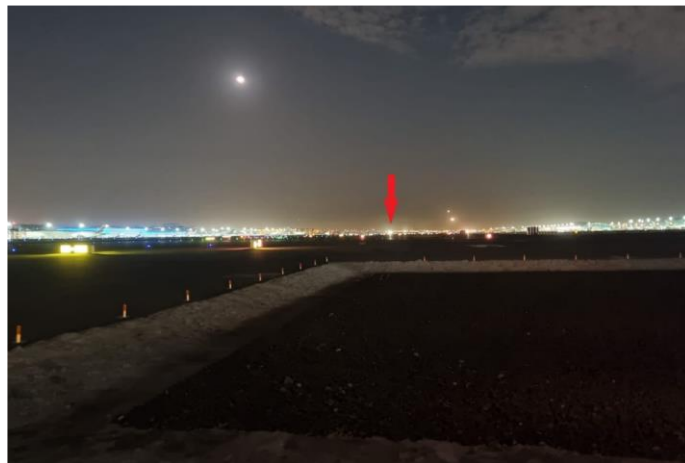
When the conditional clearance was issued to NJE316K, SVA561 commenced its take-off roll just slightly in front of threshold runway 30R, about 3,110 meters away from NJE316K's position. The situation occurred at night under visual meteorological conditions (VMC), with bright lights surrounding the aerodrome. Although the NJE316K flight crew could see some objects at the threshold of runway 30R, the surrounding bright lights likely made it difficult for them to distinguish the SVA561 aircraft lining up and just starting the takeoff roll on runway 30R from the surrounding background lights.

**Figure 15.** Picture captured from ITHP Lima 3 Alpha (NJE316K position) shows a red arrow pointing to an aircraft lining up for departure on runway 30R  
[source: dans]
