- Preliminary Report -

AAIS Case N° AIFN/0016/2024

Helicopter Severe Vibration Upon Touchdown

Operator: Falcon Aviation Services
Make and Model: AgustaWestland, A109E
Nationality and Registration: The United Arab Emirates, A6-ONE
Place of Occurrence: Private Helipad, Al Badayer, Sharjah
State of Occurrence: The United Arab Emirates
Date of Occurrence: 21 December 2024

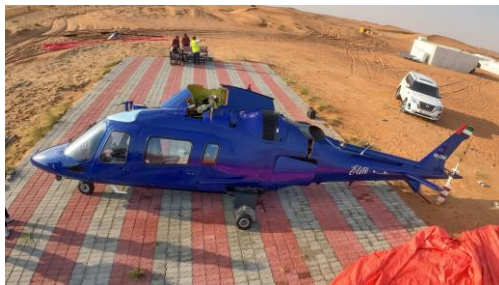
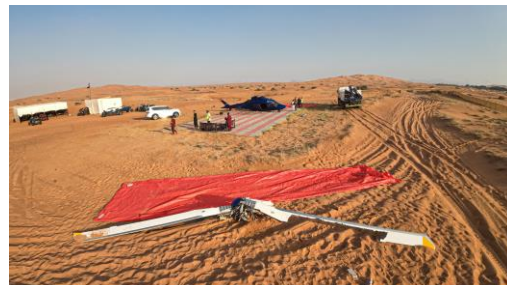
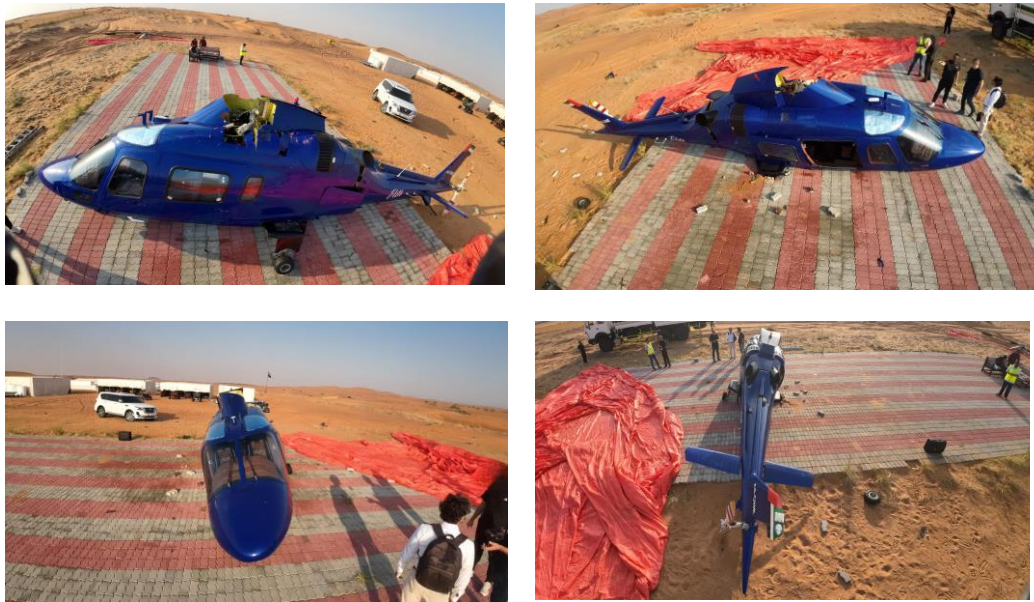
Figure 1. Helicopter damage and wreckage distribution

However, upon touchdown, the Helicopter experienced severe rocking oscillations for about six seconds, making control inputs impossible. The intense vibration caused the main rotor and part of the gearbox to detach, coming to rest about 29 meters away from the main body of the Helicopter. According to the Pilot, he was unable to shut down the engines and struggled to maintain grabbing the controls. One of the blades detached from the hub and was found about 14 meters from the main rotor. The Helicopter sustained structural damage and came to rest facing 228 degrees, with about 12-degree rightward tilt, caused by damage to the right main landing gear and the detachment of its wheel.

The Helicopter was substantially damaged due to the severe vibration (figure 1).

The helipad was damaged due to a ditch caused by the helicopter's right main landing gear becoming embedded in the ground.

The Helicopter was substantially damaged as a result of ground impact. The main rotor and part of the gearbox detached and rested at a distance of 29 meters from the main body. The right main landing gear was damaged and embedded in the ground with the wheel detached (figure 1).
