# Air Accident Investigation Sector

## Accident - Preliminary Report -

AAIS Case N°: AIFN/0017/2024

# Aeropark A22 Overwater Crash

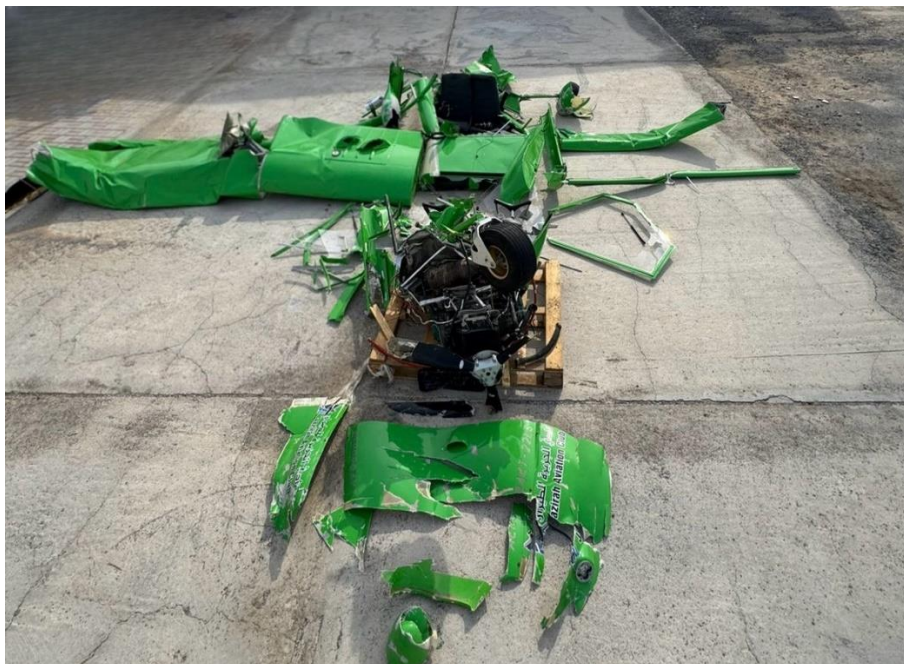
**Figure 3.** Recovered wreckage

The Aircraft was destroyed due to the forces induced by sea impact. The wreckage was located on the seabed at a depth of approximately 5.7 meters, about 1 nautical mile from Cove Rotana Beach in Ras Al Khaimah.

The recovered wreckage was transported to the Club's facilities (figure 3). However, the tail section and the right wing remained on the seabed.

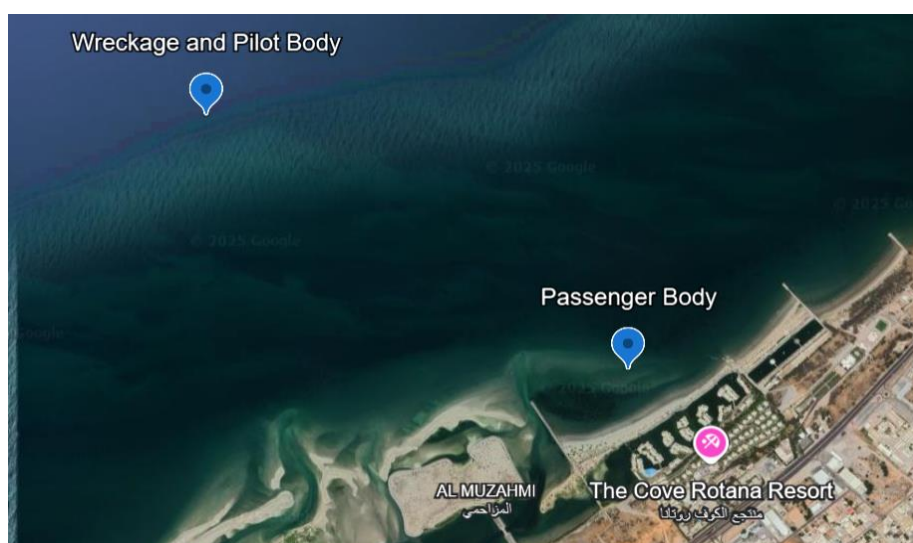
**Figure 4.** Location of the Wreckage and Bodies

The Passenger's body was discovered deceased at 1535 LT, floating near the coast, while the Pilot's body was recovered at 1640, floating offshore alongside the Aircraft's wreckage.

The locations of the wreckage, as well as the bodies of the Pilot and Passenger, are depicted in figure 4.
