# Air Accident Investigation Sector

### - Summary Report -

AAIS Case N° AIFN/0013/2024

### Loss of Control (In-Flight)

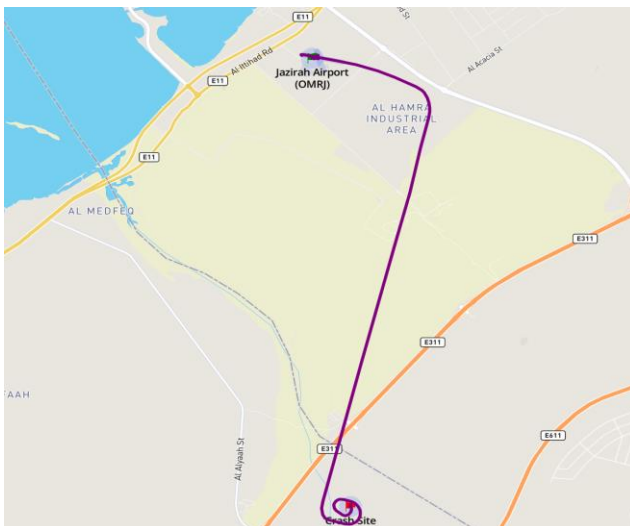
Figure 1. Flight path of the Aircraft

The Pilot aimed to land on a small farm with a flat area. He disengaged the autopilot and manually attempted to control the descent. With full power applied, the Aircraft still struggled to maintain stability. The Pilot maneuvered in a spiraling descent, attempting to reach the ground as safely as possible (figure 1).

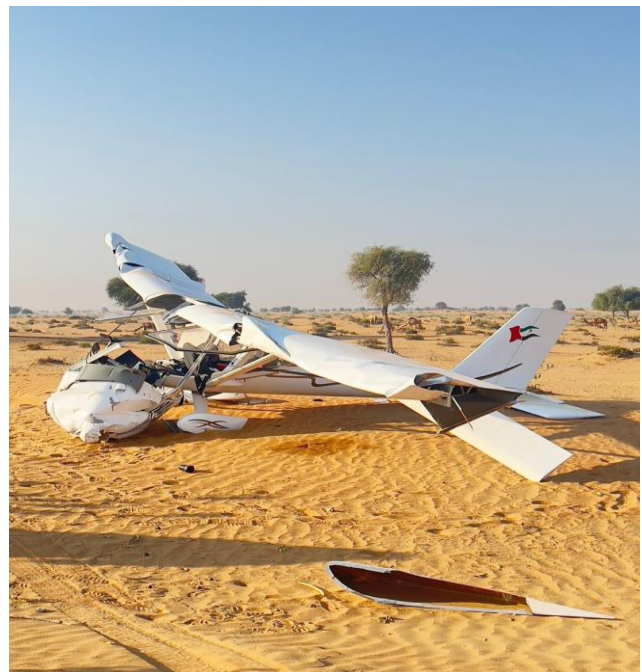
Figure 2. Aircraft damage

The Aircraft suffered substantial damage because of ground impact forces. The cockpit, propeller blades, engine bay, and nose gear were significantly damaged (figure 2).

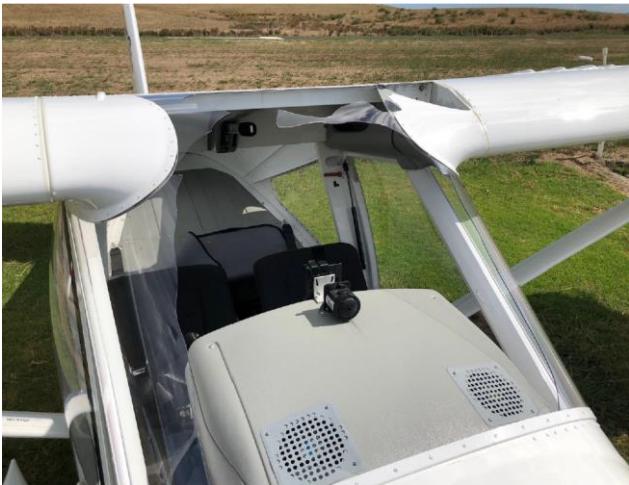
**Figure 8.** A32 windshield

cruising at 2400 feet ASL, and a speed of approximately 105 knots, in fine weather, the windshield of the aircraft suffered a catastrophic failure without prior warning (figure 8). The sudden loss of the windshield caused severe turbulence inside the cockpit, dislodging items and temporarily impairing the pilot's ability to maintain a controlled flight.

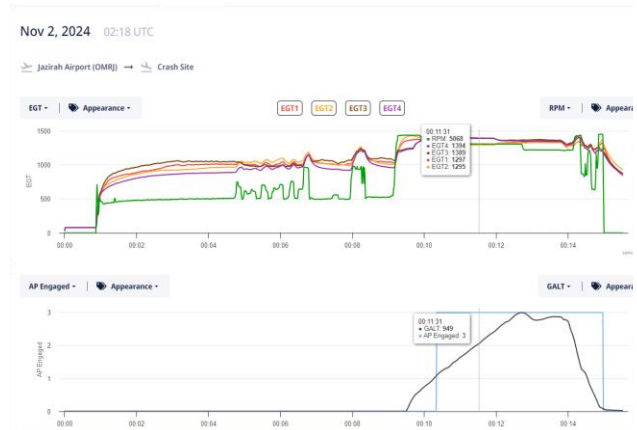
Figure 9. Engine, RPM, groundspeed, autopilot data

The review of the dataset revealed no anomalies, malfunctions, or system failures. All recorded parameters were within normal operational ranges, indicating that the Aircraft's systems were functioning as designed throughout the flight as shown in the (figure 9).

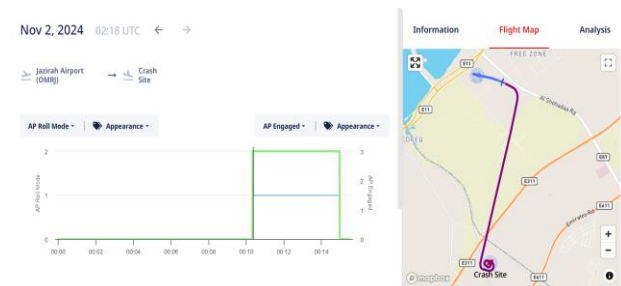
Figure 10. Autopilot Data

Based on the data retrieved from the avionics system (figure 10), the autopilot was engaged approximately 10 minutes after takeoff and remained active until the ground impact.

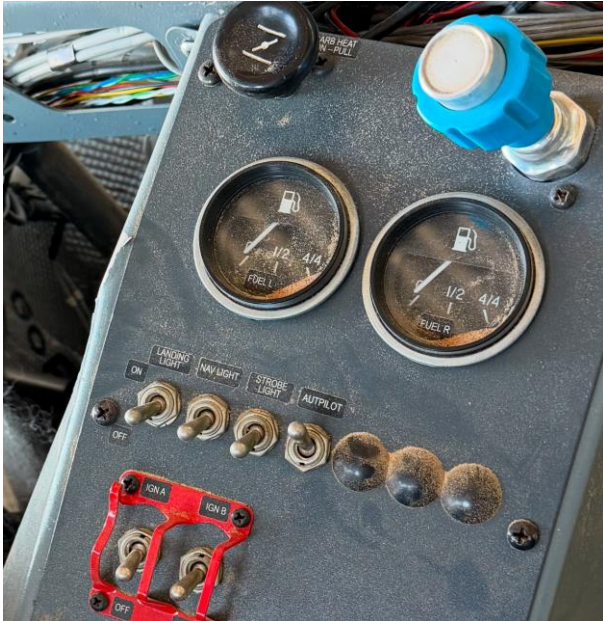
Figure 11. Autopilot switch

Additionally, the electrical switch was recorded as being in the "ON" position at the time of impact, as indicated in the (figure 11).

The Pilot reported manually disengaging the autopilot by applying force through the control yoke following the windshield failure. However, the recorded data did not reflect a disengagement event, and the autopilot switch remained in the "ON" position throughout the flight, indicating that electrical power to the system was still present.
