Serious Incident - Summary Report -

AAIS Case N° AIFN/0009/2021

Ground Collision

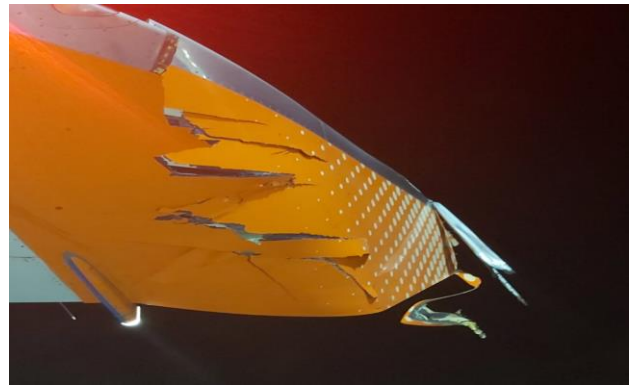
As indicated by the flight data recorder (FDR) data, at 1943:58, the FDM1461 (B737) left wingtip contacted the holding GFA513 (A321). During the interview, the FDM1461 commander stated to the Investigation that the flight crew had checked for the wing clearance and perceived that the left wing was clear to taxi behind the holding A321, but this could not be confirmed since the cockpit voice recorder (CVR) was overwritten.

The B737 wingtip and A321 tail sustained minor damages (figures 1 and 2).

Figure 1. Damage to the B737 wingtip

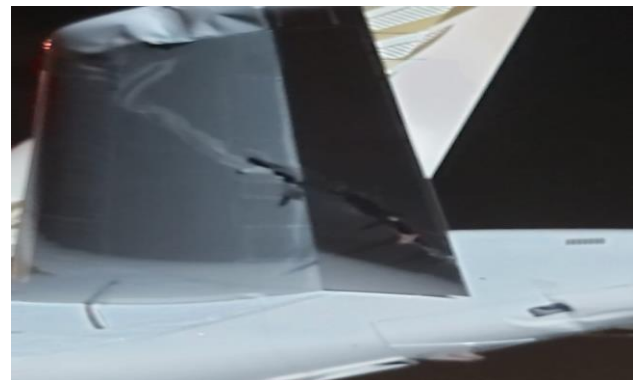
Figure 2. Damage to the A321 tail

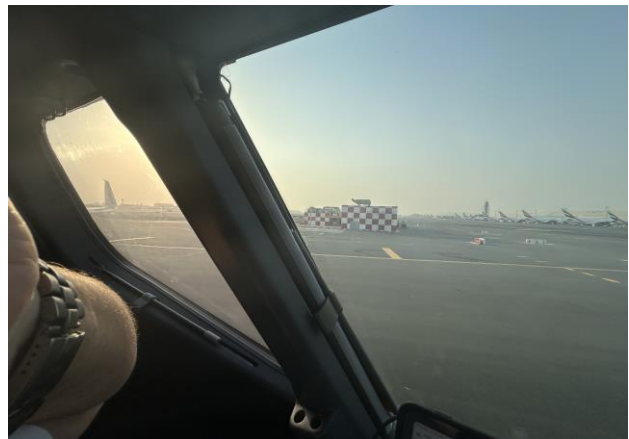
As per the *flight crew training manual (FCTM)*, "There is a larger area near the Aeroplane where personnel, obstacles, or guidelines on the ground cannot be seen, particularly in the oblique view across the flight deck. Special care must be exercised in the parking area and while taxiing."

Figure 4 shows the cockpit's external view, approximately 135 degrees to the left, near the window.

Figure 4. B737-800 cockpit external view to the left 135 degrees close to window [Source: flydubai]

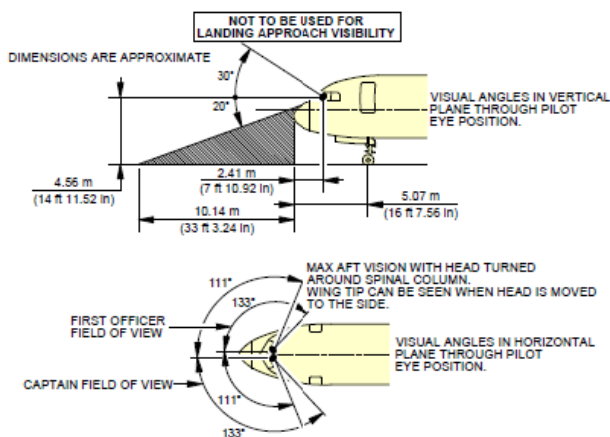
Figure 6. A321 pilot's eye level-A321 [Source: Airbus Document]

4.56 meters above ground level, the pilot's line of sight is extended for only 12.55 meters. The slope of the pilot's line of sight is restricted to 20 degrees downwards from the cockpit (figure 6). The hashed area in figure 6 lies outside the pilot's line of sight.

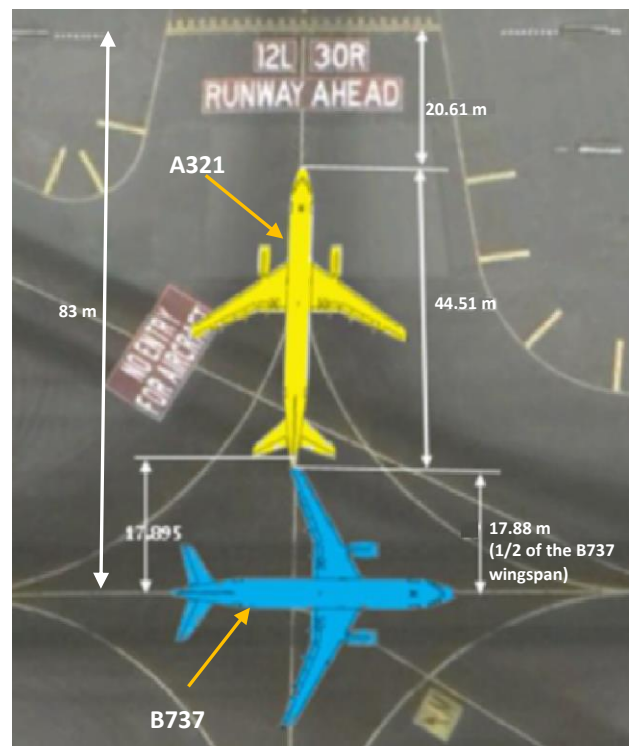
The Investigation could not determine the definite position of the A321 from the stop bar lights from direct observational evidence, and how far the nose was exactly away from the bar. Therefore, the Investigation carried out estimations based on the following facts and assumptions:

The Investigation estimated that the GFA513 was stopped at a position where the nose of the aircraft was more than 20.61² meters short of the stop

bar lights (figure 8). At that time, FDM1461 was about 500 meters away while taxiing.

Figure 8. Sketch of the collision [Edited version of image from Dubai Airports internal report]
