الهيئة العامة للطيران المدني
GENERAL CIVIL AVIATION AUTHORITY

Serious Incident

AAIS Case N° AIFN/0004/2025

Tail Strike

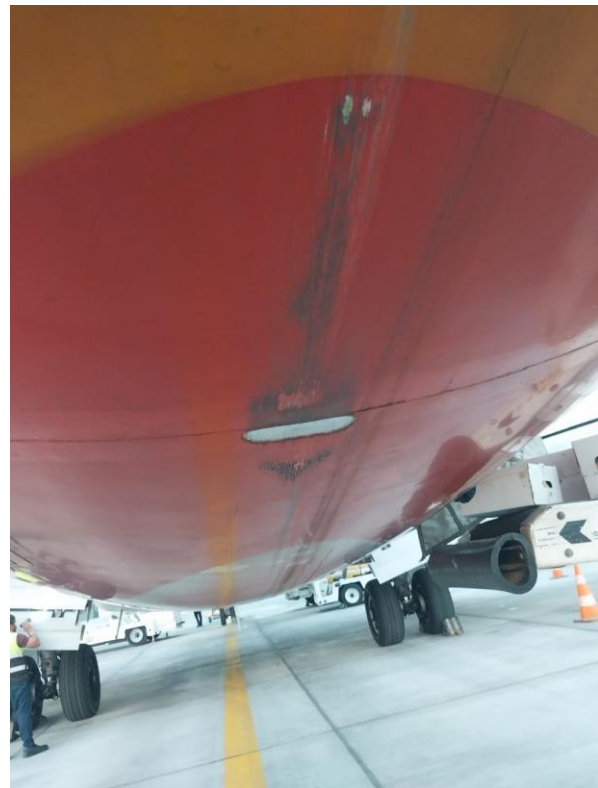
The tail strike caused minor damage to the underside of the rear fuselage. Figures 1 and 2 illustrate the damage and its dimensions.

Damage assessment indicated that the tail strike occurred at station (STA³) 887 between stringers (STR) 27L and STR 27R. The rub mark was located in section 46, lower skin (STA 867 to STA 887), and section 47, lower skin, measuring 6 inches in length and 2 inches in width. A pinhole puncture with a 1.25-inch crack line was identified between two rivets with no damage to the internal.

Figure 1. Skin abrasion on the aft lower

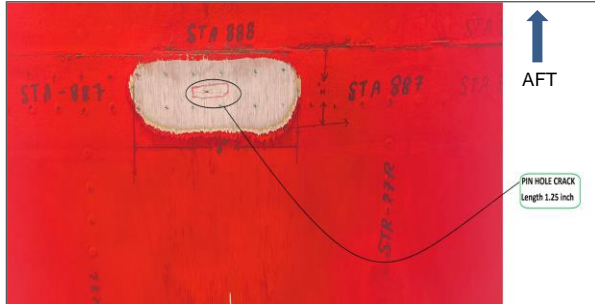
Inspection of the section 47 lower skin, between STA 888–904 and STR 27L–27R, revealed only minor rub marks. The markings extended through the red paint and the second-

layer white paint, or to the green primer, which was visible.

Figure 2. View of STA 887 damage

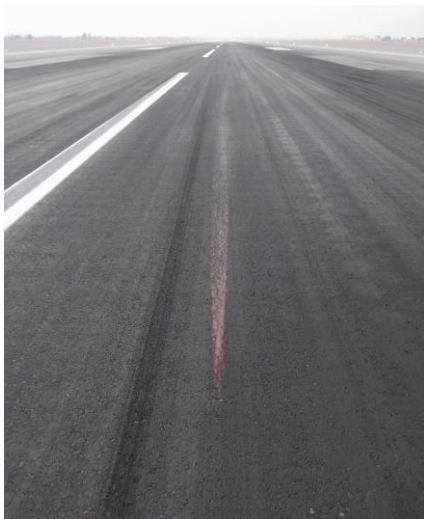
The tail strike left paint marks on the runway surface in the touchdown zone of Runway 34, with the color matching the Aircraft and consistent with a tail strike (figure 3). No foreign object debris (FOD) was found. Minor damage was observed on the runway surface at the point of tail contact, located to the right of the Runway 34 centerline.

Figure 3. Paint marks on the runway

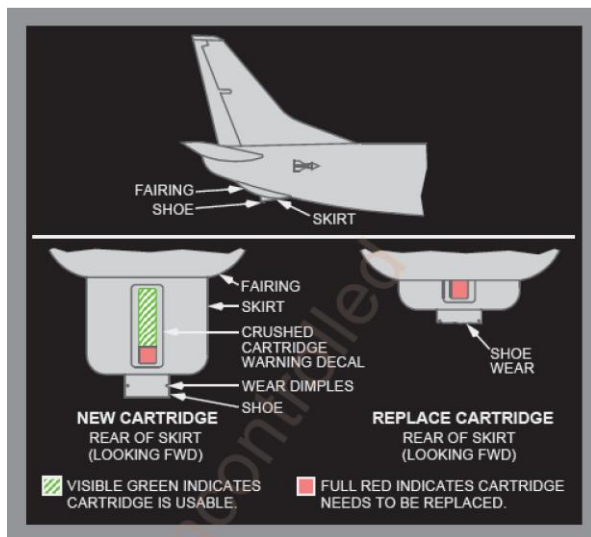
Figure 4. Tail skid [Source: FCOM]

- (m) The second touchdown was a hard landing with a maximum pitch attitude of 9.5 degrees and a peak vertical load factor of 2.8G.
- (n) The Aircraft experienced a tail strike, but the tail skid assembly did not exhibit marks of contact.

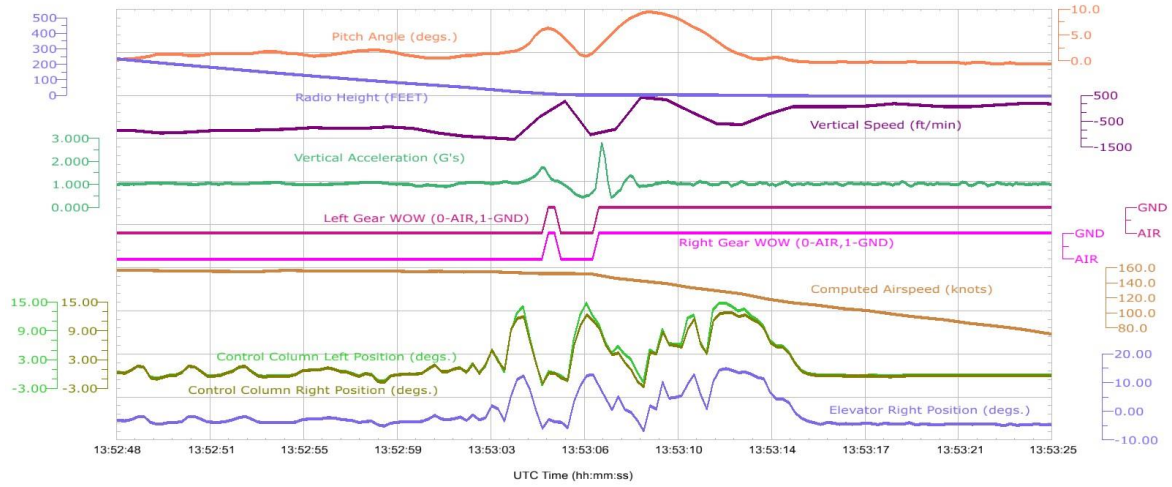
Attachment D. Flight Data on Landing

At 1353:04, the elevator input was near neutral (about 0 degrees), while the Aircraft pitch was approximately 1.6 degrees. One second later, the elevator deflected to a maximum of +12.6 degrees as the control column was pulled back, after which it was pushed forward. This coincided with the moment the Commander took control, indicating that the elevator input to +12.6 degrees was made by the Commander. The Aircraft's height was about 25 feet radio altitude.

About six seconds before touchdown, the rate of descent was about 780 feet per minute, increasing to 1,200 feet per minute in four seconds

later (two seconds before touchdown), as the control column was pulled back reaching a peak pitch rate of 5.3 degrees per second. The rate of descent then decreased to 330 feet per minute one second prior to touchdown.

At 1353:06, the thrust levers were retarded from 51.2 degrees to 26 degrees (idle). Simultaneously, the Aircraft made its first touchdown, with both main landing gears, at an airspeed of 152 knots. The vertical load factor recorded was 1.7G, with a pitch attitude of 6.3 degrees. Within two seconds, the thrust levers reached idle (about 26 degrees), with both engines spooling down to N1 47% RPM. The flight spoilers began to deploy. The elevator deflected to a maximum of -5.2 degrees, generating a nose-down input with a pitch rate of 5.3 degrees per second. At the first touchdown, the recorded wind was 316 degrees at 2.5 knots.

Following the first touchdown, the Aircraft bounced, and as it became airborne again, the elevator was pulled back, producing a pitch rate of 4.9 degrees per second. The elevator reached a maximum deflection of 13.5 degrees at 1353:07.

The Aircraft remained airborne for approximately 1.5 seconds before making a second, firmer contact with both main landing gears at 1353:08. At the same time, the elevator control input was pushed. The flight spoilers continued to extend, and the ground spoilers deployed automatically.

On the second touchdown, the vertical load factor peaked at 2.8G, with the pitch increasing to 9.5 degrees and the airspeed reducing to 146 knots.
