Air Accident Investigation Sector

- Final Report -

AAIS Case N°: AIFN/0011/2023

Controlled Flight Into Terrain (CFIT) (Sea Impact)

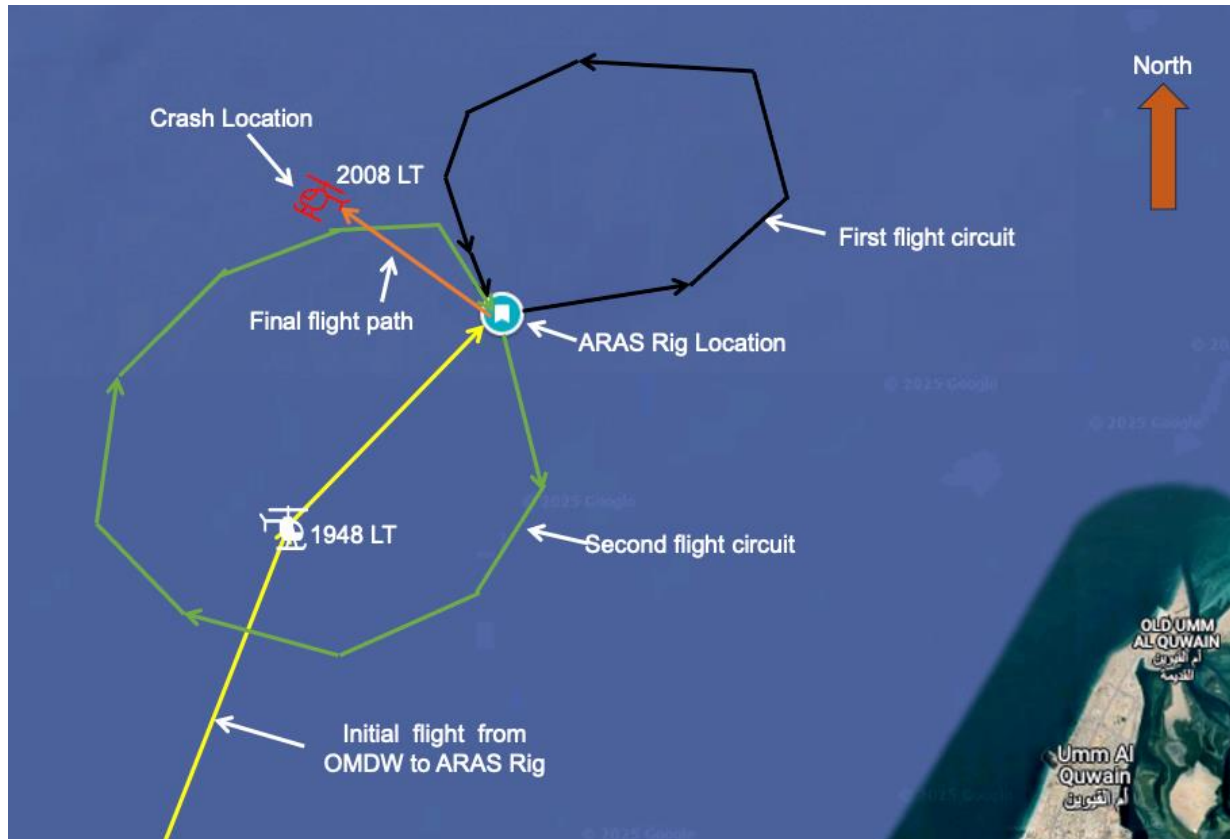
Figure 2. The Helicopter flight circuits and crash location

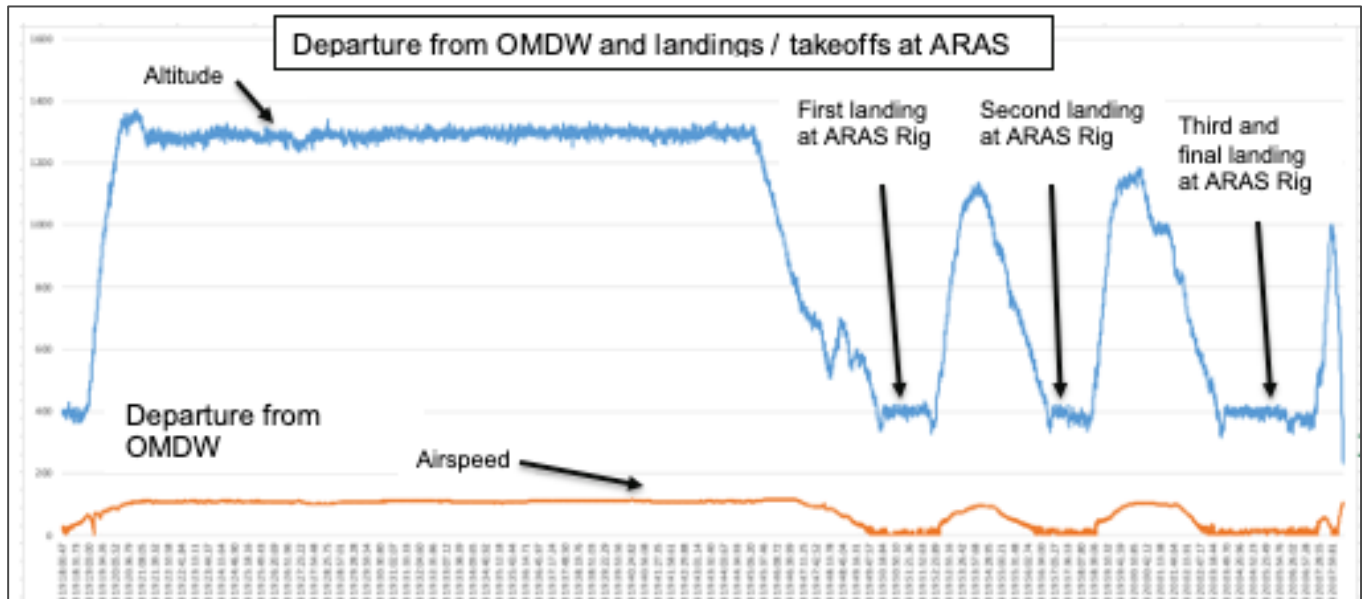
The recorded data indicates that the Helicopter's first landing at the Rig occurred at approximately 1950, and it departed at 1952, steadily climbing for two minutes to reach a pressure altitude of 1,120 feet, while attaining a maximum airspeed of 95 knots. The second landing took place at 1957, followed by departure one minute later. The Helicopter then climbed to 1,150 feet in two minutes, reaching a maximum airspeed of about 102 knots. The third landing on the helideck occurred at approximately 2004.

Figure 6. SmartCycle data – Helicopter flight from OMDW to ARAS Rig

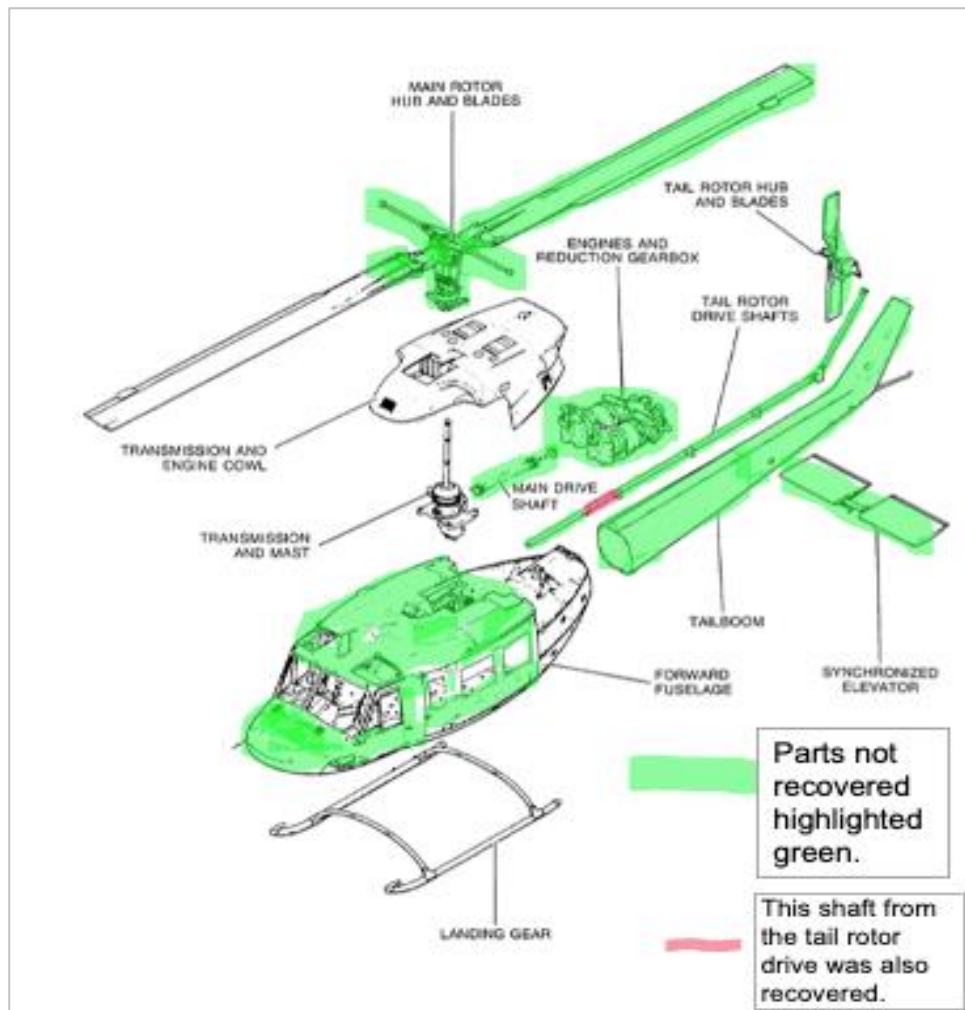
Throughout the 5-day recovery operation, major wreckage was recovered on the third and fourth days. Parts of the Helicopter were scattered in a radius of about 1 kilometre. Figure 7 illustrates the major components that were not recovered, highlighted in green.

Several parts were affected by the salt water and showed advanced stage of corrosion, particularly those made of magnesium. As a result, the accessory gearboxes of both power sections were mostly dissolved, along with the reduction gearbox.

Figure 7. Bell 212 major structure and components not recovered highlighted in green

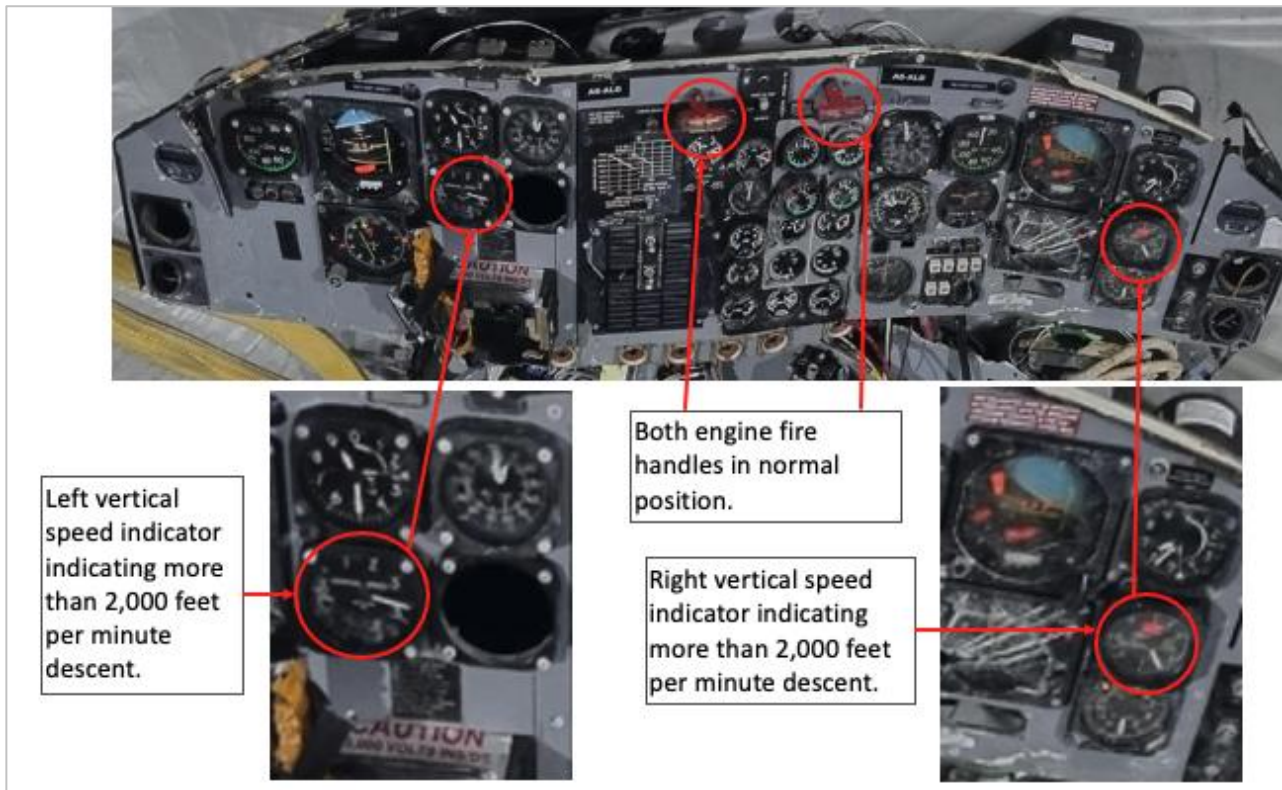
Almost the entire cockpit instrument panel was recovered as a single, intact unit. Most of the gauges were found with shattered glass faces and several missing needles. It was noted that both the left and right vertical speed indicators were pegged at a high rate of descent, exceeding 2,000 feet per minute (FPM). No other meaningful data could be interpreted from the condition of the cockpit instruments. Overhead circuit breaker and switches panel was recovered but nothing significant could be interpreted.

Both engine fuel shutoff valves appeared to be in the open position. The engine fire warning and both extinguishing T-Handles were found in their normal positions, and neither of the fire bottle pressure discharge indicators had been activated.

Figure 8. Helicopter vertical speed indicators showing in excess of 2,000 FPM

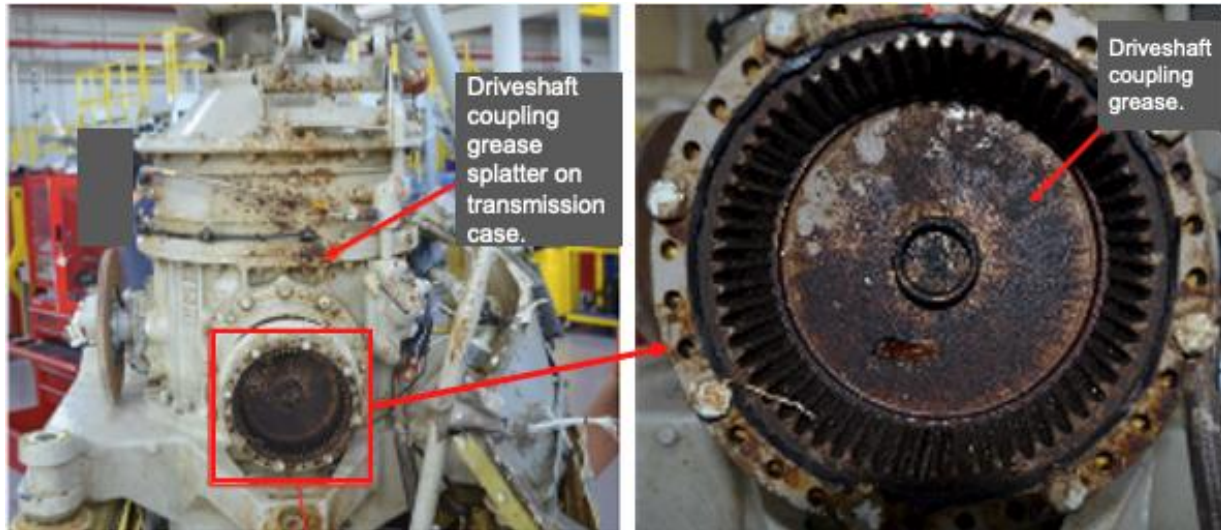
The external surface rear face (looking forward) of the main rotor transmission assembly showed evidence of splattered grease (figure 9). Analysis of the grease by Fourier-Transform Infrared Spectroscopy (FTIR) determined the material to be chemically similar to SYN Tech NS-3913-G1, which was the required driveshaft coupling grease. The main driveshaft female coupling spline teeth were all intact. The Operator confirmed that the grease used during maintenance to lubricate the main driveshaft coupling was Syn-Tech NS-3913-G1.

Figure 9. Main transmission case showing the grease splatter

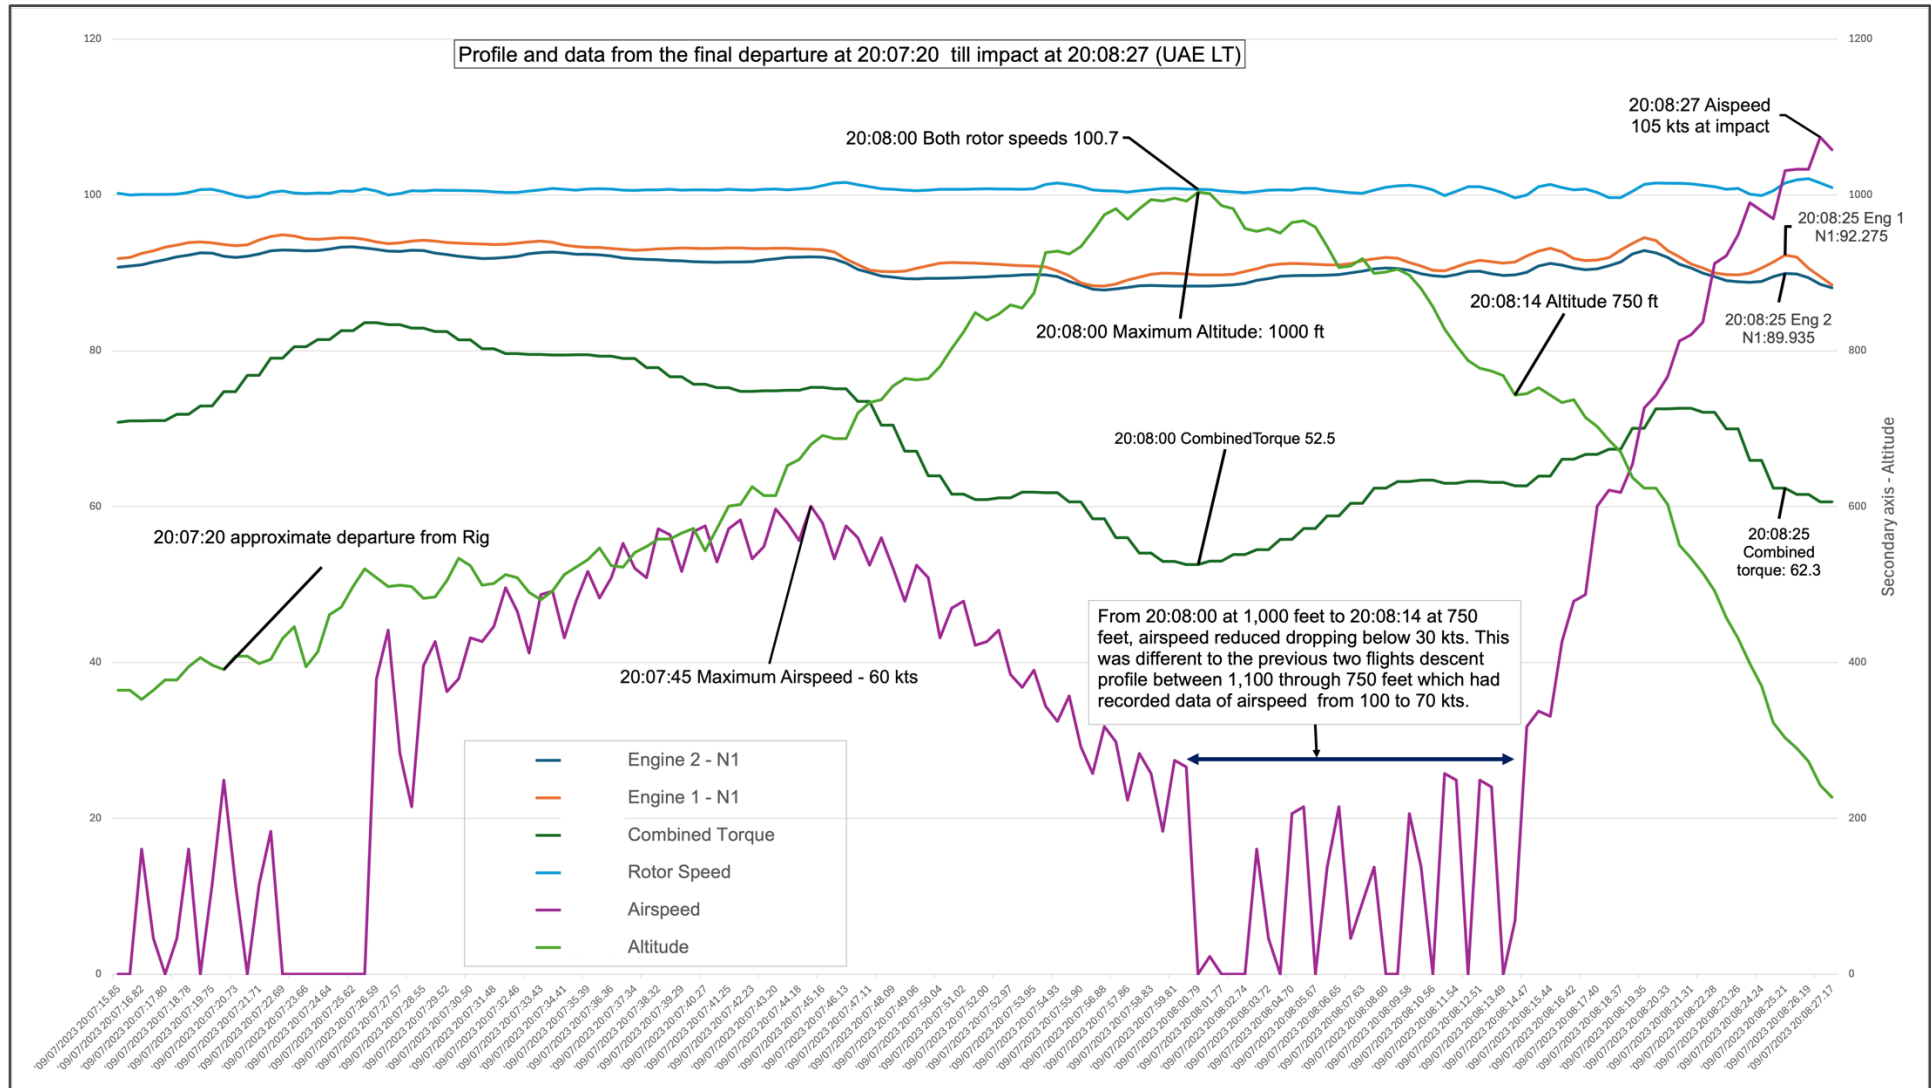
Appendix A: SmartCycle data showing final departure until impact

Thereafter, the recorded data shows that the airspeed decreased to between 0 and 20 KIAS, and a high rate of descent was established. Further, the recorded data indicates that this condition prevailed for a period of about 14 seconds reaching an altitude of 750 feet.
