الهيئة العامة للطيران المدني
GENERAL CIVIL AVIATION AUTHORITY

- Final Report -

AAIS Case N° AIFN/0015/2023

Severe Air Turbulence Encounter (TURB)

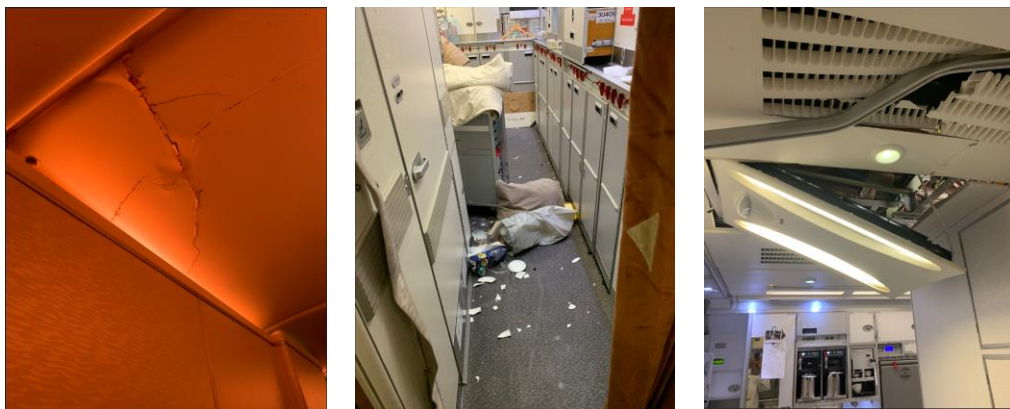
Figure 3. Some of the damages and scattered service equipment

An inspection of the cabin revealed extensive damage in various areas, particularly to the overhead bins, ceiling panels, and passenger service units (PSUs), which were cracked from impact. Additionally, some curtain rails above the aft economy class seats and in the upper deck galley had deformed chassis. A visual map illustrating the damage distribution and indicating the positions of crewmembers and injured passengers is given in Appendix B.

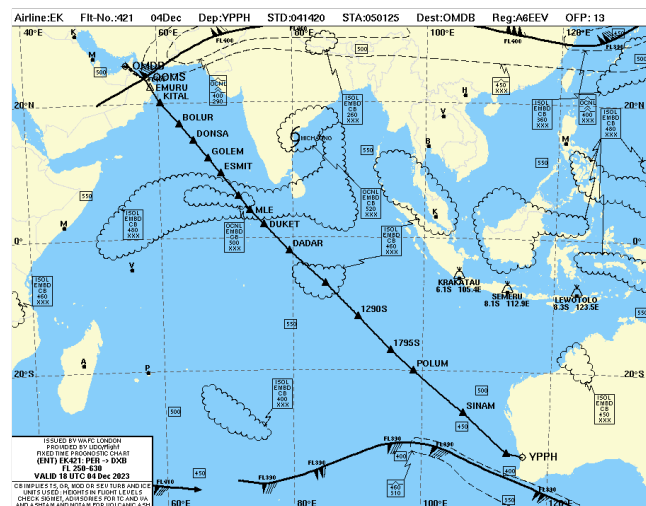
Figure 9a. Significant weather fixed time prognostic chart of the Indian Ocean valid for 18:00 UTC, 4 December 2023 from FL250 to FL630

According to figure 9a, the flight route was expected to traverse an area with isolated embedded CB clouds. These clouds had cloud tops reaching up to FL460, and occasional embedded CB with cloud tops reaching up to FL500 were anticipated between waypoints DUKET and ESMIT near the area where the severe turbulence was encountered.

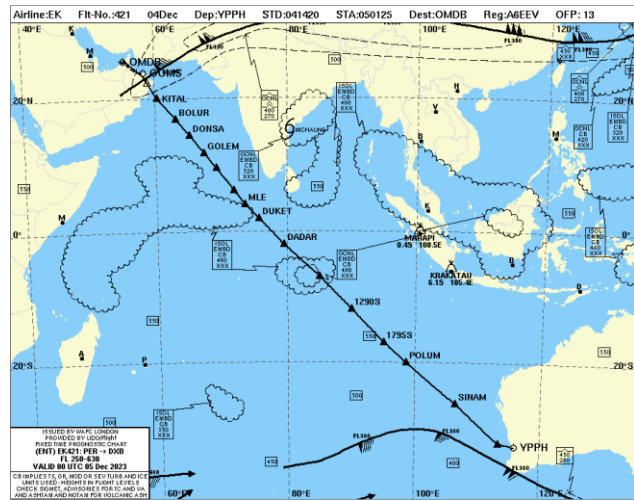
Figure 9b. Significant weather fixed time prognostic chart of the Indian Ocean valid for 0000 UTC, 5 Dec 2023 from FL250 to FL630

According to figure 9b, the flight path was anticipated to pass through an area containing isolated embedded CB cloud, with cloud tops reaching up to FL460 expected between waypoints DUKET and MLE in the vicinity where severe turbulence was encountered.

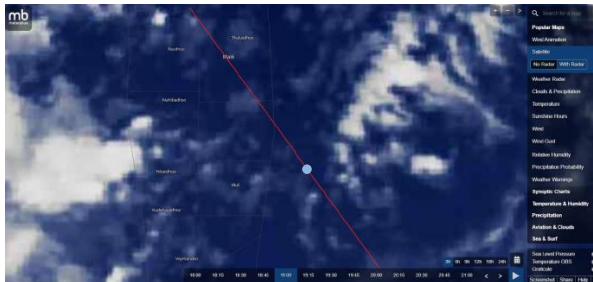
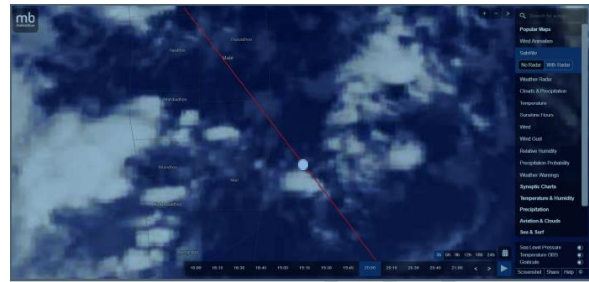
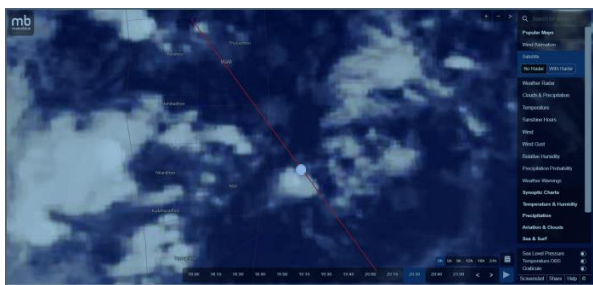
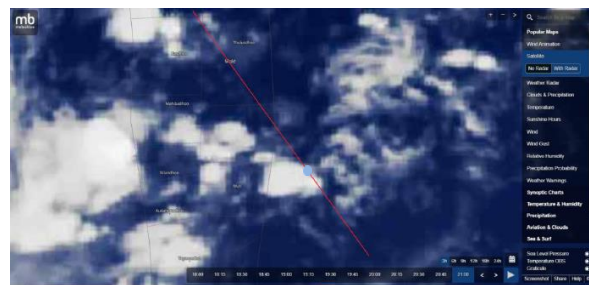
Figure 10. MeteoBlue satellite images of atmospheric conditions snapshots over two hours (1900 – 2100 UTC) in the area of the severe turbulence encounter

Furthermore, the Investigation was provided with historical satellite images at the event's time and location that show a developing cloud formation that grew larger over the two hours, from 1900 to 2100 UTC, preceding the turbulence encounter (figures 10a to 10d).

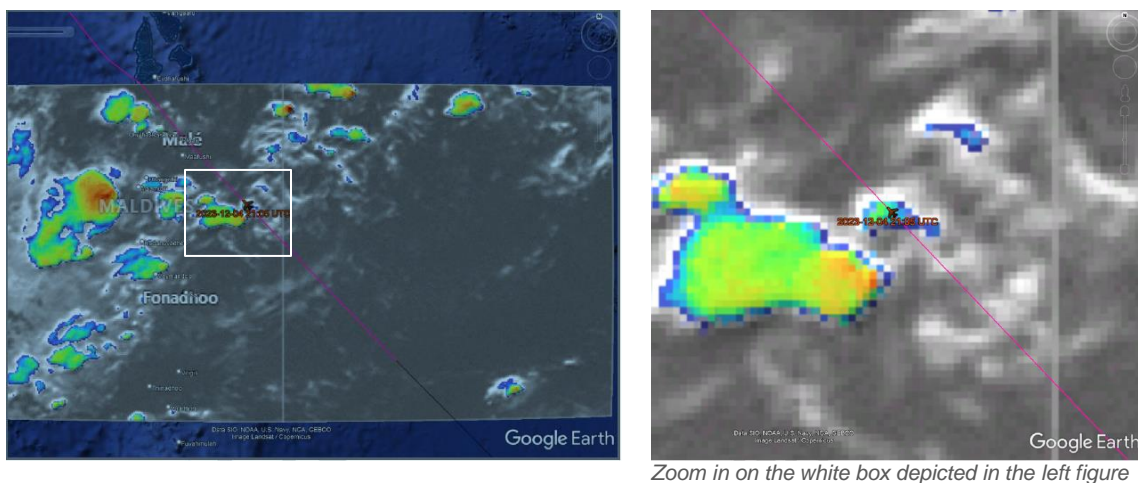
Figure 11. Satellite radar image at 2105 UTC

Through the Operator, the Aircraft manufacturer provided a satellite weather chart and stated that, at 2105 UTC, the Aircraft overflew a thunderstorm, when severe turbulence was encountered (figure 11).

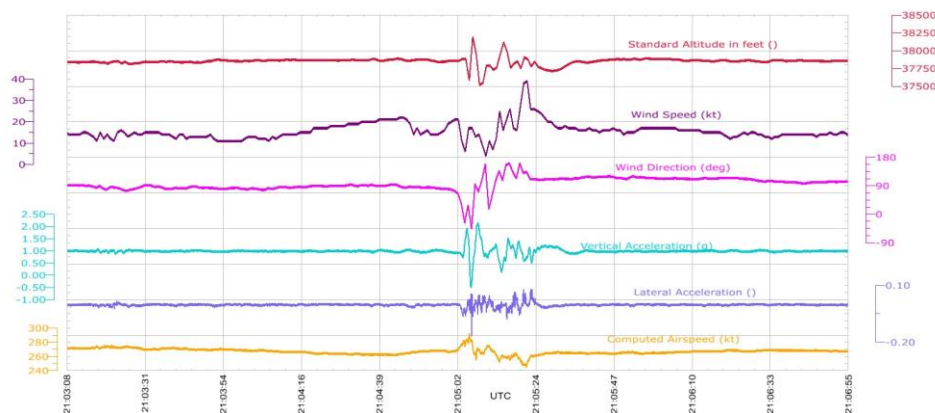
Figure 12. Vertical and lateral g variation, altitude, airspeed, and wind conditions during turbulence

- The longitudinal wind varied between 31 knots headwind and 39 knots tailwind
- The lateral wind varied between 19 knots from the right and 15 knots from the left
- The vertical wind varied between 11 knots downdraft and 46 knots updraft
- At 21:05:05 UTC, speed brakes were selected for 11 seconds and spoilers deflected accordingly
- At 21:05:06 UTC, the master caution triggered on both sides for 11 seconds. This master caution is linked to the PFR message OVERSPEED LOADS ANALYSIS REQUIRED
- The autopilot remained engaged throughout the entire period of the turbulence.

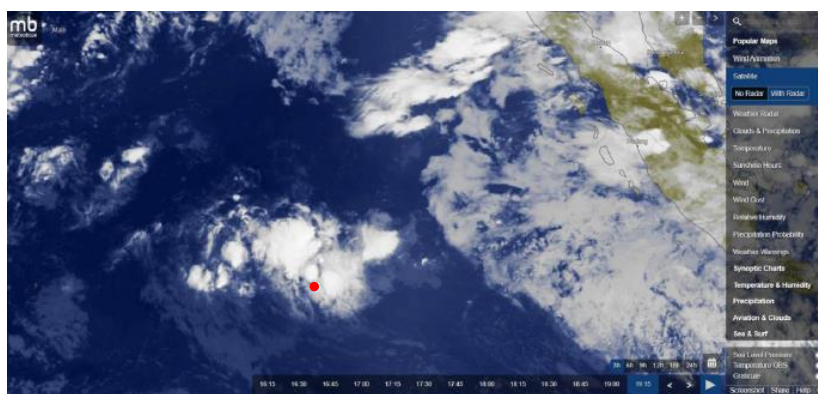
Figure 13. MeteoBlue satellite image of atmospheric conditions, 4 December 2023 at 1915 UTC in the area where the Aircraft flew

The fixed-time prognostic charts valid for 1800 UTC on 4 December 2023 and 0000 UTC on 5 December 2023 (figures 9a and 9b) indicated isolated embedded CB clouds along the planned route. The timing and location of the route deviation were consistent with the forecast isolated CB activity within the Melbourne FIR. Additionally, a MeteoBlue satellite image (figure 13), captured on 4 December at 1915 UTC, showed atmospheric conditions at the time, with the Aircraft's position at 1911 UTC marked for reference.
