Accident

AAIS Case N° AIFN/0009/2020

Gyrocopter Landing Strip Excursion after Landing

Operator:	Nad Al Sheba Private Club
Make and Model:	Gyrocopter – ROTOX 914
Nationality and Registration:	United Arab Emirates, A6-GY7
Place of Occurrence:	Nad Al Sheba, Dubai
State of Occurrence:	The United Arab Emirates
Date of Occurrence:	24 July 2020

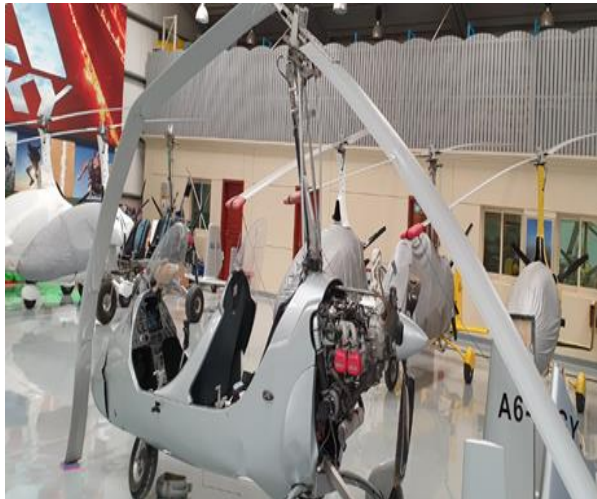
The Aircraft sustained substantial damage. The rotor blades of the Aircraft fractured. The Aircraft nose severely damaged after impacting the fence at high speed. The engine cowling detached. The Aircraft fuselage broke up (Figures 2, 3 and 4).

Figure 2. Damage to rotary blades

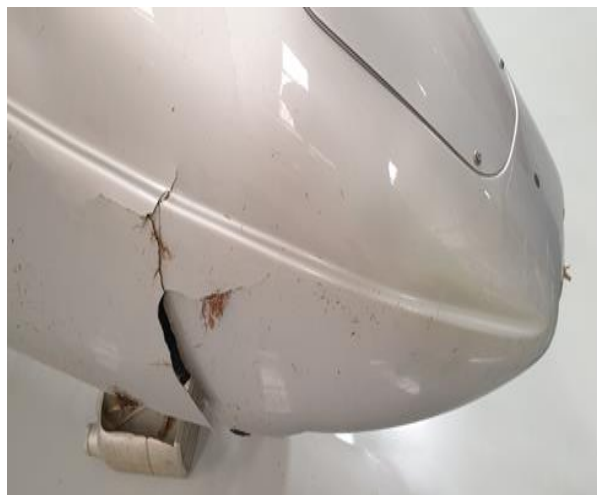
Figure 3. Aircraft nose

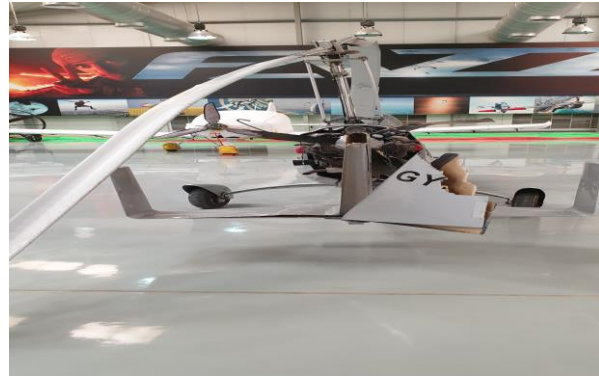
Figure 4. Damage to the tail

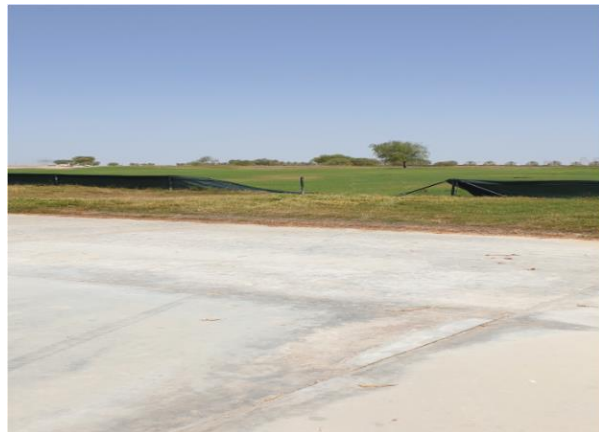
Property damage was limited to the fence and scars on the grass area.

Figure 5. Damage to the fence

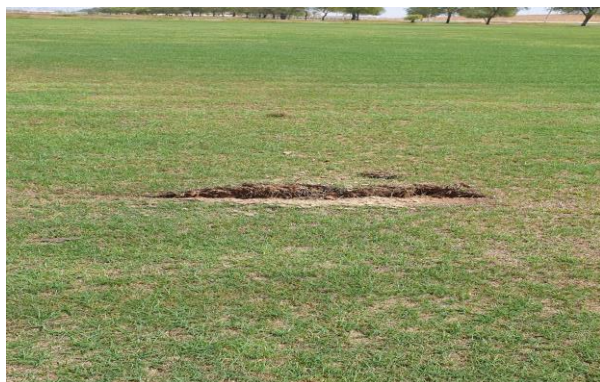
Figure 6. Damage to the grass area
