# AIR ACCIDENT INVESTIGATION SECTOR

## AIR ACCIDENT INVESTIGATION REPORT

## AIRCRAFT CRASH AFTER TAKEOFF

Boeing 707-330C  
ST-AKW  
Azza Air Transport  
Near Sharjah International Airport  
The United Arab Emirates  
21 October 2009

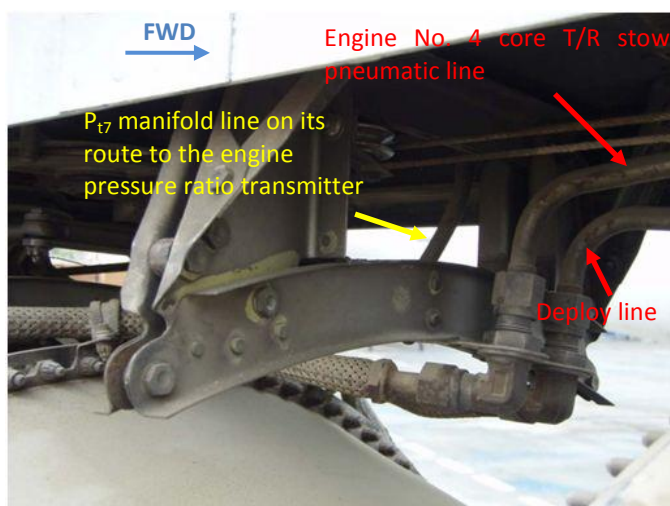
**Figure 2-** A photo taken on a sister aircraft showing the hinge support structure at NS 198.82 mounted on the strut of the No. 4 engine.

The EPR transmitter converts the sensed  $P_{t7}$  and  $P_{t2}$  pressures into a ratio, and generates a three-phase electrical signal corresponding to pressure changes in the engine and sends that signal to the EPR gauge in the cockpit. The EPR transmitter consists of two bellows (multicell diaphragms), a sensing mechanism, an amplifier, a motor-gear train, and a synchronous generator. The EPR transmitter is mounted in the center section of the pylon. On No. 4 engine installation, a flex line from the  $P_{t7}$  manifold is routed just aft of the NS 198.82 hinge support structure (Figure 2).

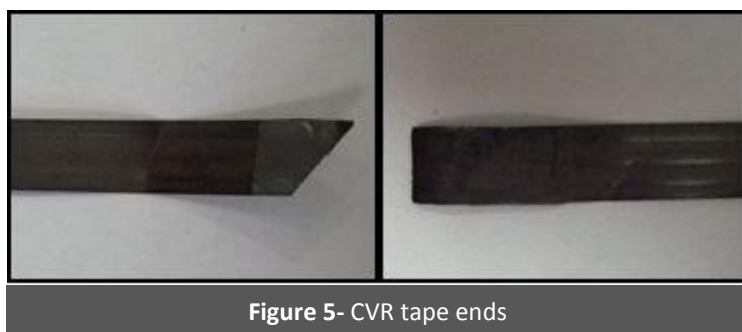
Figure 5- CVR tape ends

was not intact. The end of the tape that feeds out from the center of the reel, adjacent to the rotating hub, had been tucked back into the center of the reel, while the end of the tape from the outside of the reel was still within the confines of the reel. Thus, no tape was present along the tape path or over the recording heads.

Also, it was noted that the ends of the tape did not match each other (Figure 5). No other undamaged or usable segments of recording tape were found in the CVR.

On the subsequent playback of the tape, the recording was found to be unrelated to the accident flight lasting 23 minutes and 46 s, indicating that at least 6 minutes and 15 s of recording, or 701.25 inches (1,781 centimeters) of tape, was missing.<sup>17</sup>

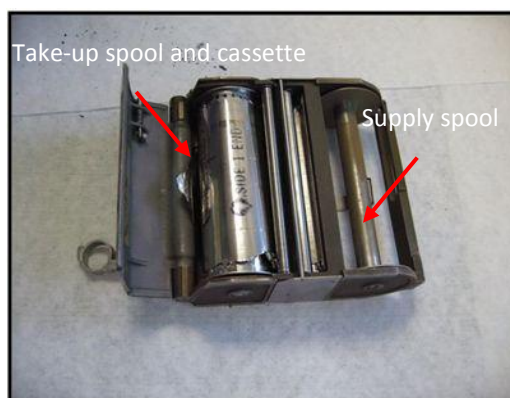
Figure 6- FDR foil

maintenance seals (one on top of the FDR and the other on the back) were broken. The top seal was also partially stuck over a 'Hunting' service sticker with the year 1996 printed on it.

The foil cassette (Figure 6) was then removed from the FDR, and on inspection, showed no signs of damage. There was no foil on the supply spool (RH spool in Figure 6) with all of the used foil on the take-up spool (LH spool in Figure 6). An examination of the foil showed that it had been reused

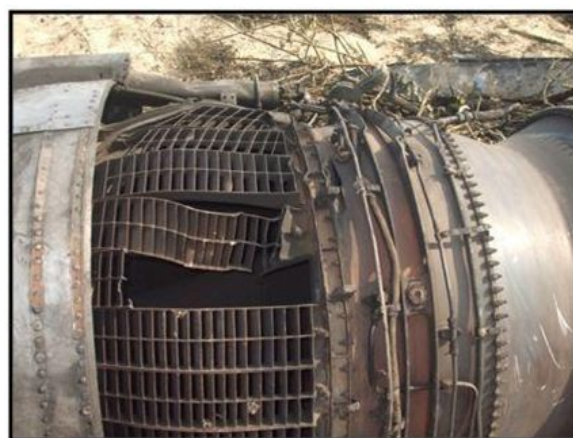
Figure 8- No. 4 engine core T/R as found at the Accident site

The No. 4 engine was found with the core T/R still attached and the T/R was in the partially deployed position. The outer translating sleeve and the RH T/R clamshell were almost to their fully deployed position, while the LH T/R clamshell was found in the stowed position. (Figure 8).

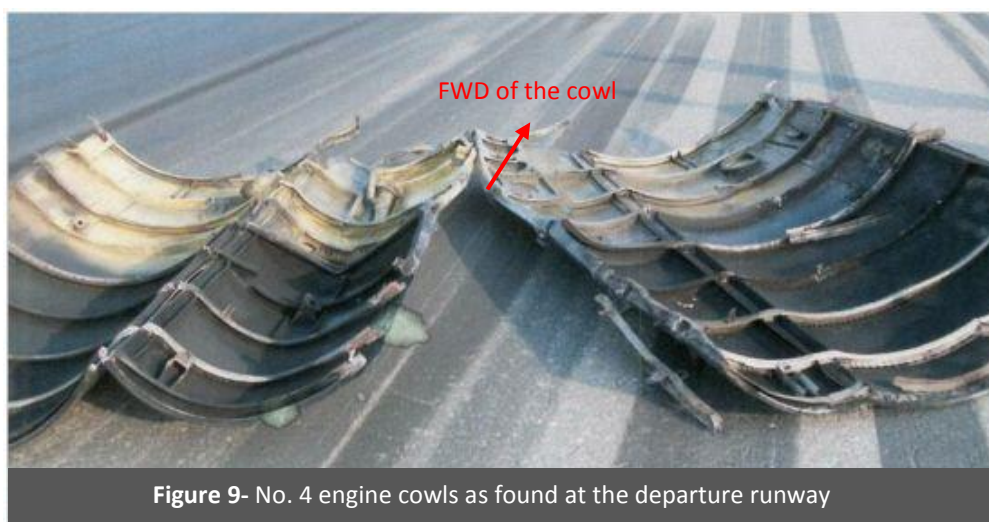
Figure 9- No. 4 engine cowls as found at the departure runway

Photo documentation of cowling and hinge support structure found on the departure end of RWY 30 revealed that one latch was still engaged, the cowls were lying on their outer surfaces and exhibited buckles consistent with the ground impact. Based on measurement of the hinge support structure, Boeing was able to identify it as coming from the No. 4 engine pylon.

The two halves of the No. 4 engine core cowls (Figure 9) were found at the departure runway latching at one point (latch B in Figure 10 counting forward to aft of 6 latches). The cowls were damaged, torn, and folded forward at the AFT-INBD corner.

The damage on the core cowls was consistent with ground impact, no witness marks were identified that could be attributed to contact with the airplane after separation.

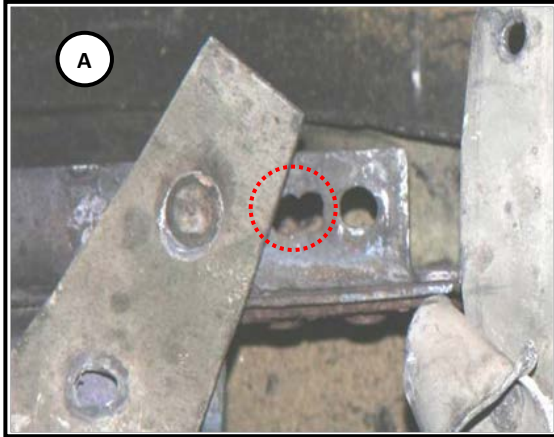
Additionally, numerous skin repairs to both cowls were noted that were not performed to typical aviation standards. The repairs shown in figures 11A and 11B were examples of these repairs. Figures 11C and 11D illustrate examples of indents caused by the alignment pin of the LH cowl on areas next to the pin receptacles on the RH cowl due to repetitive improper engagements.

Example of one double drilled hole underneath a reinforcing patch at station E, LH cowl

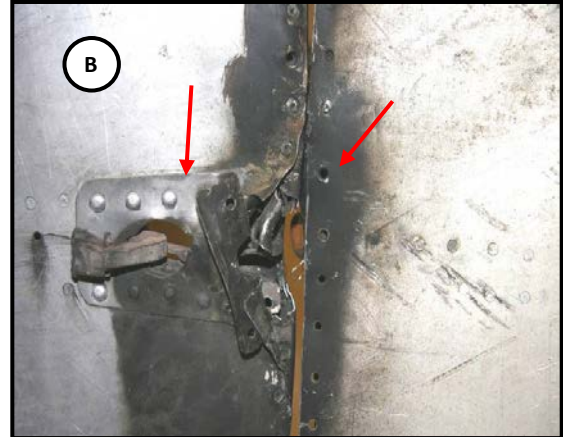
Example of skin repair around E latch assembly on the RH cowl and missing rivets on the LH cowl

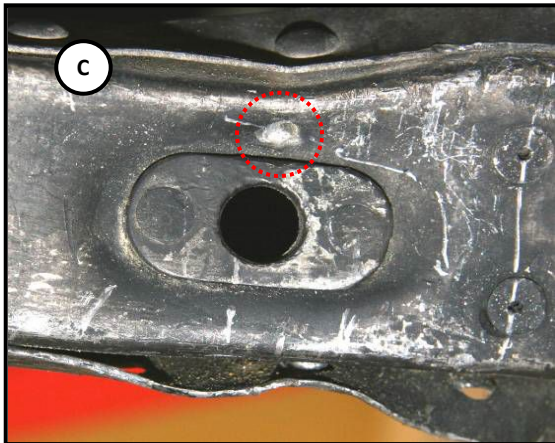
Multiple indentations and secondary hole were noted on the RH cowl hinge line flange in the vicinity of the guide pin hole consistent with the guide pin on the LH cowl being misaligned when the cowling doors were closed and latched. The number of misalignment pin marks was consistent with repetitive engagement problems and the deformations of both the alignments pins and the alignment pin receptacles confirmed this. The Investigation could not determine if all the cowl alignment pins and latches were properly engaged prior to takeoff on the Accident flight.

Cylindrical damage adjacent to the guide pin hole at location E on the RH cowl

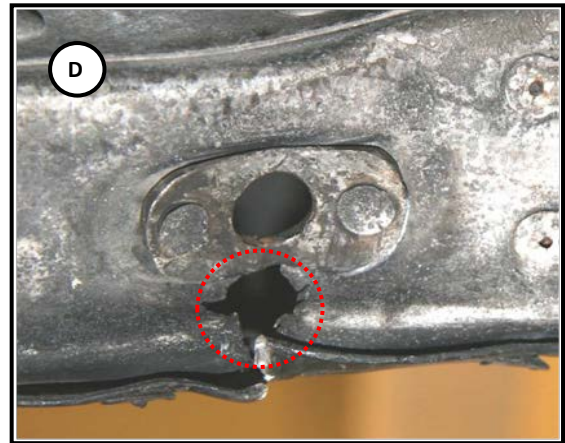
Cylindrical damage adjacent to the guide pin hole at location F on the RH cowl

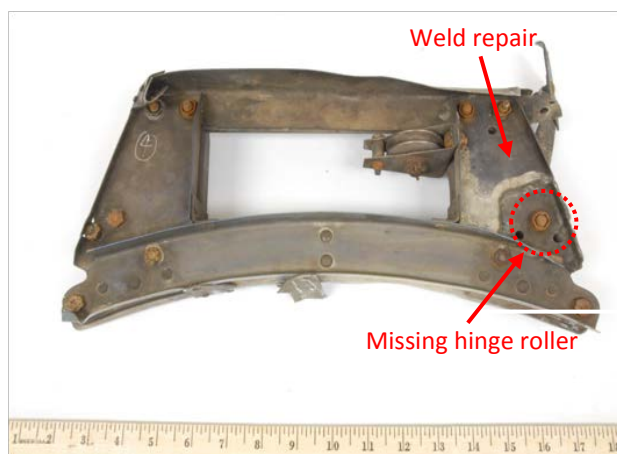
Figure 12- Engine No. 4 cowl hinge support structure

Visual examination revealed evidence of a welding repair on a corner of the assembly and a missing hinge roller on the same side as the weld repair. The roller mounting location through-holes were not distorted suggesting the possibility that the roller may have been missing prior to the accident (Figure 12).

Metallurgical examination of the cowl hinge support revealed fatigue striations on the upper mounting point fracture surfaces consistent with a pre-existing fatigue condition. The design specification for the hinge support is titanium ("Ti") 17-7; however the two upper hinge support structure's angles were found to be made of corrosion resistant steel ("CRES") consistent with a 300-series alloy.

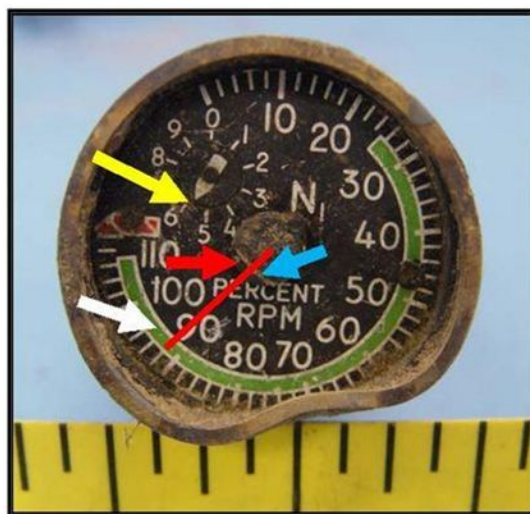
Figure 13- No. 4 engine, N<sub>1</sub> %RPM Gauge

Examination revealed that the hub of the center needle remained attached to the gauge but the pointer was missing (Blue arrow in Figure 13). A red line extending from the hub center through the fracture (Red arrow) needle end matched to a gauge reading of about 92% N<sub>1</sub> (Red arrow in Figure 13). The inset needle was intact and was pointing between 5 and 6 (Yellow arrow in Figure 13).

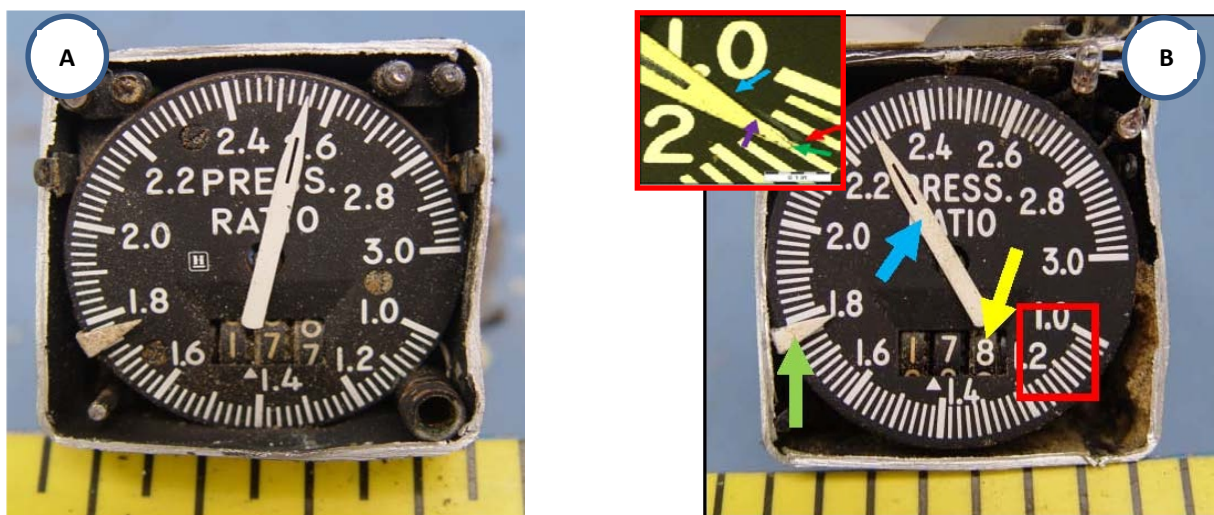
Figure 14 A & B- No. 3 and 4 engines EPR Gauges, respectively

Initial examination of the No. 4 engine EPR gauge revealed that the number in the counter window was 1.78 consistent with the EPR setting bug (green arrow Figure 14B) and the needle (blue arrow) was pointed in the vicinity of 2.7. During disassembly of the gauge the needle moved and eventually stopped at the location shown in Figure 14B (2.28).

Microscopic examination of the dial revealed a band of disturbed paint at the 1.05 EPR location contained within the red box in Figure 14B. The area within the red box is illustrated in the upper LH red box (Figure 14B) with the disturbed paint indicated by the red arrow. The needle was moved to the 1.06 position in order to illustrate that the needle tip indicated by the green arrow matches the outer end of the disturbed area indicated by the red arrow. It was noted that the edge of the disturbed area matched the adjacent edge of the needle and that the intensity of the disturbed area decreased as the distance from the tip increased, consistent with the needle impacting the dial surface during the impact sequence.

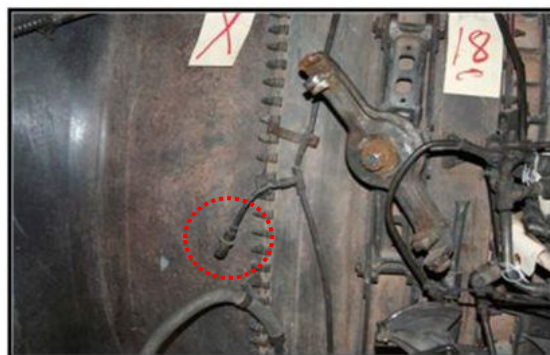
Figure 15- P<sub>t7</sub> manifold

The engine structure was complete from the front of the HPC (10<sup>th</sup> stage) through to the exhaust nozzle. None of the cases from the diffuser case back to the TEC exhibited any breaches or indications of external fire. The rear 14 inches of the IMC rear shirt was still attached and no indications of any breaches or indications of external fire were noted. The majority

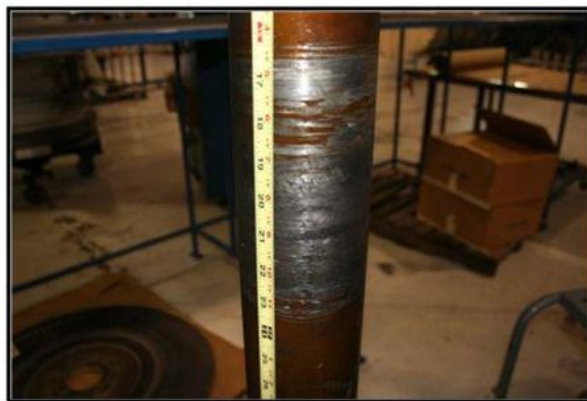
Figure 16 Example of rubbing marks (LPT shaft)

The HPT rotor rotated freely by hand but the HPC did not rotate, consistent with the HPC hub fracture and HPT and HPC no longer coupled together. All the HPT hardware: blades, nozzle guide vanes, vane support, and blade outer air seals were intact, in place and exhibited circumferential contact marks consistent with the HPT rotating at impact. All the LPT hardware: blades, nozzle guide vanes, vane support, blade outer air seals, spacers, and disks - were intact, in place, and exhibited some amount of circumferential contact marks that varied in location and severity from stage to stage. The LPT shaft was intact and exhibited heavy 360° circumferential rubbing that measured about 8 inches in length. All the circumferential rub observed in the LPT was all consistent with the LPT rotating at impact (Figure 16).

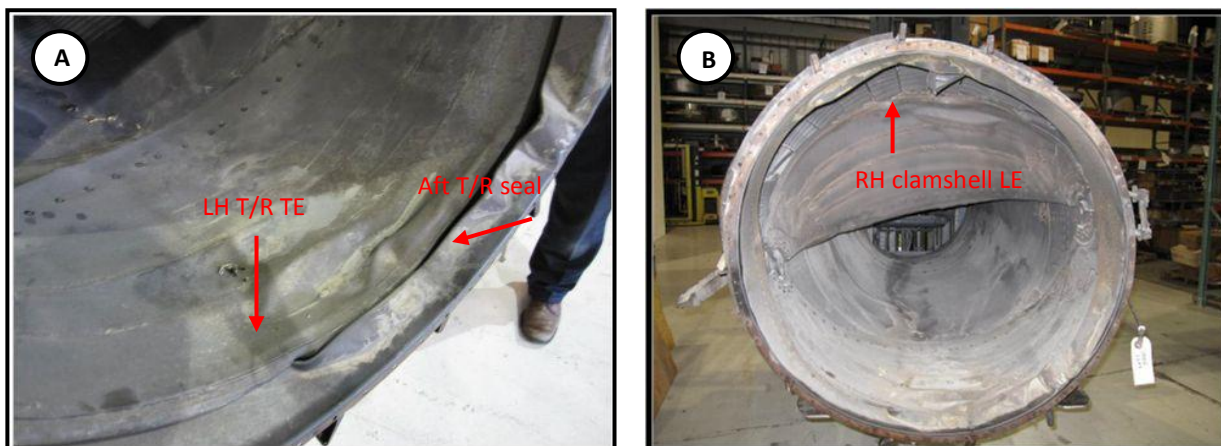
Figure 17- Overview of LH and RH clamshells

The SEM testing on the T/R driving AFT follow-up rod mechanism showed cup and cone fracture with dimpled appearance of the fractured surfaces, the control cable attached to the T/R feedback mechanism exhibited elongation reduction of area, the upper right side clamshell drive mechanism on the inner hinge shaft was fractured and the dimples had no rotational nature. Those natures of failures were consistent with tensile overstress resulting from impact forces which drove the mechanism.

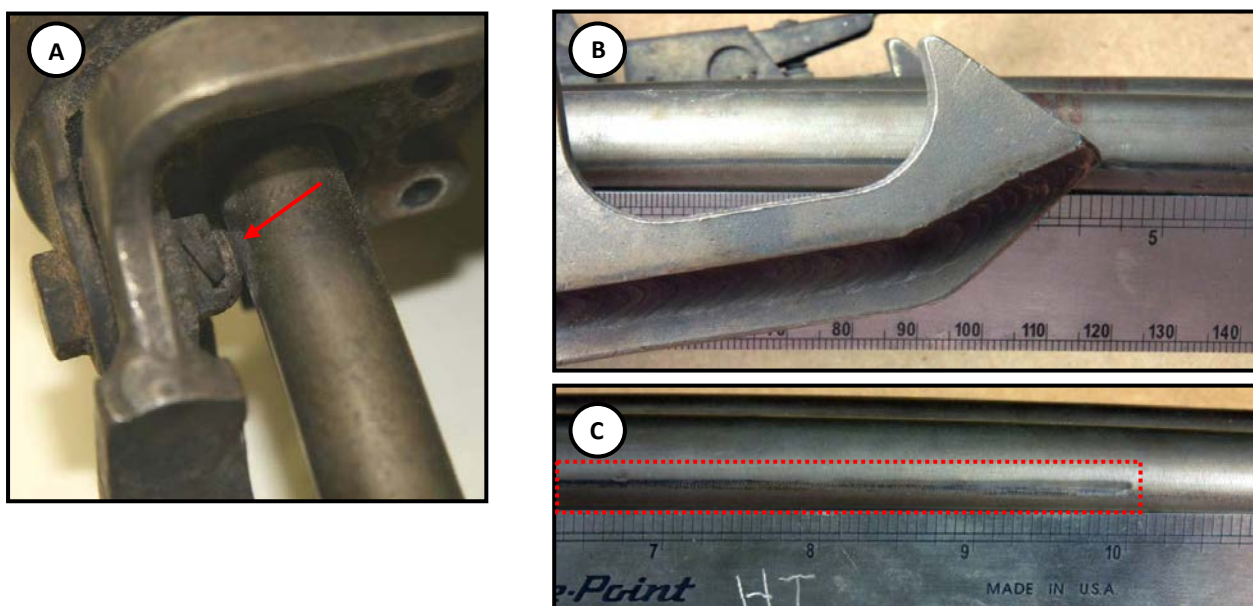
Figure 18- Lower RH actuator

The examination observed that the lower RH actuator was marked by a longitudinal score on the piston rod that was consistent with the actuator having been in the stowed position until ground impact forced it to become displaced from the stowed position and extend to the nearly fully extended position. (Figures 18A, B and C).

Since the field observations confirmed that this stowed lower actuator, along with the other three actuators (other lower actuator and two upper actuators), were properly installed and still attached at their thrust reverser outer sleeve attach points and their movement should have been simultaneous; the Investigation believes that all the four actuators were at their stowed position prior to the Aircraft impact thus the T/R was at the stowed position at impact.

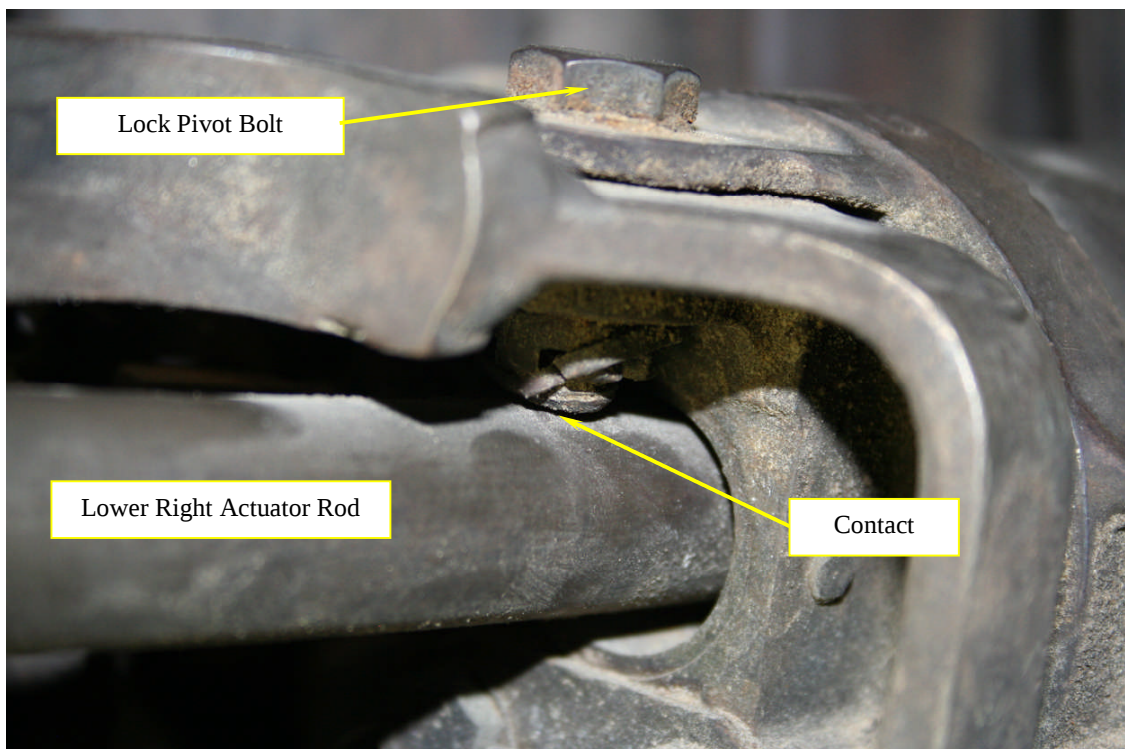
Photo (10) – Lock Pivot Bolt to Actuator Rod Contact

10. The lower right actuator rod contacted the lock pivot bolt.
11. The translating sleeve moved to the deployed position rotating the right clam shell into the deployed position also.
