AAIS Case Reference: 18/2012

## SERIOUS INCIDENT INVESTIGATION REPORT

### **Passenger Door Separation Inflight: SCF-NP: System/component failure or malfunction (non- powerplant)**

Diamond DA42NG Twin Star  
A6-HIC  
Al Ain  
United Arab Emirates  
12 October 2012

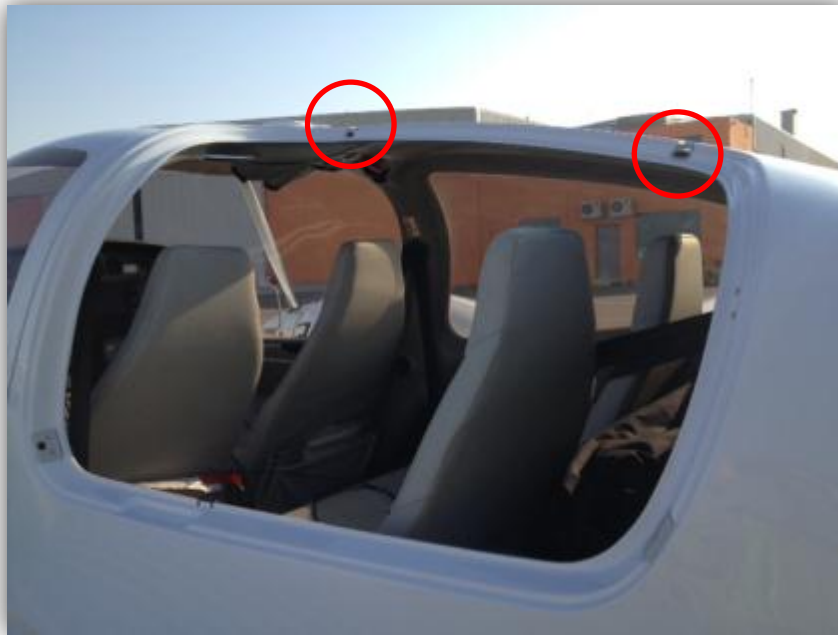
Picture 1 Door Hinge Location

- 1.3.1 The passenger door separated from the fuselage in one piece as a complete door assembly
- 1.3.2 The passenger door lifted from the latched lower edge, extending up due to the aerodynamic loads before separating on the upper hinge line which failed beyond the hinge design limit load.

- 1.12.1. The rear passenger door was recovered from the desert adjacent to the active runway, relatively intact with door edge damage due to the ground contact
- 1.12.2. The upper hinges for the rear passenger door has damage consistent with failure beyond limit load
- 1.12.3. The door support/gas operated strut retainer had failed under load.
- 1.12.4. There was an impact damage line abrasion/scuff mark on the top surface of the fuselage consistent with the angle of elevation of the pax door as it was lifted due to the aerodynamic loads and the door hinge geometry. The abrasion line indicates the door elevation restraint mechanism - the gas sprung strut – had failed.<sup>6</sup>

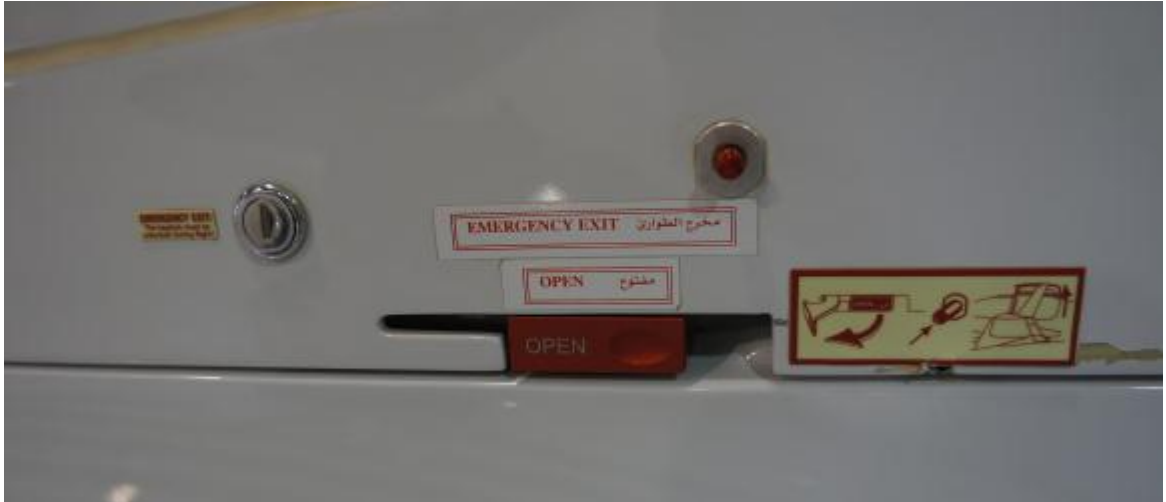
Picture 5 Pax Door External Handle/Latch

A handle on the left of the door operates two locking bolts. The locking bolts are at the bottom front and rear corners of the door.

The handle has two parts. The inner handle is red and has a double lever. The outer handle is red and attaches to the inner handle with two roll pins.

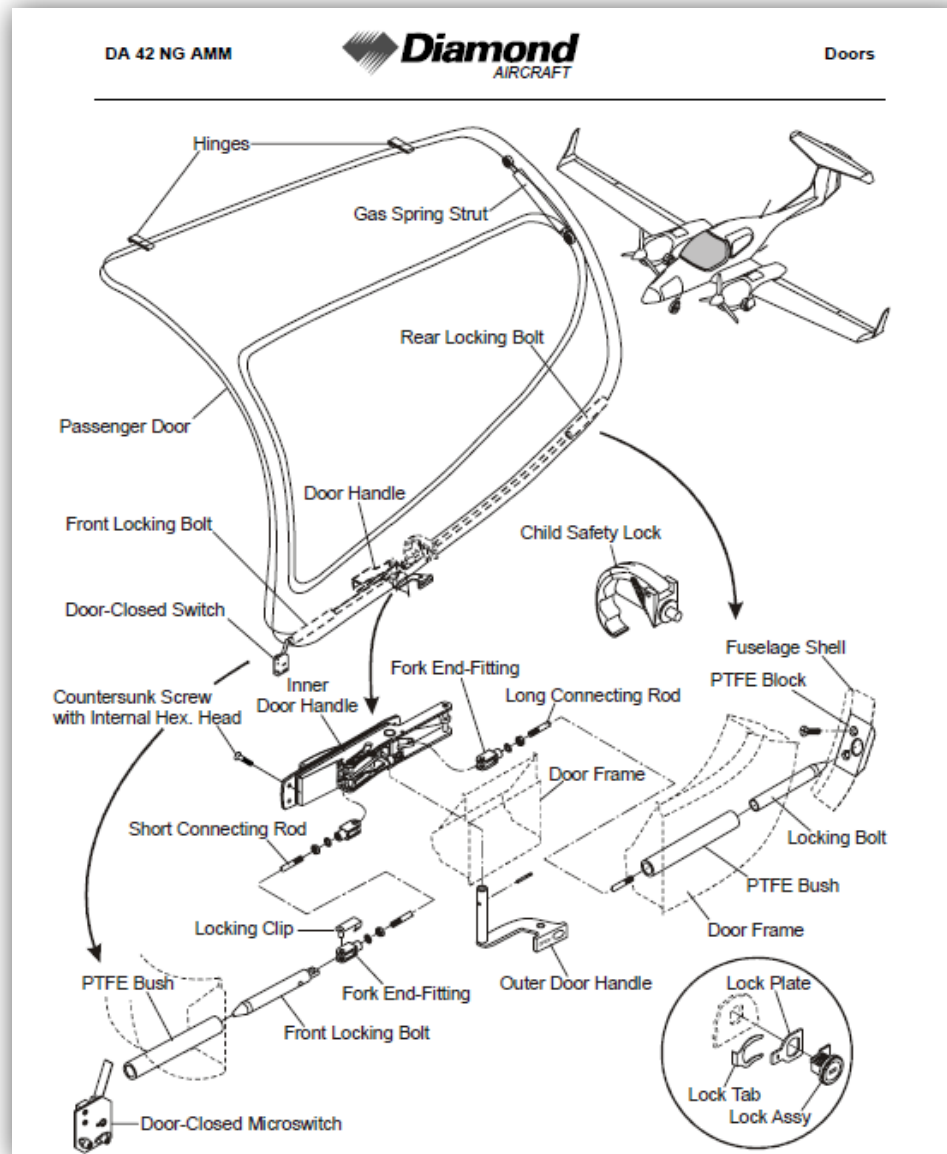
Figure 1 Rear Passenger Door Latching System

A short connecting rod attaches to the front of the double lever. The short connecting rod goes to the front locking bolt. If you pull the canopy handle away from the canopy frame, these things happen:

- The double lever turns to pull the both of the connecting rods.
- The long connecting rod pulls the rear locking bolt forward.
- The short connecting bolt pulls the front locking bolt aft. The aft movement of the locking bolt operates a micro switch for the warning caption located on the ICS.

The door can be pushed up and out to open. With the door fully closed, push the door handle towards the door frame. This engages the locking bolts in the fuselage holes. The forward locking bolt operates the door unlocked micro switch. When the handle is flush with the door frame, the door is locked.

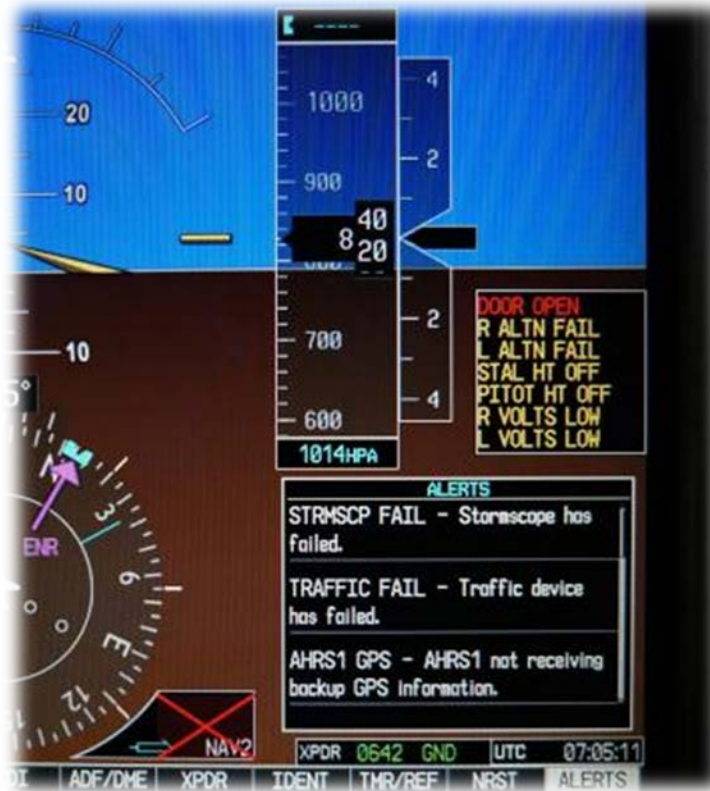
Picture 6 Primary Flight Display ICS Crew Alerts

- The Primary Flight Display has a door open warning<sup>4</sup>
  - A red door warning message on the PFD
- Audible Alarm through the cockpit speaker and the headset if connected
  - An audible alarm
