AAIS Case Reference: 01/2013

PRELIMINARY

AIR ACCIDENT INVESTIGATION REPORT

Bell Helicopter-Textron 206-3B
A6-FTI
Al Ain/Training Area 6
United Arab Emirates
02 January 2013

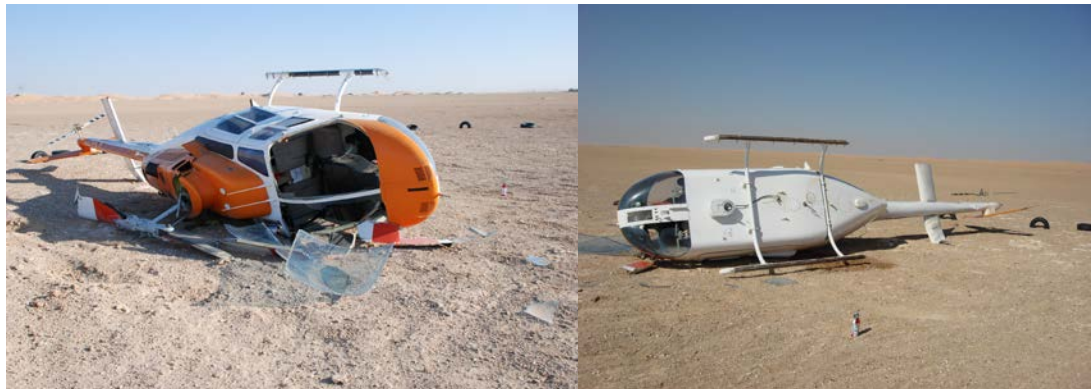
Photo 1: BHT 206-B Accident Aircraft

The student applied left pedal to arrest the yaw, the aircraft then rolled rapidly to the right , followed by the main rotor blades contacted the terrain and the aircraft rolled 90° onto the right-hand side

The aircraft was damaged beyond economic repair.

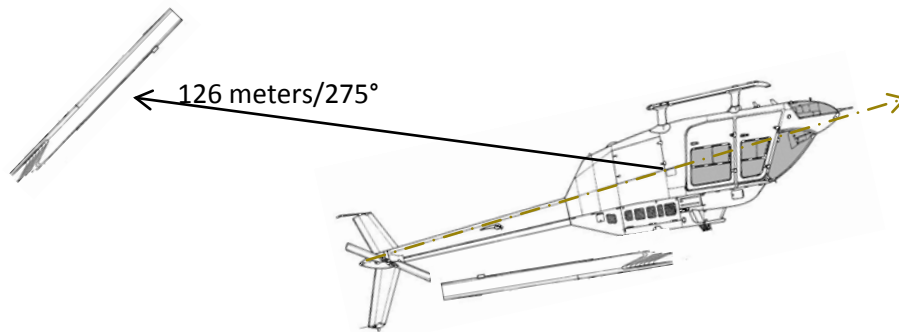
Figure 2 Wreckage Location – View from above orientated on North [360°]

- 1.12.1 The location of the accident was in TA6. The wreckage was localised in the immediate accident area, with one main rotor blade 126 meters from the fuselage to the west of the accident site.

- 1.12.3. The accident site was 18.3 nm from OMAL on a radial of 294° from the operators fixed base.
- 1.12.4. The accident site surface is level compacted sand, with an estimated CBR⁷ of 3-4, with a blown and drift sand accumulations scattered locally.
- 1.12.5. The wreckage is localised to the immediate area of impact with exception of one main rotor blade 126 meters from the main accident site. The majority of the wreckage is localised in one location.
- 1.12.6. There was pooling of leaking fuel from the fuel tank.
