AAIS Case Reference: 16/2012

SERIOUS INCIDENT INVESTIGATION REPORT

In Flight Turn Back – Engine Nacelle Fire

Abu Dhabi International Airport
United Arab Emirates
09th September 2012

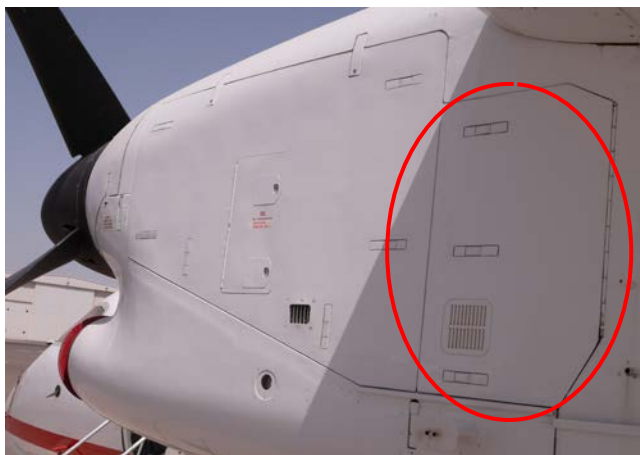
FIG 3

#2 Engine LH side Typical normal nacelle panel – 425AL

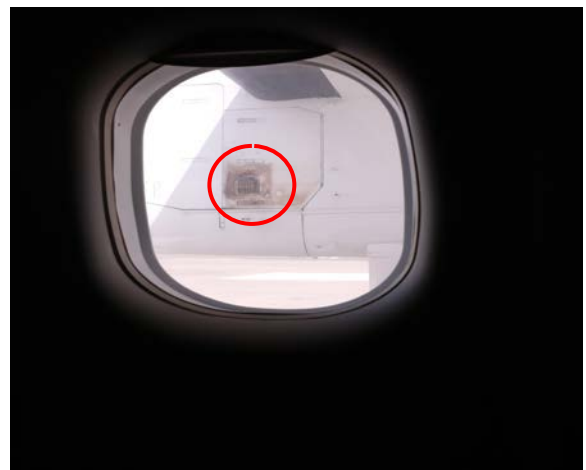
FIG 4

Eventually the cabin staff did attend to the passenger and immediately reported to the flight crew that there was something wrong on #2 engine nacelle. The first officer, after takeoff at around FL 2300 feet, went to the passenger. At this point in the flight the paint on the exterior of the panel had already started to blister and the bare metal was now visible.

View of #2 Engine panel 425AL from row 6 RHS

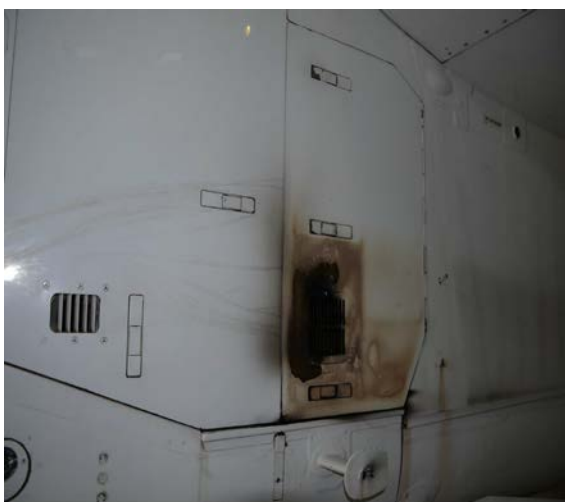
Initial inspections revealed that there was overheating as a result of the escaping hot engine gases through the open igniter boss on the compartment structure, the access panels and associated lines. There were no signs of overheating seen on the compartment fire detectors which were located approximately 16.5 inches from the open port.

FIG 6
#2 Engine LH side access panel 425AL showing discoloration

As a result of the overheating, several parts will be replaced before the aircraft is returned to service and this includes the following and are similar for both engines. This is only a summary and more details will be given as the investigation continues:

1. Engine struts located within the compartment
2. Fire seals
3. Hoses
4. Clamps
5. Fire detector support grommets
6. Access panels
7. Igniter harness

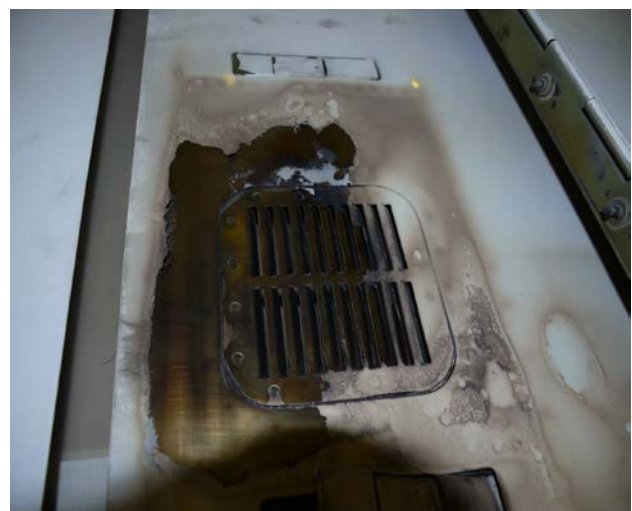
FIG 7
Close up view of 425AL with paint peeled off due to overheat

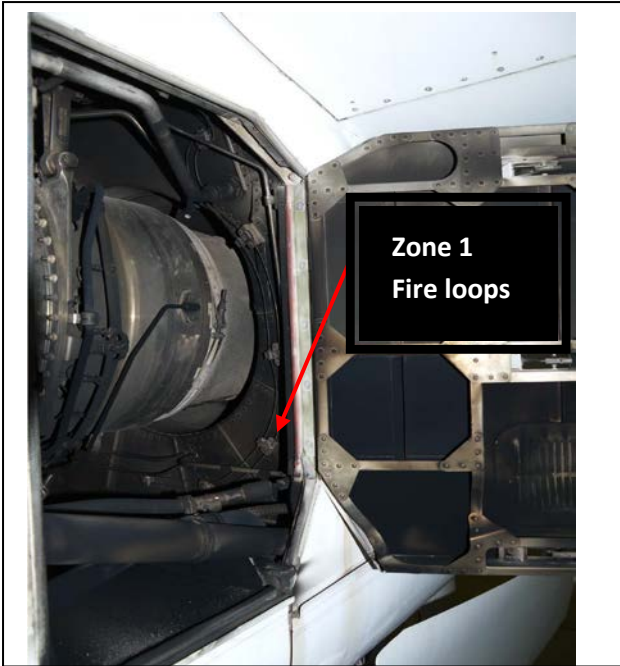
FIG 8

#2 Eng – LH side -Location of the engine fire detector loops on the compartment bulkhead

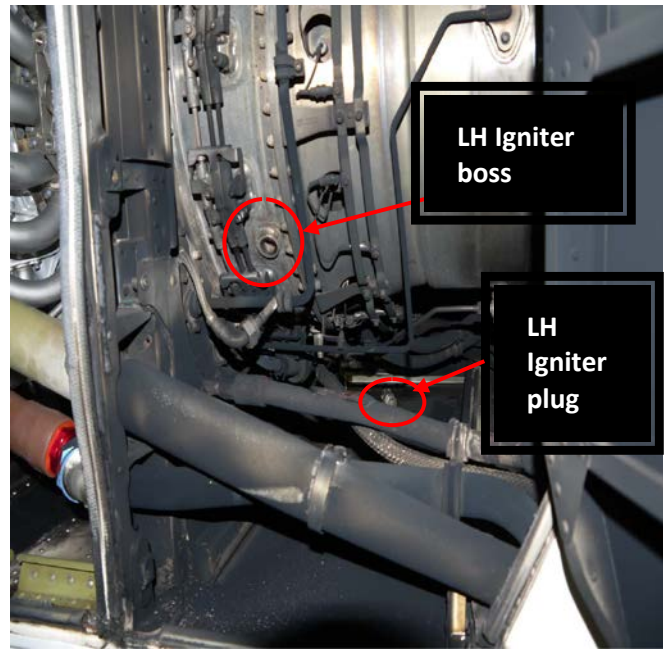
FIG 9

#2 Eng- LH side - Overheating of the lines/structure & LH igniter boss and igniter plug where it was found

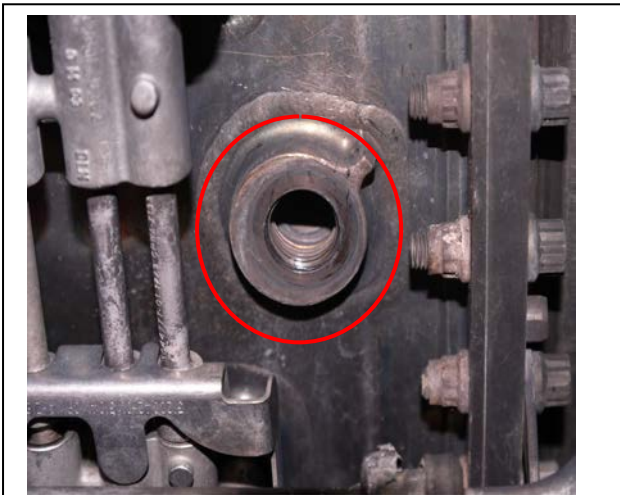
FIG 10

#2 Eng- LH side- LH igniter boss where the hot gases exited as the igniter plug was not fitted

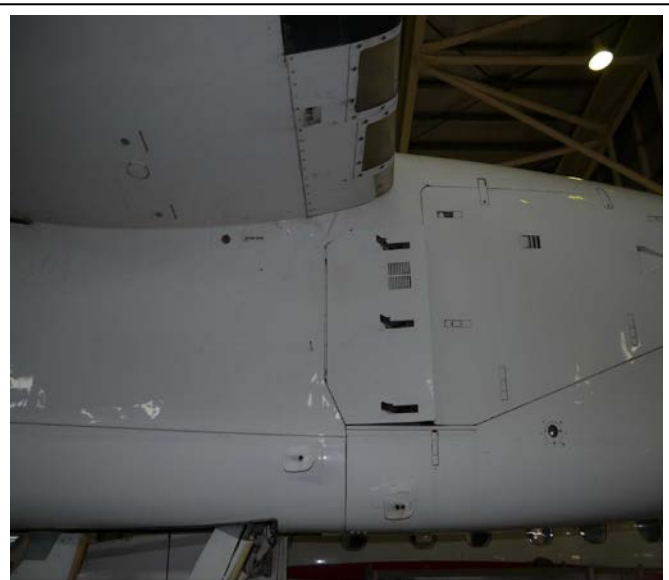
FIG 11

#2 Eng- RH Side nacelle panel 425AR – No external signs of overheat

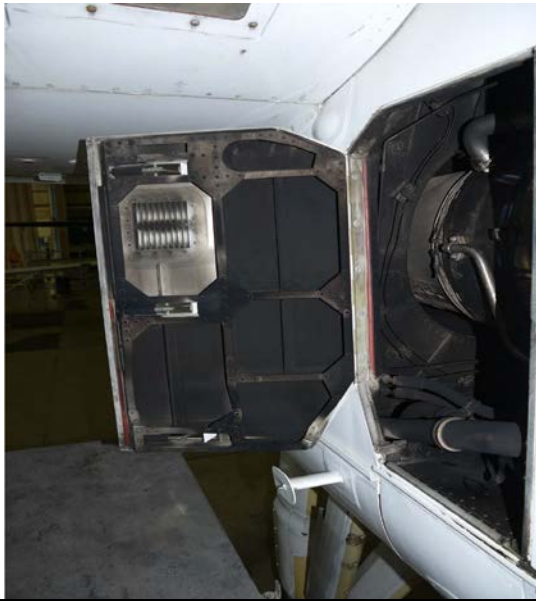
FIG 12
 #2 Eng- RH side- showing signs of soot deposit

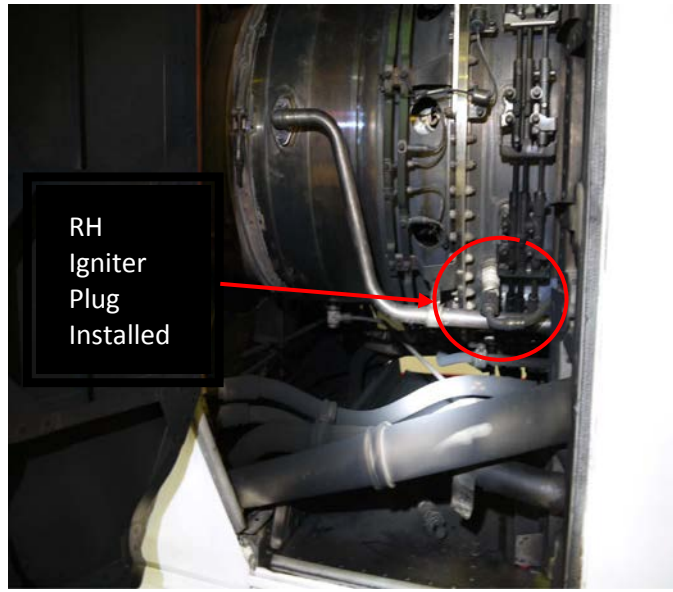
FIG 13
 #2 Eng- RH side- Igniter plug fitted

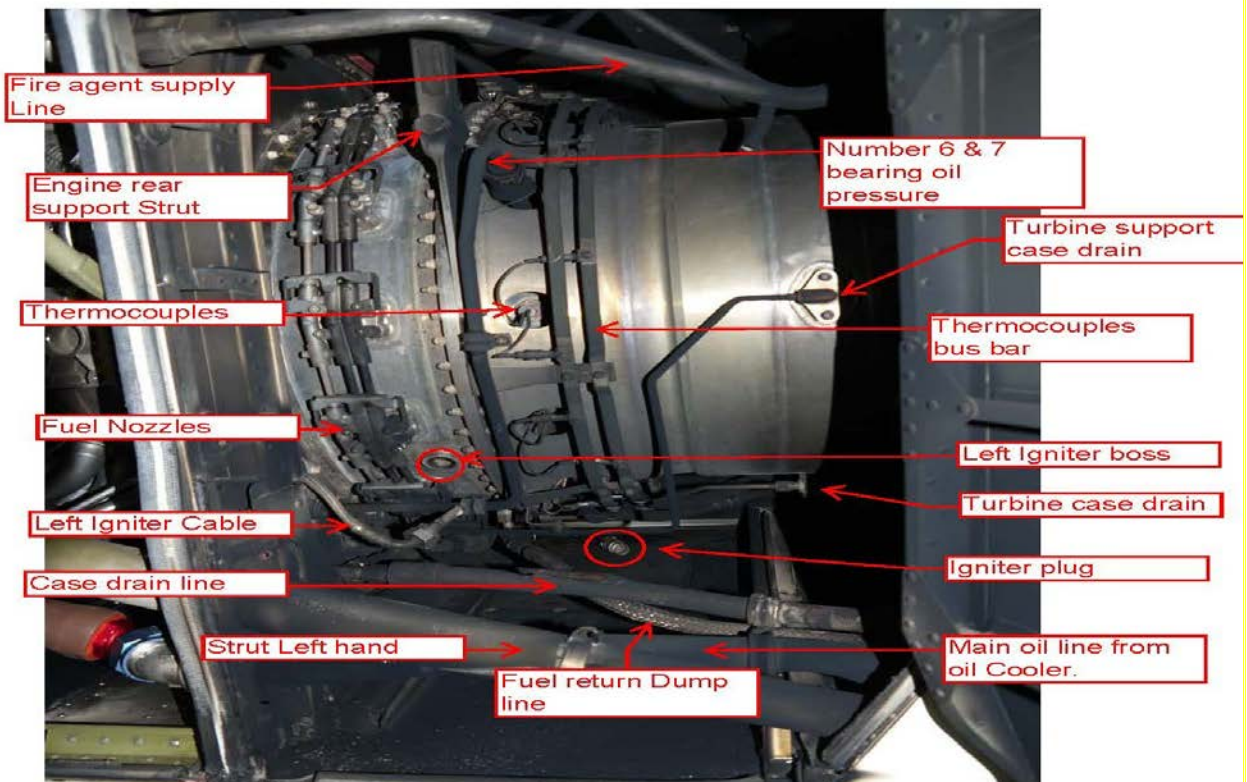
FIG 14 - #2 Eng LH Side (#1 Eng LH Side is symmetrical)
 Fig shows location of parts. Some of these were affected as a result of the escaping hot gases from the igniter boss
