Accident
- Final Report -
AAIS Case N° AIFN/0006/2020

Collision with Ground Support Vehicle during Parking

Operator:	Sigma Airlines
Make and Model:	Airbus A300B4-203F
Nationality and Registration:	Republic of Kazakhstan, UP-A3003
Place of Occurrence:	Sharjah International Airport, Sharjah
State of Occurrence:	The United Arab Emirates
Date of Occurrence:	28 February 2020

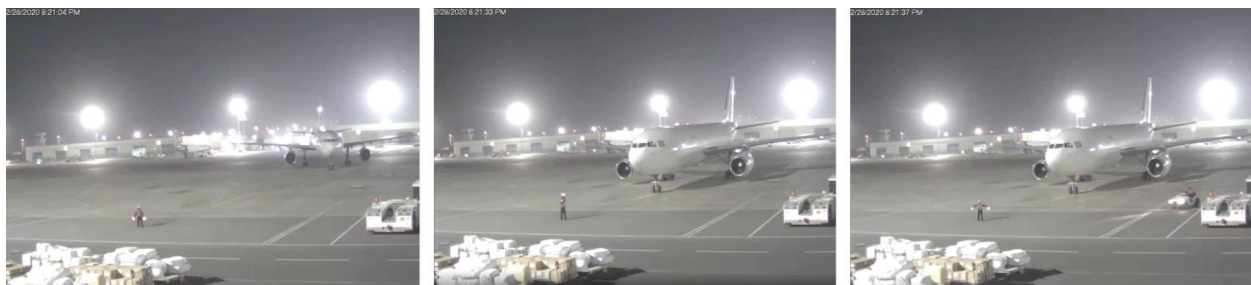
Figure 1. Aircraft taxiing, stopping and beginning to roll forwards

The Commander stated that the descent, approach, landing and taxiing to the cargo apron were uneventful, and that the manual brakes functioned normally. The Aircraft stopped at the assigned A300 position mark on parking stand 57, in front of the cargo hangar.

Footage obtained from the apron surveillance camera (figures 1 and 2)¹ showed that the Aircraft stopped on the parking mark for a few seconds and then moved forward. The Aircraft turned left until its left engine impacted the tug. The Aircraft came to a stop with the nose landing gear on the service road, approximately 36 meters beyond the A300 position mark.

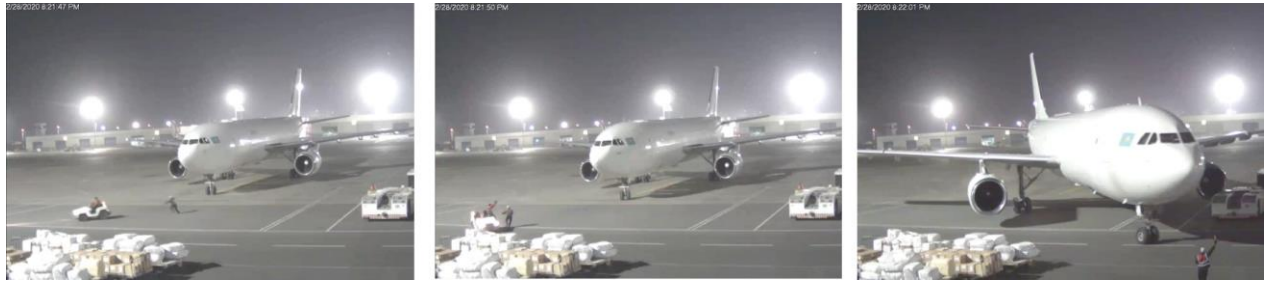
Figure 2. Ground staff noticed Aircraft movements, Aircraft turning, and impact with tug

The Commander stated that once the Aircraft came to a stop, he maintained manual brakes. While the crew started the parking checklist, the Copilot prepared to shut the engines down. When the Commander looked up, he realized that the Aircraft was moving forward. He stated that he repeatedly applied manual brakes and set the parking brake but the Aircraft did not stop. He steered the Aircraft to the left to avoid the cargo area in front and collided with a tug, which was parked in the equipment area.

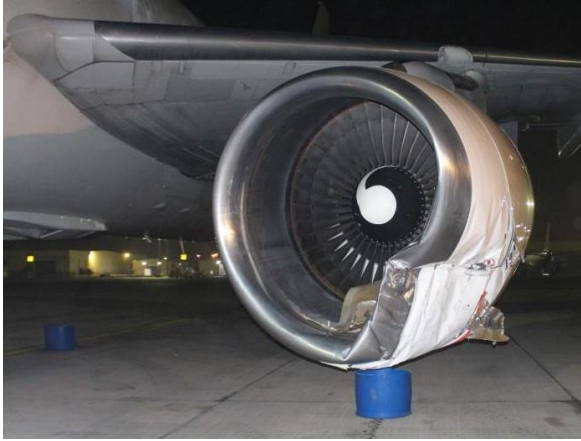
Figure 3. Damage to the left engine

The Aircraft sustained substantial damage to the left engine pylon and wing attachment. Hydraulic oil and other fluids were observed leaking from the damaged engine. (Figure 3)

The Aircraft's left engine impacted the tow tug. The engine nose cowl was substantially damaged and the engine fan blades exhibited signs of rubbing with the outer shroud. The fan could not be rotated during the post-Accident inspection.

The left engine pylon and wing attachment, fan case, hydraulic and fuel lines, and the engine gearbox were damaged during impact.

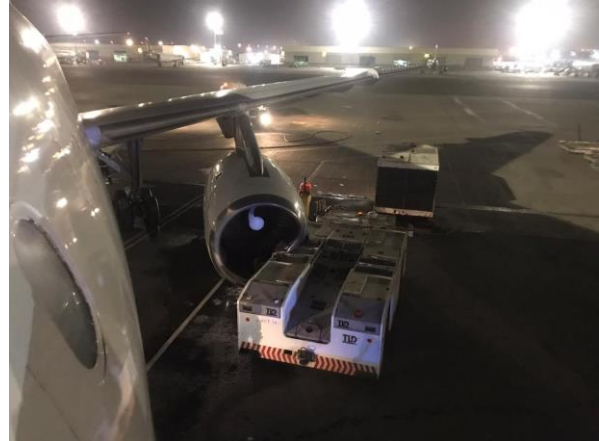
Figure 4. Left engine impact with the tug

The tow tug, parked 19.5 meters from the parking stop line in the equipment storage area, was damaged by the collision with the engine. (Figure 4)

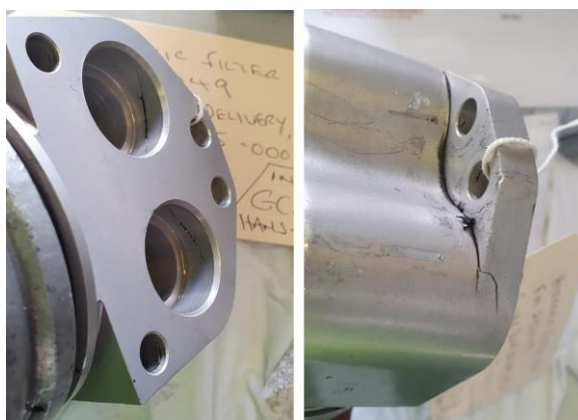
Figure 8. Hydraulic filter housing fracture

An inspection of the Aircraft during the on-site investigation phase identified that the yellow hydraulic system high-pressure filter housing, located in the lower fuselage, had fractured and leaked hydraulic fluid. (Figure 8)

The filter head was identified as part number P6952, serial number 1602. It was installed during Aircraft manufacture in May 1981 and accumulated 51,941 hours and 29,441 flights in service.

Based on these checks and the system examination, the Investigation concludes that the fractured high-pressure filter head in combination with an undetermined failure of the accumulator part of the yellow hydraulic system caused the system failure. The Investigation could not determine the cause for the complete depletion of the yellow hydraulic system and the consequent failure of the parking brake.

The design of the high-pressure hydraulic filter head with its small curve radius, and the use of inappropriate mounting bolts, were identified by Airbus as contributing to developing fractures along the mounting flange. The problem with the inappropriate mounting bolts was rectified by the issue of service bulletin *SB A300-29-098* and a revised *illustrated parts catalogue*. The curve radius issue was addressed by the filter assembly manufacturer by a design change in the manufacturing process and became effective in the production of the units. While this ensured that future filter assemblies were addressed, the already installed units on operational aircraft were not systematically surveyed and replaced. Airbus' *Technical Follow-Up* document was last updated in May 1994.
