# AIR ACCIDENT INVESTIGATION SECTOR

## AIR INCIDENT INVESTIGATION REPORT

### ENGINE FAILURE

IL-76TD  
RA76799  
Abakan Avia  
Sharjah International Airport  
5 February 2012

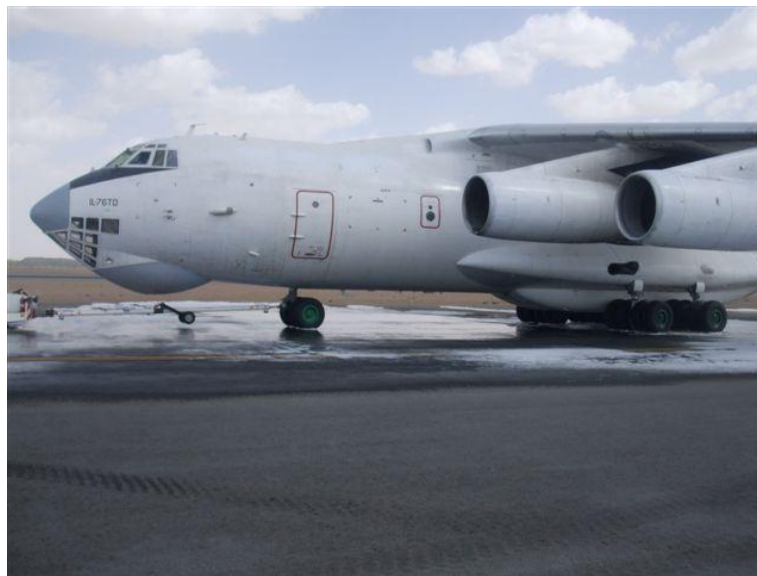
Fire brigade was launched to the Aircraft and fire extinguisher was fed to the engine inlet, the Aircraft was towed to the cargo stand without further consequences. (Figure 1).

Figure 1- Aircraft towing to the maintenance bay

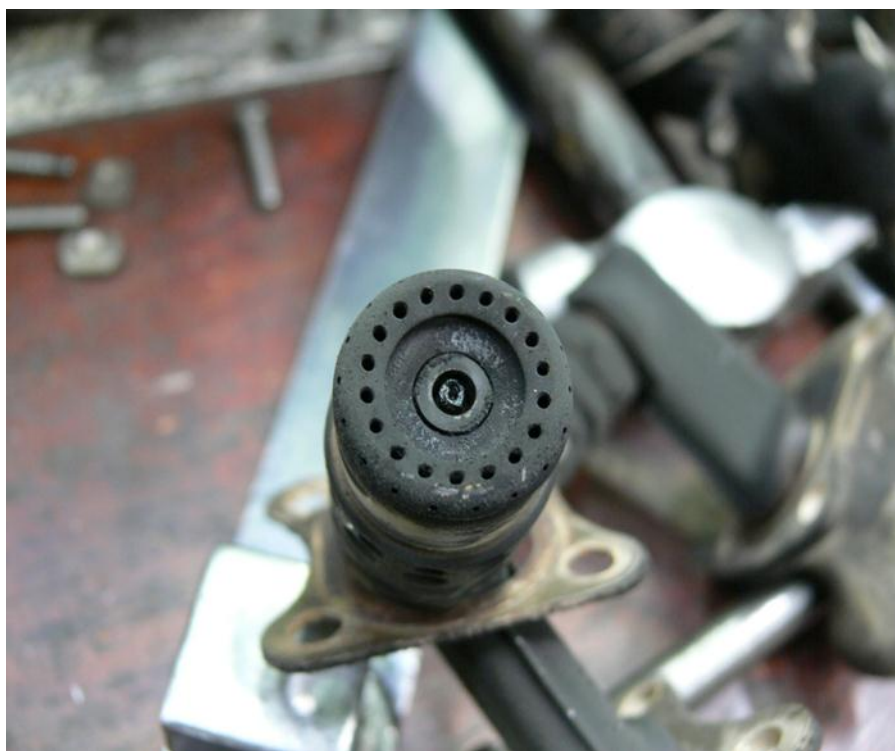
The test revealed that the fuel consumption through the manifolds, the irregular atomisation and the angle of atomisation before and after removal of the burnt deposits were in conformance with the technical limitations.

Figure 2 shows the most fuel nozzle, out of twelve nozzles, that was adversely affected by residues of solid contaminants and existent gum.

After the removal of the burnt deposits, the test of all fuel nozzles characteristics revealed that they met the technical limitations.

Figure 2- the most affected fuel nozzle

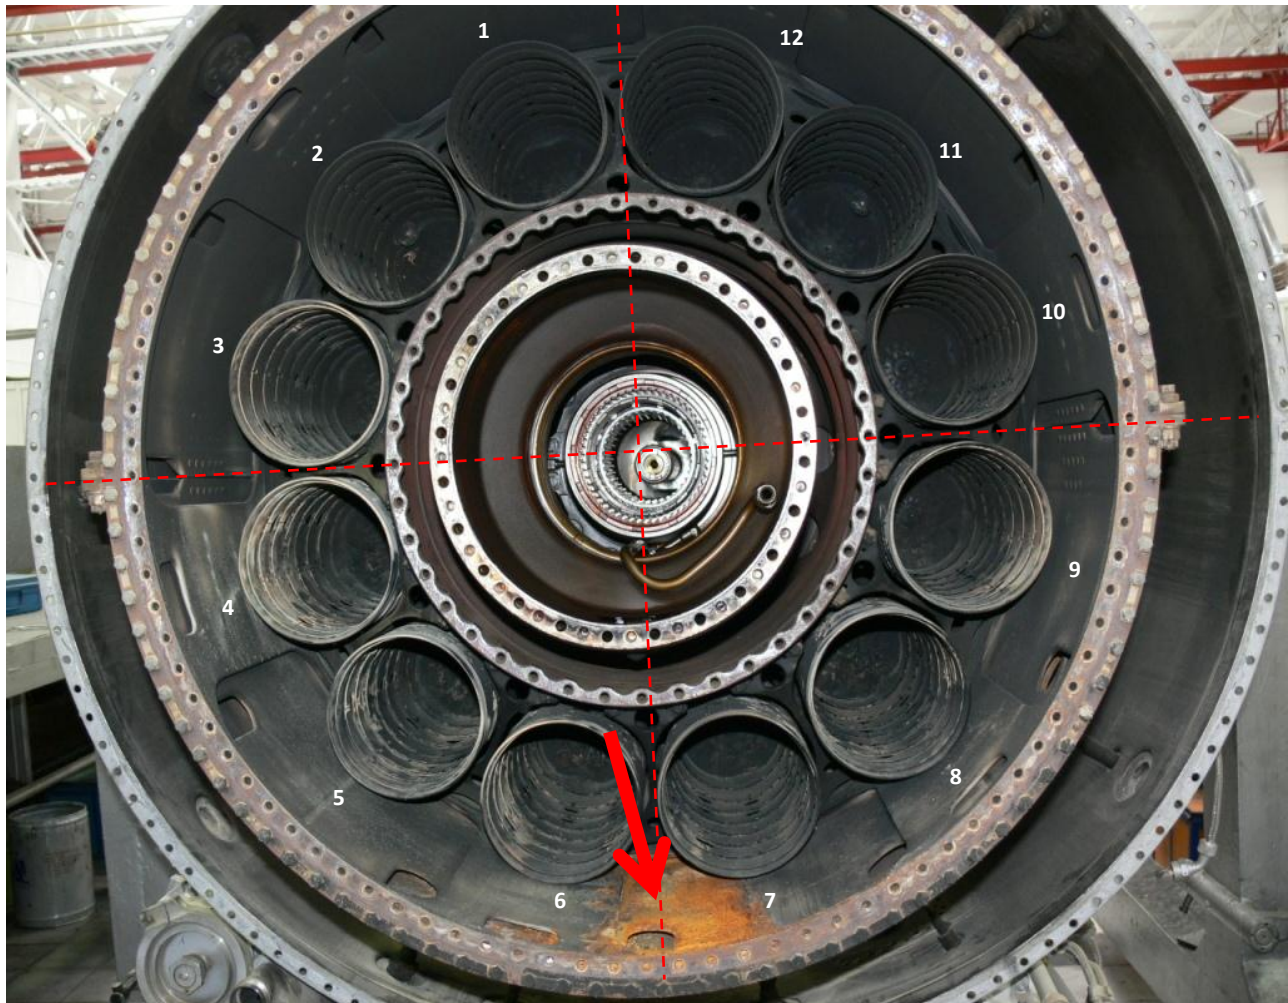
- Combustion cans showed signs of insignificant, within-limits, heat damage with cracks. A noticeable corrosion area due to concentrated heat and fire agent was found at the 6-O'clock position.
- The nozzle diaphragm of the 1<sup>st</sup> turbine stage was intact with discoloration marks due to overheat.
- Rotor blades of 1<sup>st</sup> turbine stage damaged at their tips.
- Approximately 80% of the rotor blades and NGVs of the 2<sup>nd</sup> to 6<sup>th</sup> turbine stages severely damaged.
- The examination did not reveal marks of damage due to foreign object.

Figure 3- Combustion cans

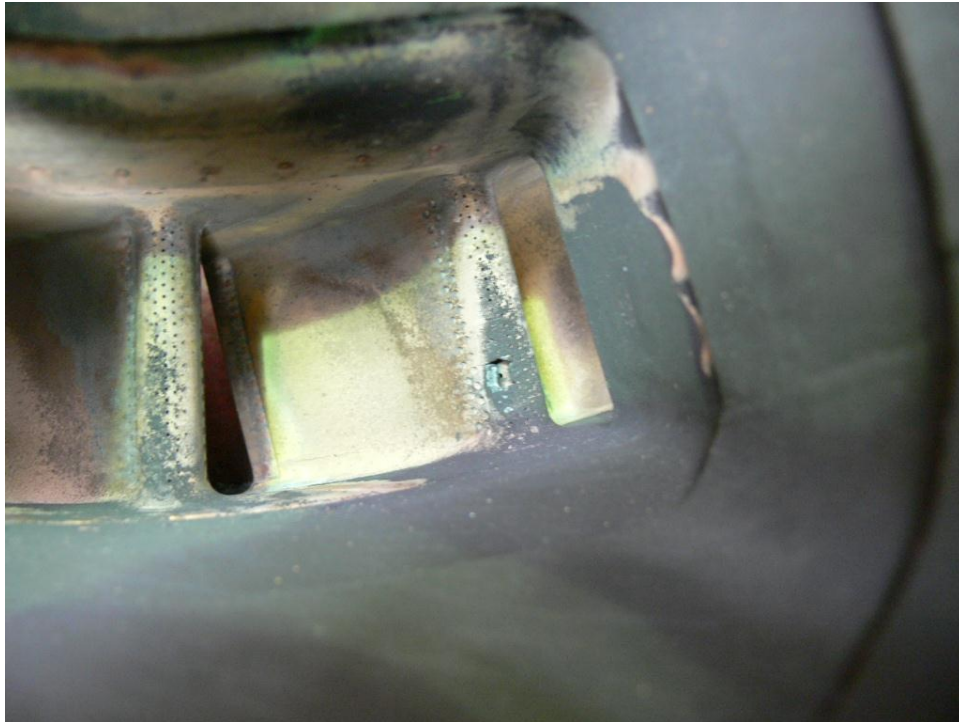
The No. 2 engine turbine nozzle diaphragm and NGVs depicted marks of heat stress concentrated on the area expanding between the 6 to 9-O'clock positions. The turbine gas temperature (TGT) at that area was extreme due to the torch effect of the flame resulting from inhomogeneous fuel flow coming from the fuel nozzle located at position No. 7 (refer to figure 3) due to accumulated deposits resulted from the burn of the existent gum and other solid particles.

According to the engine teardown report, the nozzle diaphragms of the 1<sup>st</sup> stage had shown insignificant damage with signs of overheat discoloration. The 1<sup>st</sup> stage of the turbine rotor showed damage at the tip of the blades whereas 80% of the turbine rotor blades and NGVs of the 2<sup>nd</sup> to 6<sup>th</sup> stages showed severe damage.

Figure B1- Nozzle diaphragm overheated mark

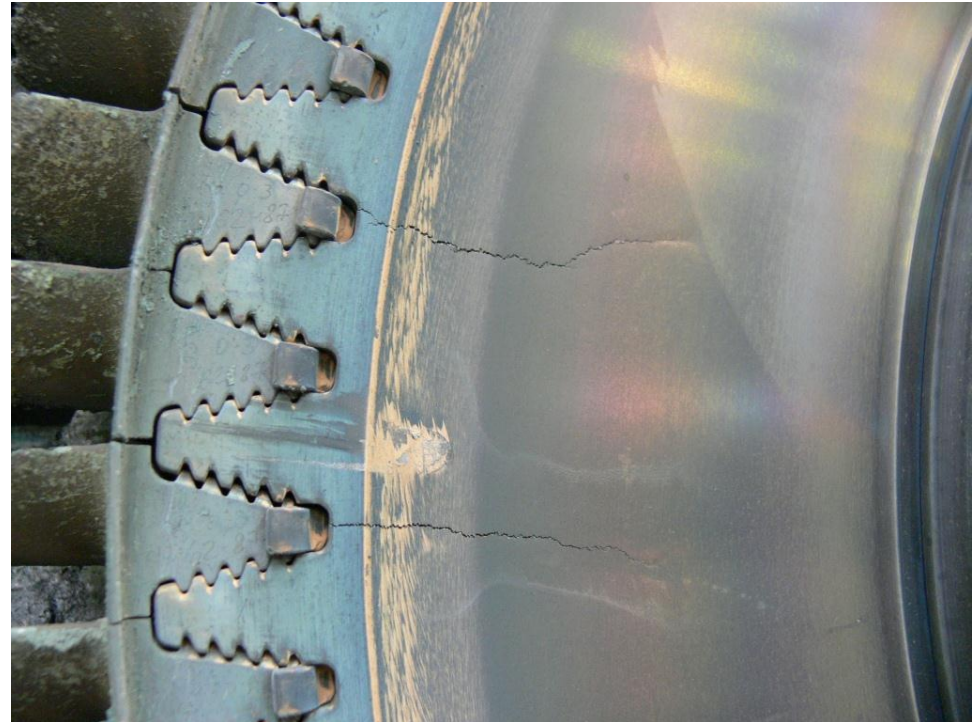
Figure B2- Example of turbine disc overheated discoloration and cracks

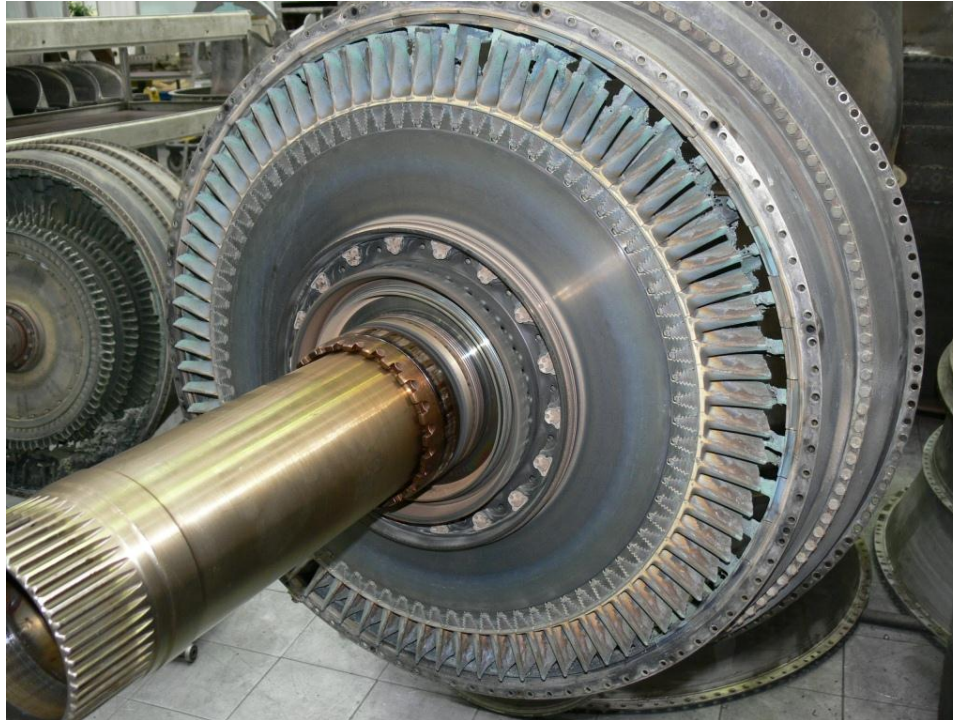
The turbine blades had severely damaged with some of them disintegrated and departed the engine.

The Investigation finds that it is highly probable that one of the 2<sup>nd</sup> stage NGVs had dismantled after the heat stress reached to a critical point. The dismantled debris continued with the gas stream causing mechanical damage to the consequent parts of the turbine where they had already exposed to heat stress less than a critical point leading to their distortion and then dismantling.

Figure B3- HPT damaged rotor blades
