SERIOUS INCIDENT INVESTIGATION REPORT

## UNRELIABLE AIRSPEED

Airbus A340-600

A6-EHF

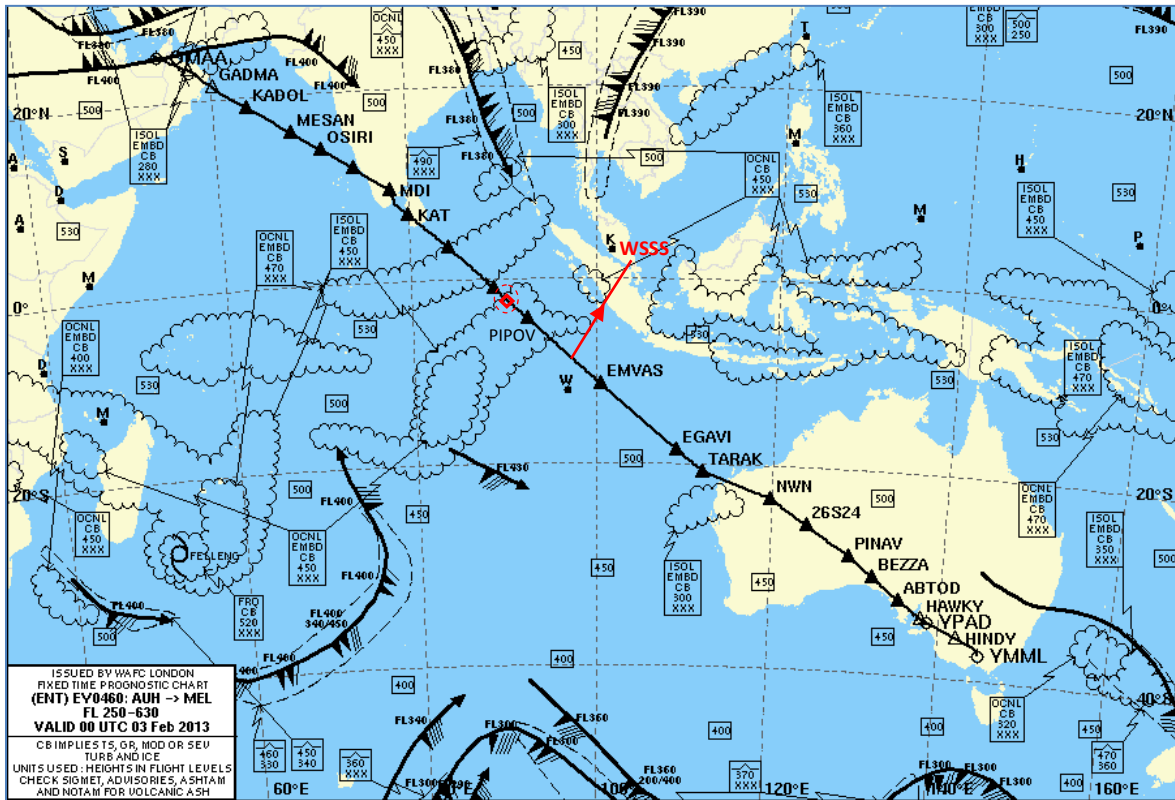
The dispatch documents provided to the flight crew included a fixed time prognostic chart of the Indian Ocean valid for 00:00 UTC, 3 February 2013 from FL 250 to FL 630. This chart including the flight route plan, indicated an area of isolated embedded cumulonimbus clouds up to FL 450 in the area where the incident occurred before the PIPOV waypoint, just after passing into the Melbourne FIR from the Colombo FIR. The area of isolated embedded cumulonimbus clouds stretched longitudinally from approximately 68°E to 99°E and latitudinally from approximately 19°S to 0° (equator line). The red point mark is the Aircraft's position when the occurrence of the incident started, while red line indicates the flight diversion towards Singapore Changi International Airport.

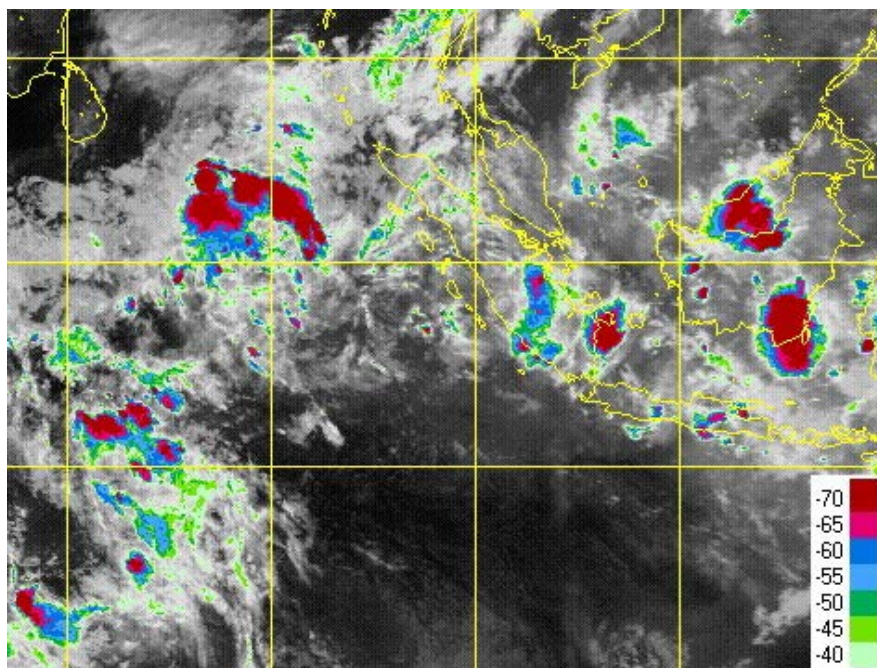
A color satellite image of the area where the incident occurred taken at 16:30 UTC 2 February 2013 was also provided in the dispatch package. This image was taken about 8 hours 20 minutes before of the incident. The image indicated an area of intense convective activity from approximately 5°N down to the equator latitudinally and from approximately 86°E to 92.5°E longitudinally.
