AAIS Case Reference: 06/2013

SERIOUS INCIDENT INVESTIGATION REPORT

LOSS OF SEPARATION

UAEAF BAE Hawk
Emirates Airlines Boeing 777
AIRPROX Category A – Risk of Collision
12th February 2013

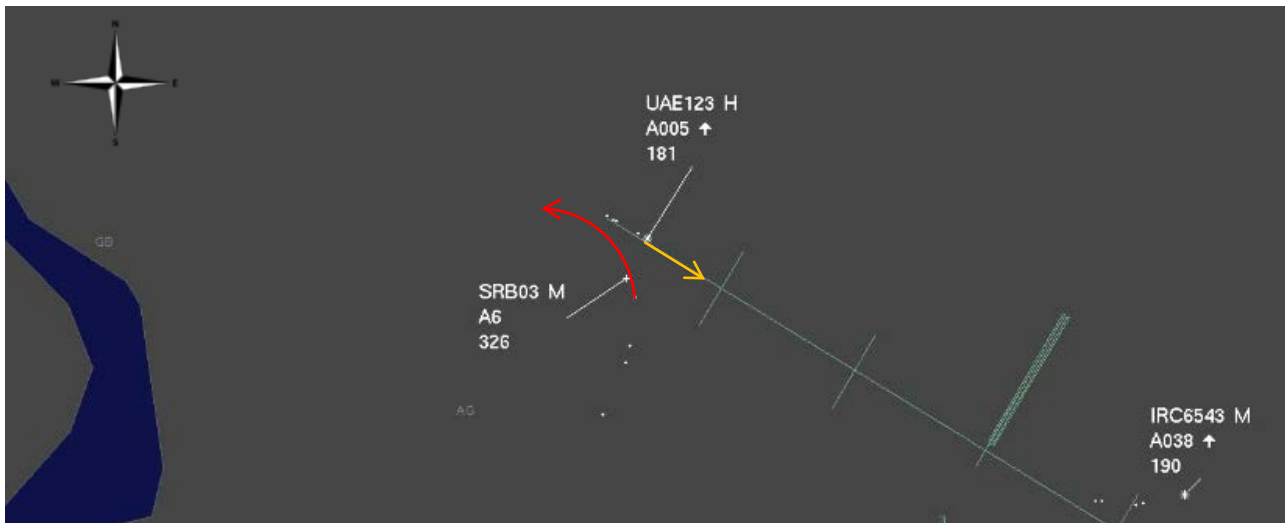
Figure 3 - Hawk Evasive Manoeuvre

Figure 1 above and Figure 2 below are radar display snapshots of the Hawk traveling north. Immediately prior to the Hawk's evasive manoeuvre, the ground speed is 353kts.

- i The yellow arrow indicates the direction of travel of the Boeing 777
- ii The red arrow indicates the direction of travel of the BAE Hawk
- iii The plan projection is a radar screen shot of the OMDB RWY 12L vicinity to the south and west of the aerodrome
- iv No scale is included, however the linear horizontal distance between the two aircraft in Fig above is 0.3 nm, or 1822 ft.

- › Time 07:37:16
- › UAE123 rotated from RWY 12R with GS of 188kts and is climbing through 500ft AGL.
- › The BAE Hawk had 0.3nm (1822 ft) horizontal separation from UAE123
- › Vertical separation is estimated at 100 feet
- › The Hawk performed a left hand turn, climbing 100 ft before the aircraft was observed to track due south from RWY12R towards OMDM.
- › The closure speed was approximately 595 ft/s with a minimum lateral separation distance of 0.3 nm/1822 ft.

Based on the data, when the Hawk maneuvers to the left of UAE123, the Hawk was less than 3.5 seconds from intercepting the climb profile of UAE123, the departing traffic on RWY12L.

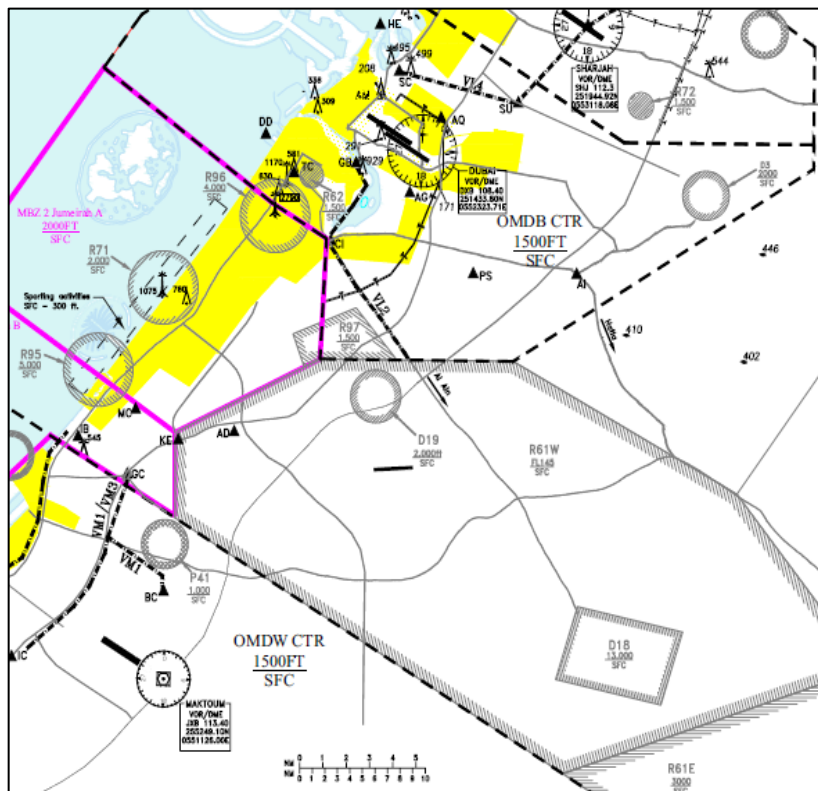
Figure 4 - OMDB Controlled Airspace

Several CTR's are conjoined in the areas surrounding Dubai. They are adjacent. OMDW to the south and OMDB to the north with OMDM, controlling the military airspace between the two CTR's, offset to the east.
