# Air Accident Investigation Sector

## Serious Incident - Summary Report -

AAIS Case N° AIFN/0005/2020

# Balloon Impacting a Sand Dune

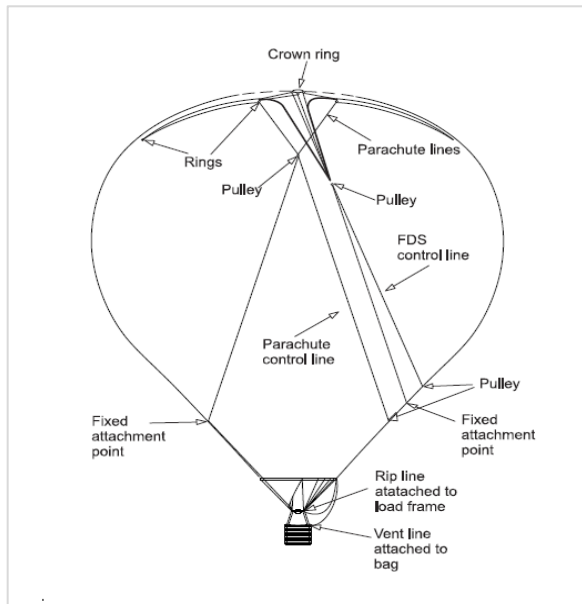
Figure 5. FDS Mechanism

The Balloon was equipped with FDS incorporating a parachute venting system with extra opening capabilities. As shown in figure 5 the rip line, which is red in color, pulls the center of the parachute together creating a large opening, which allows a large outflow of hot air for final deflation of the envelope. The line must not be used for venting.

The opening action of the red rip line (the FDS) can be reversed by pulling on the red parachute (vent) cord/line. According to the *Flight Manual* it is forbidden to use the FDS above an altitude of more than 10 meters (30 feet). This is noted as a WARNING in the *Flight Manual*. The FDS is used if a need arises for a rapid loss of altitude. The Commander could not recall at what height he had activated the FDS. He believed that he activated the FDS at approximately 50 feet AGL. (Figures 5 and 6)

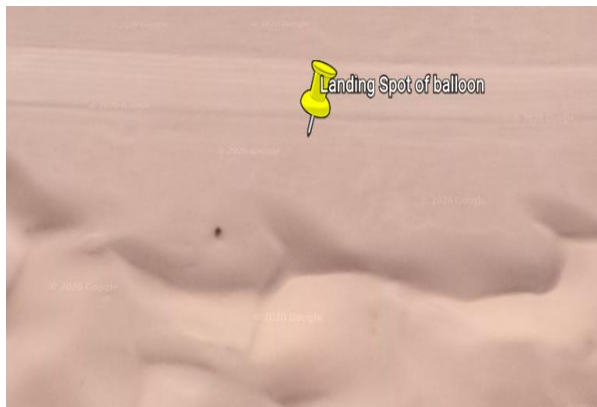
**Figure 7.** Second Flat Area landing site

The Incident Balloon approached the landing site in Second Flat Area from over sand dunes located at the edge of the landing site. The Balloon contacted one of these sand dunes during the approach.
