Air Accident Investigation Report

- Preliminary Report -

AAIS Sector Accident Case # 02/2014

Registration: A6-DYR

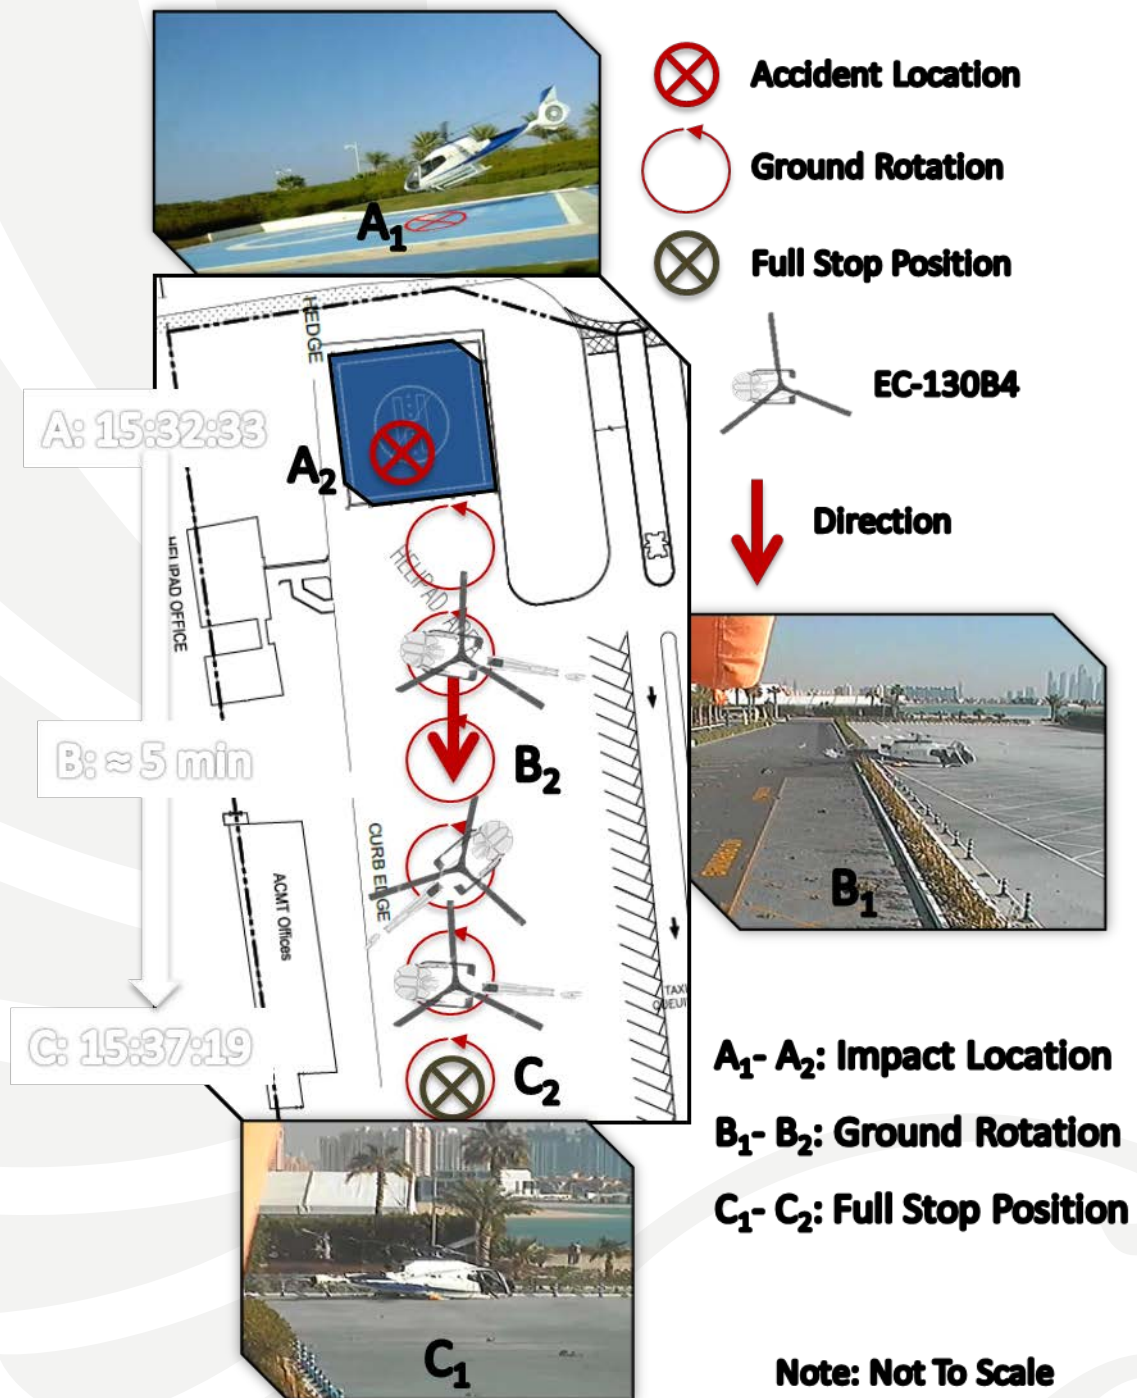
Figure 4: Heliport Accident Sequence

1. 15:32:21 [GST]: Lift off from the Heliport
2. 15:32:33 [GST]: Loss of control and abnormal contact with the heliport
3. 15:37:19 [GST]: Full stop position. Engine Stop.
4. 15:38:00 [GST] and onwards: Pilot and passenger extraction/recovery

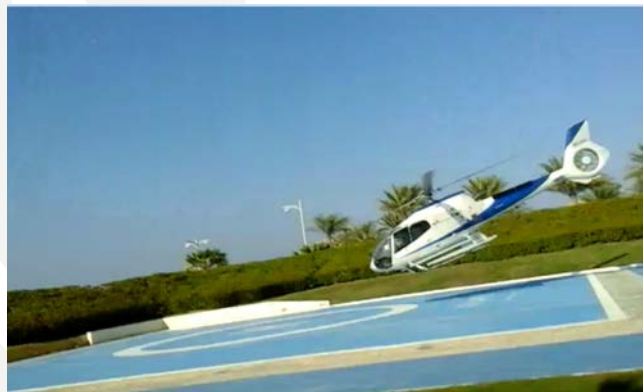
Figure 6: Event Sequence Prior To The Abnormal Helipad Contact

On this particular flight the helicopter simultaneously picked up to a climb while turning counter-clockwise. The turn continued past the optimal northerly heading for departure, continued rapidly turning counter-clockwise with a turn rate which was

accelerating, increasing to approximately 180° per/sec. The helicopter was continuing to climb.

The climb was arrested at approximately 22m/[72ft] feet AGL, the helicopter then descended rapidly, pitched forward while in a continued counter-clockwise turn prior to the contact with the helipad.

The helicopter contacted the helipad vertically, in a level attitude, with minimal forward speed, nose down and with a rapid Rate of Descent [ROD], resulting in a hard landing.

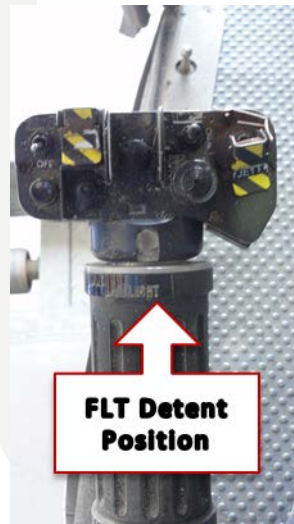
Figure 7: Collective/Throttle Position

The rotor blade tips contacted the surrounding terrain and structures damaging the blades. The throttle remained at the FLIGHT detent position⁸.

⁸ During flight, the twist grip throttle on the accident helicopter is normally positioned in the flight detent position, where the Electronic Engine Control Unit (EECU), and Full Authority Digital Engine Control (FADEC), control engine rpm.

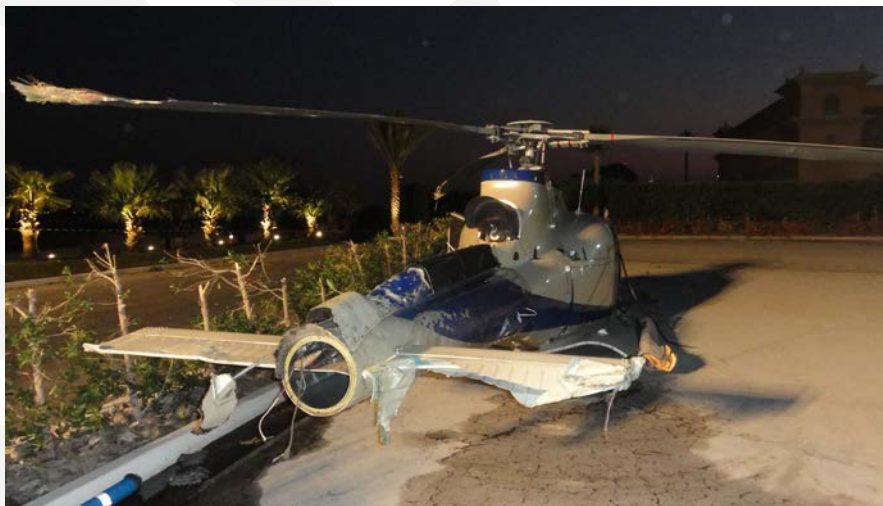
Figure 8: Helicopter At The Full Stop Position

The aircraft was extensively damaged due to the rapid descent and abnormal contact with the heliport, followed by the uncontrolled rotation of the helicopter on the heliports' extended centreline.

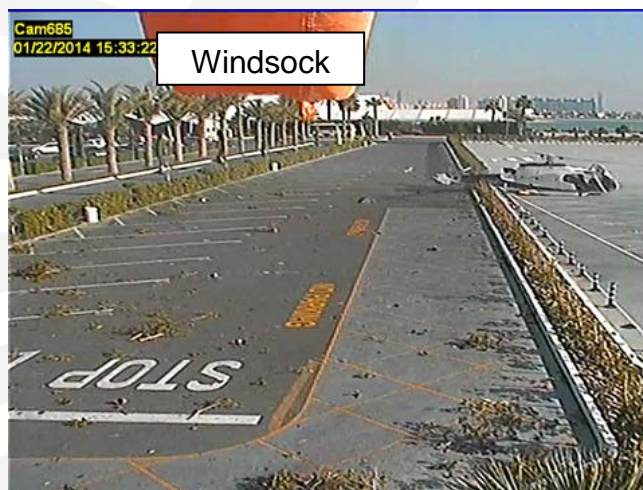
Figure 9: Windssock Deflection

The CCTV camera images indicate that the Wind Direction Indicator [WDI], a wind sock¹² in this case, was hanging vertically from the stanchion, fluttering in the ambient conditions.

Based on the CCTV camera information, the wind strength is 0-4 knots, with the wind direction variable.

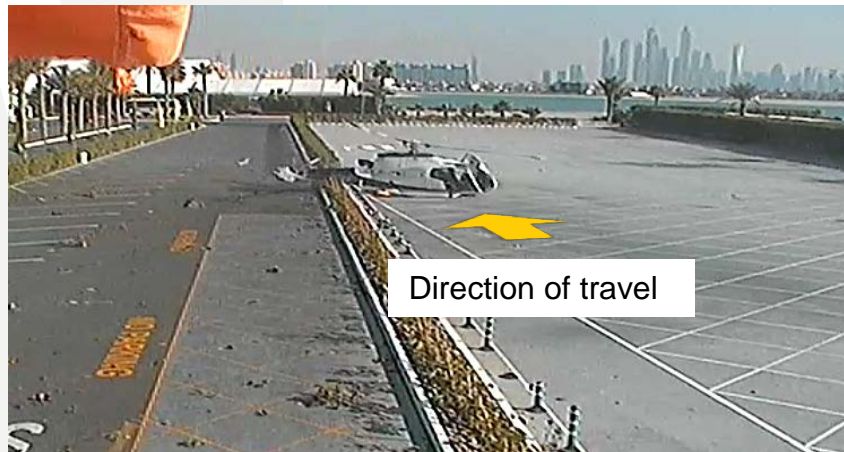
Figure 11: Ground Rotation/Transition Down the Heliport

The aircraft remained on the helipad with the engine running and the damaged rotor blades continued turning while the helicopter was moving down the heliport extended centreline. The helicopter made approximately fifty rotations on the helipad prior to contacting a retaining wall which arrested the rotation. The aircraft remained in that position with the engine running and the damaged rotor blades turning.

Phase two: This phase of the accident sequence involves the engine power setting and the loss of the tail rotor effectiveness resulting in uncontrolled counter-clockwise high turn rate rotation on the helipad, across the length of the heliport.
