# Air Accident Investigation Report - Preliminary Report -

AAIS Case File 03/2014

## Ground Vehicle Collided with Parked Aircraft

A321-231

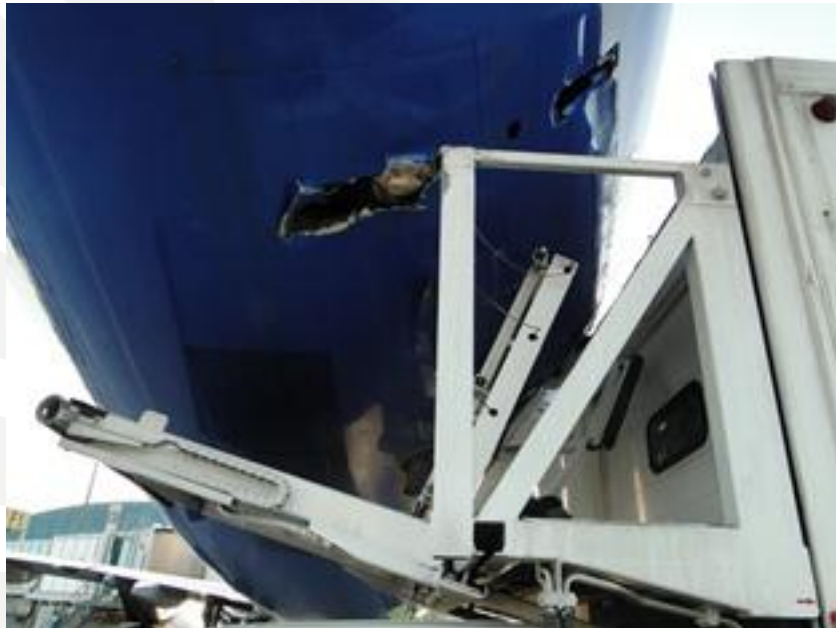
Approximately 3 hours and 30 minutes after blocks on, the Aircraft was struck on the aft right fuselage by a Hi-Loader catering truck. The force of the collision caused the Aircraft nose wheel to turn about its axis for approximately 30 degrees and the nose of the aircraft was deflected approximately four meters to the right of the parking bay centreline.

The aircraft sustained damage to the lower right side where the skin was punctured.

Figure 2: Catering truck and damage to the aft fuselage
