## **INCIDENT INVESTIGATION REPORT**

### **AIRCRAFT INCIDENT REPORT**

**B737-800, VT-AXP**

**July 7<sup>th</sup>, 2009**

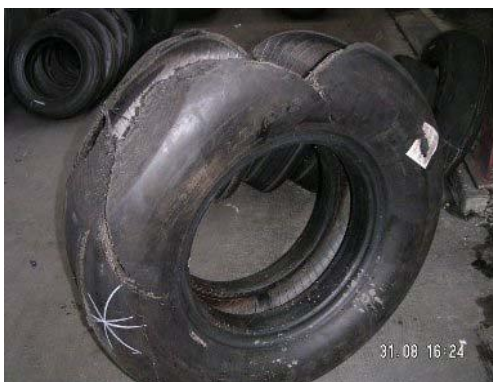
In its tyre examination report, Goodyear listed the following observations (see figures 1 and 2 below):

- Remaining skid depth is 1 mm.
- Bead and sidewall: No noteworthy observations.
- Inner liner had no wrinkles.
- There is a large flat spot at 3 o'clock.

Figure 1- Tyre as received

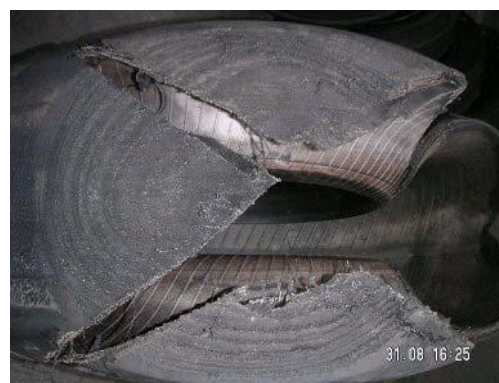
Figure 2- Flat spot

The lab examination of the tyre showed an oval-shaped flat spot in the tread rubber extending through the casing. The report stated that *"An anti-skid malfunction or a locked brake is the most probable cause of this classic skid-through and casing break"*.

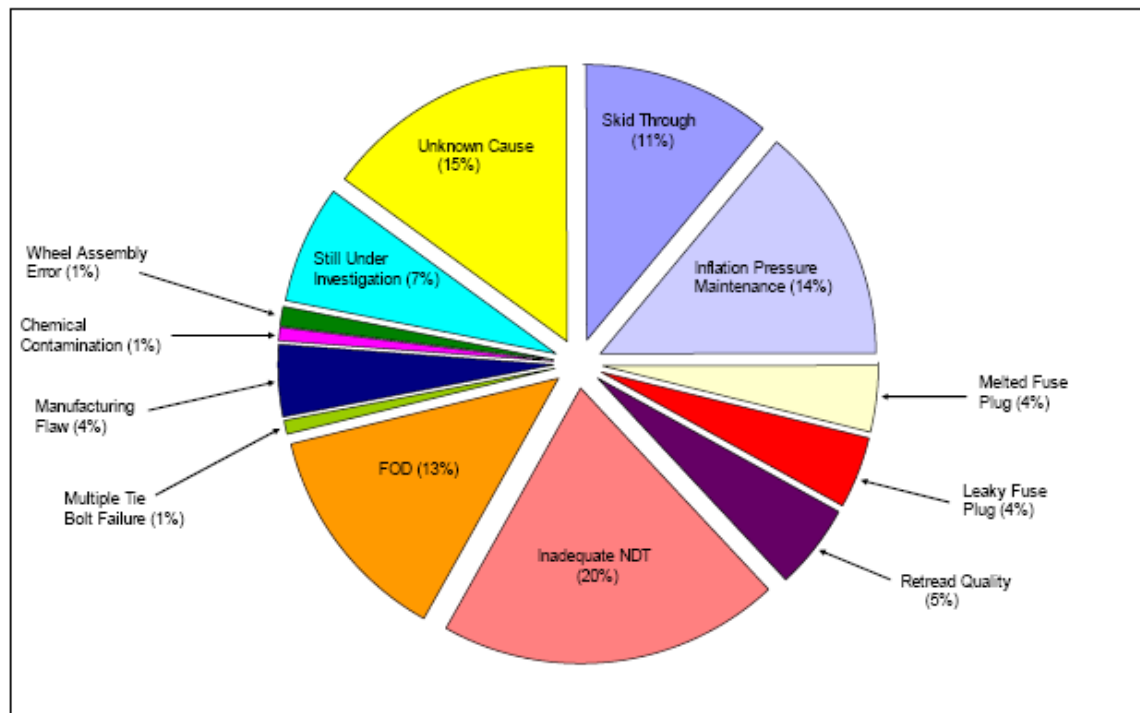
As noted in a previous paragraph, Boeing attempted to assign a primary root cause to each tire failure. The results, as well as a detailed explanation of each root cause, are provided as follows. Note that **Inadequate NDT** of the tire during the retread process and **Inflation Pressure Maintenance** stand out as the prime root causes that are preventable.

Figure 3- Distribution of Tyre Failures by Cause (Quoted)

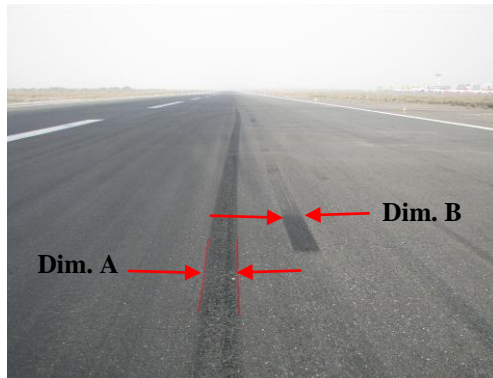
The L/H INBD tyre (No. 2) was the only one amongst the four tyres which damaged and lost a chunk. The noticeable thing was that the width of the skid mark that was left by that tyre at RWY 30 was wider than the mating tyre (L/H OUBD, tyre No. 1), which indicated that tyre No. 2 was contacting the runway pavement with a surface wider than the normal tread width due to the addition of the tyre shoulders to its tread (compare between Dim. A and B in Figure 4 below). In other words, the tyre was skidding where it was completely deflated (see Figure 5 below).

Figure 4- Width of the skid marks. Dim. A is the skid mark of the damaged wheel No. 2 tyre, B is the skid mark of wheel No. 1 tyre.

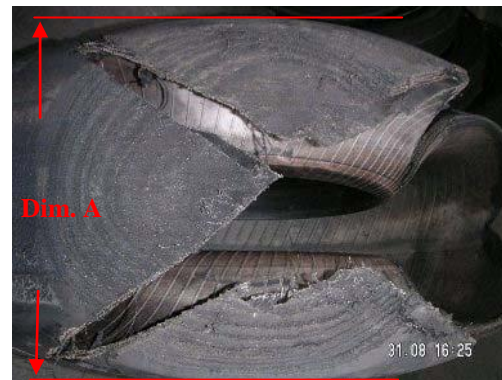
Figure 5- This portion of the tyre is the surface which made friction and caused the tyre skid mark (Dim. A in figure 3).

The deflation was a result of the tyre damage (see figure 5). The disintegrated chunk impacted the lower surface of the L/H INBD flap. The fusible plug which was intact and not melted indicated that the deflation was caused by the tyre damage and not by gas escape through the fusible plug.

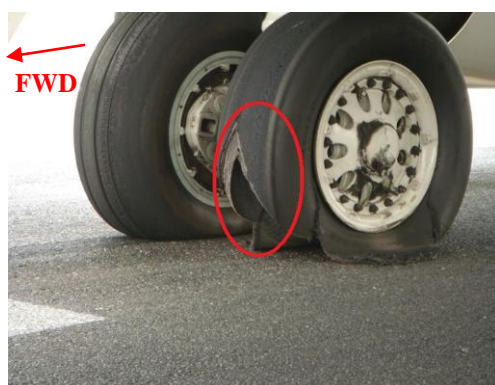
Figure 6- the place of a dismantled chunk that hit the L/H INBD flap lower surface (see figure 6 to the right).

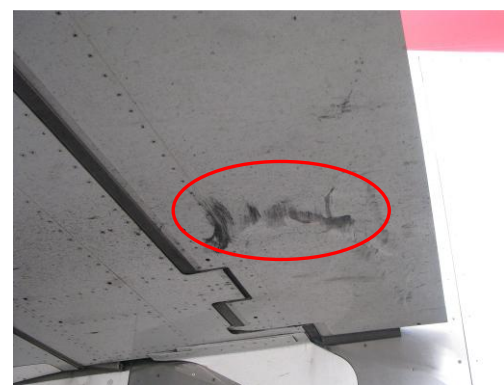
An initial inspection on the Aircraft revealed that the four MLG brakes completely seized in weldment, the L/H INBD tyre found damaged and missing a chunk that impacted the lower surface of the L/H INBD flap after it department the tyre causing a dent at that area (see figure 7).

- Dent observed at L/H inboard aft flap at centre area, L=12" ,D=1/8", area cleaned/inspected, no delamination per SRM 57-53-02 fig. 103, sheet 05-05 and within limits

Figure 7- Lower surface of the L/H INBD flap shows a mark of the rubber chunk hit at high speed.

- High energy stop/Heat damage condition Inspection as per AMM 05-51-07
- Tyre tread loss/Tyre Burst inspection as per AMM 05-51-54
- Brake seizure inspection as per AMM 05-51-15
- Reinspection of work carried out at out station done.
- L/H inboard L/E aft flap repaired.
