AAI Case Reference: 16/2010

## FINAL AIR INCIDENT INVESTIGATION REPORT

### ENGINE FAILURE DURING WARM-UP

IL 76 TD

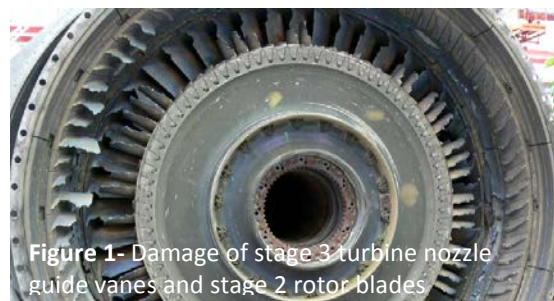
Figure 1- Damage of stage 3 turbine nozzle guide vanes and stage 2 rotor blades

- Most of the rotor blades of the turbine stages from 2 to 6 ripped-off (Figure 1).

Failure of all Stage 3 nozzle guide vanes and such damages as nicks and tear-out of material on all Stage 4, 5 and 6 nozzle guide vanes.

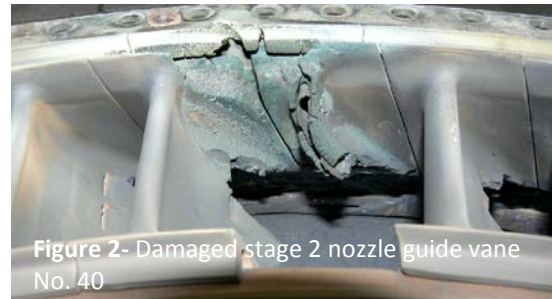
- Failure of vane 40 in Stage 2 HPT NGV (Figure 2). Availability of the material fusion on the remaining vane fragment and on NGV outer shroud ring gives evidence of increased temperature effect in this zone.

- The Metallographic Examination showed that the vane failure was related to intensive overheating of the material up to the fusion temperature.<sup>2</sup>

- From the engine examination, the following sequence could have been inferred:
  - Failure of the turbine stage 2 nozzle guide vane No. 40 occurred due to overheat stress of the vane at the outer span zone caused by exposure to local increased gas flow temperature.

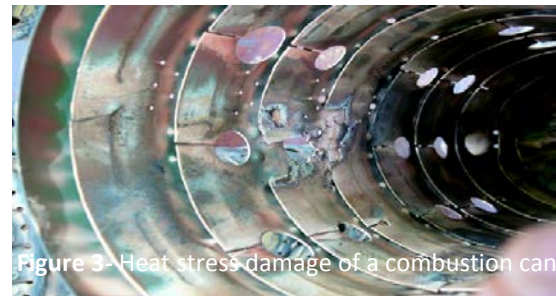
- No failures were found on Stage 1 turbine blades.
- Material fusion on Stage 1 nozzle guide vanes at the leading edge, outer platform of one of the blades and on cooled insert (Figure 3).

- On most of the combustion cans, there were thermal damages such as burning-out, distortion and cracking of material (Figures 3).
- No failures in the HP and LP compressor flowpath.

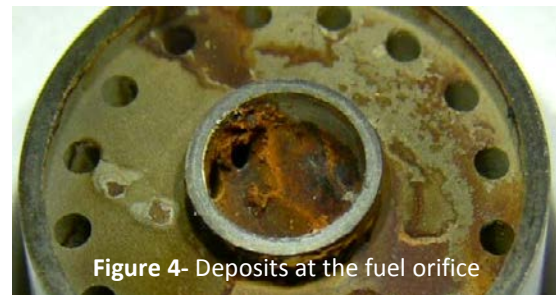
- Foreign deposits on connections, filters, adapters, main and primary fuel sprayers and on faces of fuel nozzle bodies were found.
- At adapters of some fuel nozzles the primary manifold orifices were partially or completely clogged with the foreign deposit (Figure 4).

- The foreign deposit was of a superficial nature and could easily removed.
- No damage caused by corrosion was observed.
- A significant quantity of ferrous and sulfur oxides was detected in the chemical composition of the foreign deposit.<sup>3</sup>

- Formation of local increased gas temperature was a result of the malfunction fuel nozzles which orifices were partially blocked by resin deposits.
- The foreign resin deposit could be attributed to the accumulation of the *existent gum* as could be concluded from the analysis of fresh fuel drained from the constant-speed drive governor which showed extreme exceedence of this content in comparison with the permissible rate depicted in the fuel standards.

Enhance, after consultation with the engine manufacturer, the hot section inspection procedures and techniques especially on fuel nozzles.
