Air Accident Investigation Sector

- Preliminary Report -

AAIS Case File AIFN/0014/2014

Landing Gear Separation after Touchdown

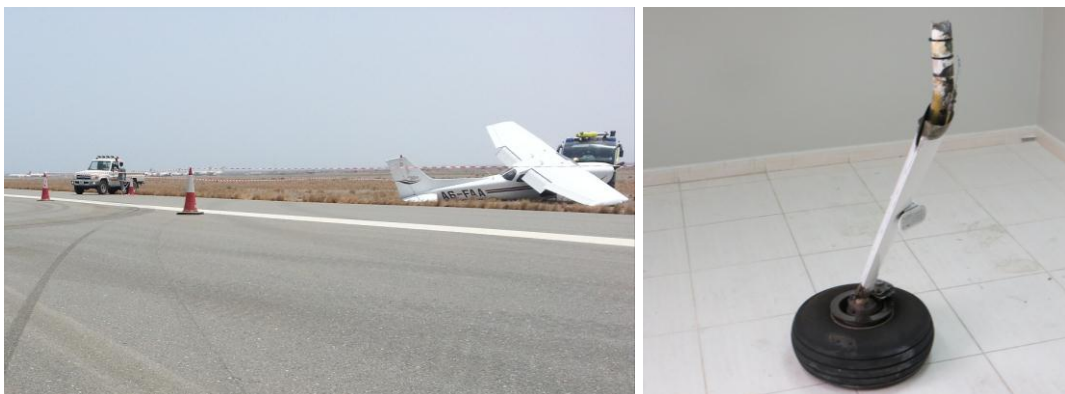
After two attempts to land and consequent go-arounds, the Aircraft touched down on the LH MLG and the instructor pilot performed a go-around for the fifth time. In his final attempt to land, the instructor pilot commanded left wheel touch down followed by nose landing gear (NLG), the student shut down the engine and the Aircraft continued deceleration with gradual lowering of the right wing and horizontal stabilizer towards the runway surface and as the Aircraft drifted to right. The wing and the horizontal stabilizer contacted the runway surface while the instructor pilot applied left brakes until the Aircraft came to rest just off the runway shoulder (Figure 1).

Figure 1. Runway excursion and RH Landing Gear Strut and Wheel Assembly

The aircraft lost the RH MLG, sustained damage to the lower right side of the undercarriage and bending of the R/H horizontal stabilizer upper and lower surfaces.

Three witness marks were observed on the runway having been caused as the Aircraft drifted, due to the contact of the right wing, right horizontal stabilizer and Aircraft belly with the runway surface.

The RH MLG detached and was found on the runway.

PSR 29/2014: *Although it is not yet verified whether the fracture was due to overload (sudden failure) or fatigue/corrosion (age-related failure), the AAIS recommends to the GCAA:*

- (a) *Request the operator to perform detailed inspection, using visual and other methods, on similar areas of the Cessna 172 MLGs (both L/H and R/H) spring assembly (PN: 0541198) to determine serviceability.*
- (b) *This information and the required inspection should also be shared with other UAE Operators of C172 Aircraft.*
- (c) *Issue a Safety Alert to all A6- Registered Cessna 172 operators to inspect the landing gear for damage before the next inspection cycle.*
