Air Accident Investigation Sector

- Final Report -

AAIS Case File N° AIFN/0009/2015

Cabin Crew Serious Injury Due to Turbulence

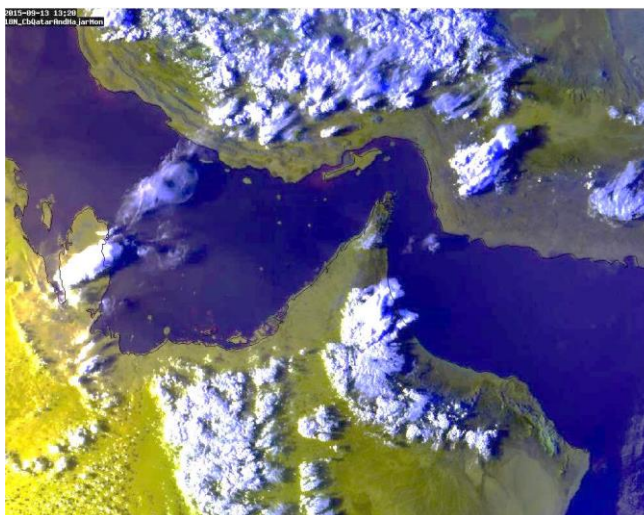
Figure 1. UAE weather at 0900 UTC

The summary of the weather at around 0900 UTC, was scattered low clouds starting to develop over the western part of the UAE to Abu Dhabi city (bases about 4,000ft and tops about 7,000ft) and towering clouds started to develop along the mountains with a base of about 3,000ft.

The Commander stated that he was not informed by ATC about any significant weather conditions and he confirmed that no significant weather was seen or indicated on the weather radar during the descent to Dubai.

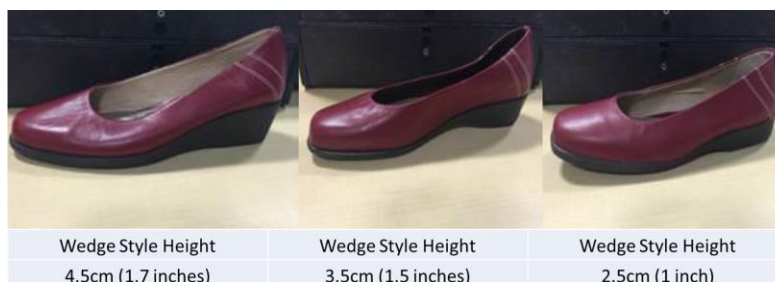
Figure 2. Cabin crew shoes

There are three different types. Wedge style – 1.7 inches (4.5cm), Flat style 1 – 1.5 inches (3.5cm), Flat style 2 – 1 inch (2.5cm) for the inflight service.

Female cabin shoe options (flatter heeled shoes)

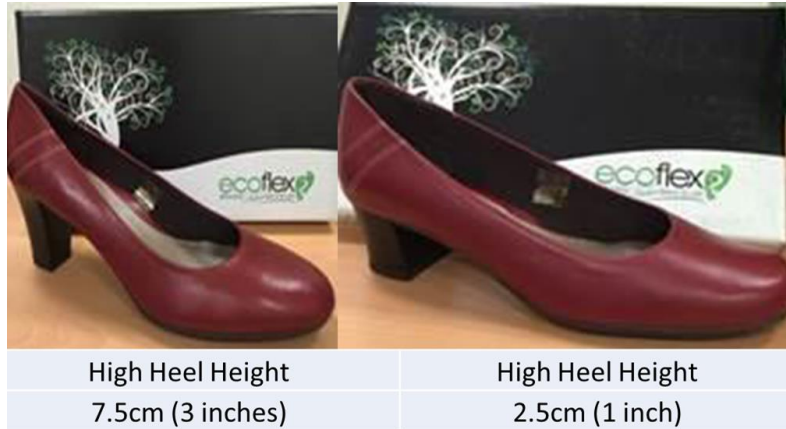
Figure 2. Cabin crew high heeled shoes

At the time of the event the cabin crewmember was wearing the heel high shoes below, 7.5cm, 3 inches high.

The injured cabin crewmember was wearing high heel shoes during the approach phase of the flight which did not provide stable support in turbulent conditions.

The injured cabin crewmember lost her balance due to the unexpected high g-force, combined with the lack of support provided by the footwear that she wore for that phase of the flight.

The cabin crewmembers' change from flat sole footwear to high heel footwear resulted in insufficient support to enable her to maintain her balance during the turbulence encounter.

The AAIS find that the risk assessment that was carried out by Emirates in May 2016 underestimated the severity of the risk and classified it as "minor" whereas the Investigation believes that the severity classification should have been "hazardous". Therefore it is recommended that the safety risk assessment be revised.

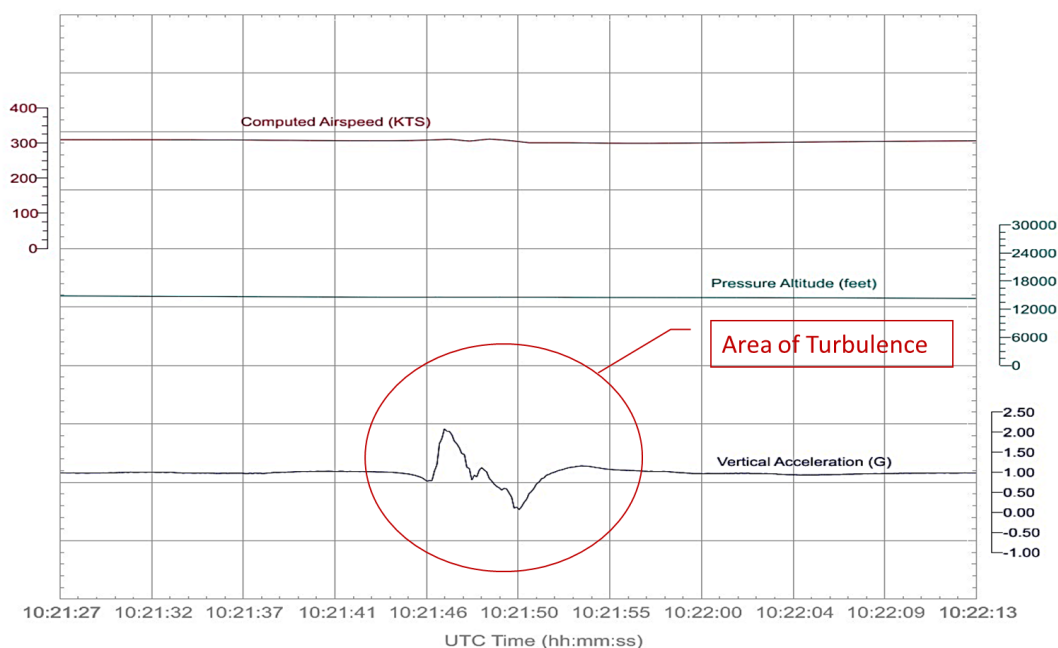
Figure 3. Vertical acceleration loads during the turbulence encounter [Source: FDR]

The analysis of the flight data recorder indicated that the Aircraft vertical acceleration during the turbulence encounter varied between +2.2g to +0.07g when the Accident occurred, with a corresponding minor speed fluctuation.

All parameters stayed within Aircraft limitations during the turbulence encounter.
