Air Accident Investigation Sector

- Summary Report -

AAIS Case N° AIFN/0012/2016

Forced Landing

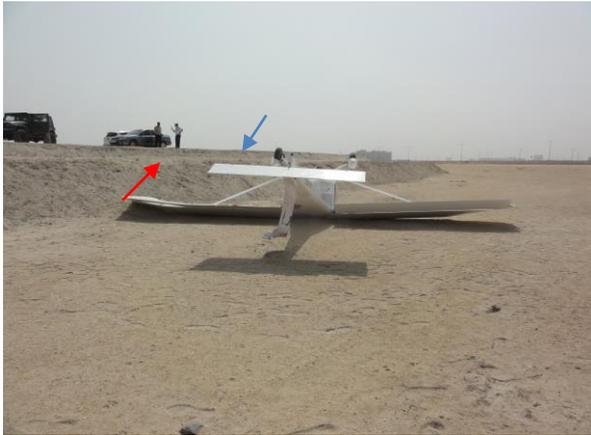
Figure 1. Ditches (↑ first ditch, ↑ second ditch)

There were two ditches in front of the Aircraft as shown in figure 1. The Aircraft entered the first ditch which had a depth of about 80 centimeters, and it then continued into the second ditch which had a depth of approximately 130 centimeters.

- (g) The Pilot did not observe two ditches in the selected landing area.
- (h) The landing was uneventful until the Pilot was surprised by the first ditch.

Ensures adherence to the precautionary off-field landing actions procedures by all pilots, as required in the *Operations Manual*.

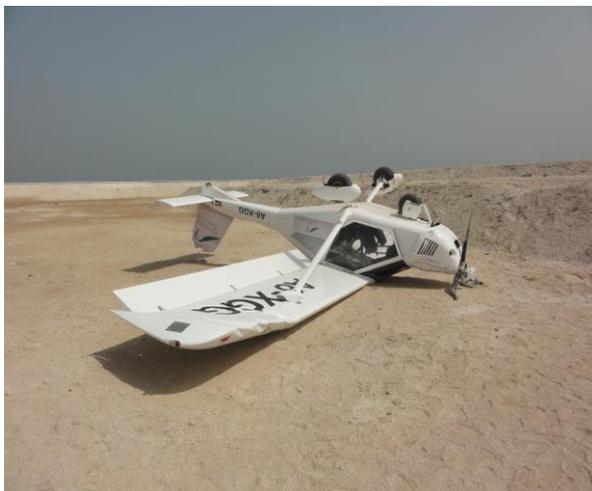
Figure 2. Aircraft final position

As the Aircraft entered the second ditch, it turned over slowly and came to rest in an upside-down position, as shown in figures 1 and 2.

- (j) The Aircraft continued its landing roll and entered the second ditch where it turned over slowly and came to rest in an upside-down position.
- (k) Neither the Pilot nor the passenger sustained injury.

- (l) The Aircraft was damaged beyond repair.
- (m) The Pilot was not suffering from fatigue or any physical or psychological effect that could have contributed to the Accident.

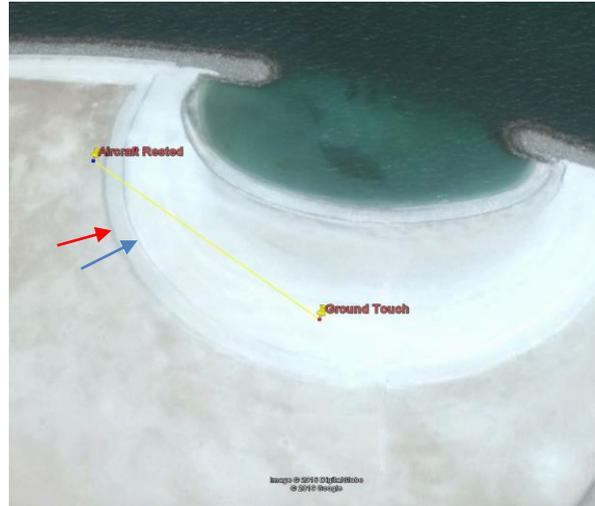
Figure 3. Off-field landing site (↑ first ditch, ↑ second ditch)

The distance between the touchdown point and the point where the Aircraft came to rest was approximately 177 meters, as shown in figure 3.

Considering the evidence and the resulting analysis, the Investigation believes that the Pilot selected an undesirable off-field landing site, which resulted in a shorter available clear landing distance than that actually required.

The Air Accident Investigation Sector determines that contributing factor to the Accident was the inappropriate selection of the off-field landing site as the Pilot did not carry out the required overflight site exploration due to time pressure as the weather conditions were rapidly changing and sunset was approaching. Accordingly, the Pilot was unable to identify ditches located in the selected forced landing area, which added to the severity of the Accident in terms of Aircraft damage.
