# Air Accident Investigation Sector

### - Summary Report -

AAIS Case N°: AIFN/0001/2014

# Oxygen System Fire

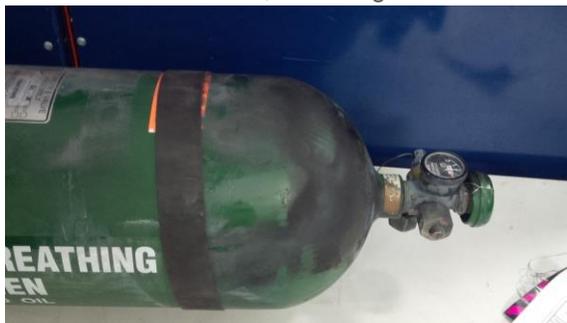
Figure 1. Oxygen bottle fire damage

of a new flight crew oxygen bottle, plumbing, and insulation blankets, followed by satisfactory leak checks and functional checks. The avionics bay and surrounding structure (internally and externally) were thoroughly inspected for signs of foreign debris and heat damage.

For precautionary reasons, the emergency transformer rectifier unit (ETRU) was replaced due to burn marks on the unit's case. The oxygen trolley was checked and re-calibrated and returned to the Operator's line maintenance for use.

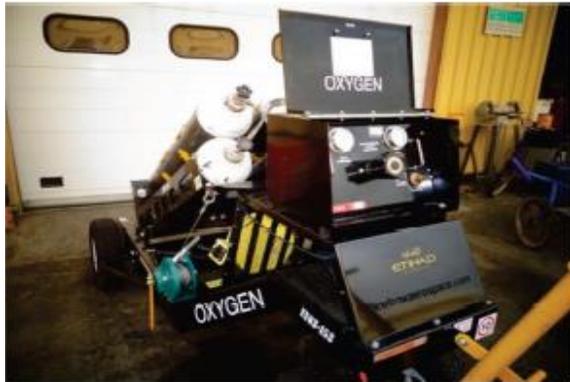
Figure 3. Newbow Aerospace 4- bottle easy load oxygen supply cart

Note 1: In case of the QA valve is set to CHARGE position after regulator pressure increase, rapid pressurization (and thus adiabatic compression<sup>2</sup>) in the filling line is possible.

Note 2: Referring to instruction 5, pressure should be increased slowly to avoid adiabatic compression in the filling line.”

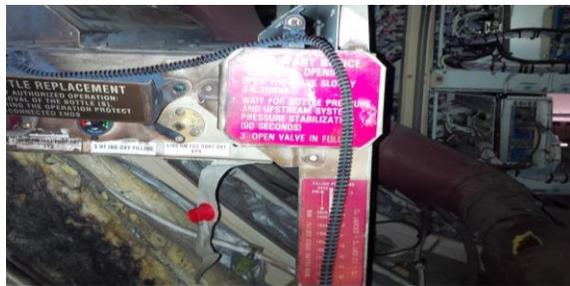
Figure 2. Oxygen bottle rack fire damage

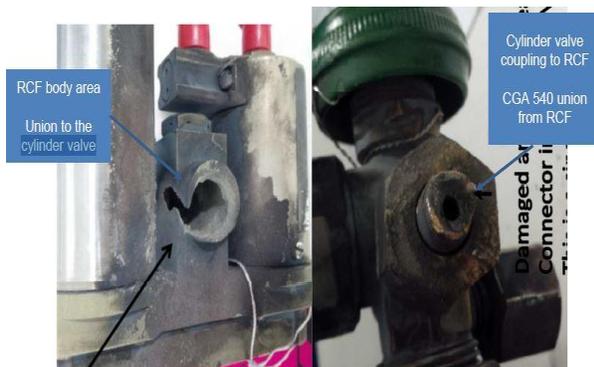
The parts inside the filling valves had disappeared (O-ring, poppet, spring and screws). The filter and its fixing parts had also disappeared.

It was observed that the damage was mainly localized on the RCF6708 at the CGA540 coupling level (figures 4 and 5). The cylinder valve was also damaged. The stem and the outlet pipe were partially melted.

Figure 4. Defective parts

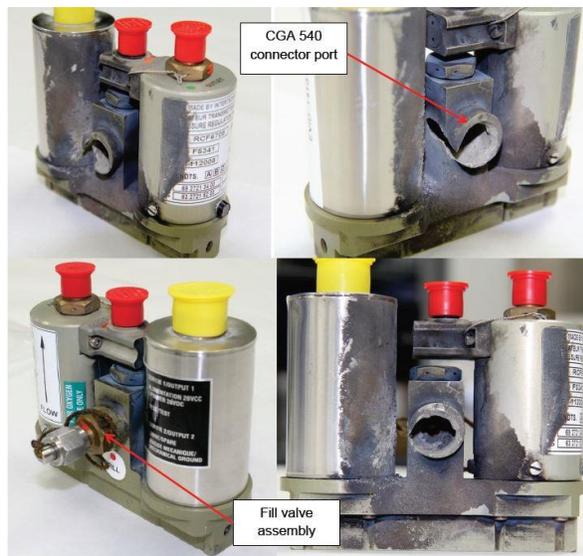
Figure 5. External views of RCF6708 assembly

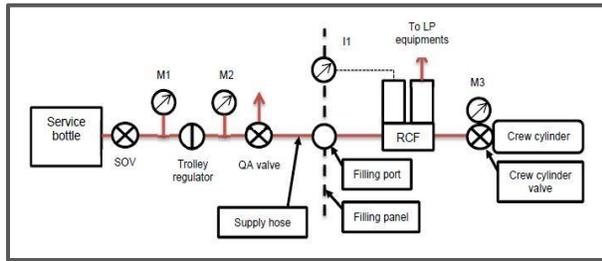
Figure 6. Installation schematic

The Investigation believes that the sequencing of the event, most probably, was as follows:

9. QA valve opening. This resulted in:
  - Adiabatic compression 0 to 1,600 psig in the filling line
  - Temperature increased to about 800°C at the PRT filling port

The Investigation believes that the adiabatic compression, most probably, occurred as a result of improper operation of the GSE filling trolley, which was not in accordance with the sequential order of the user instructions. The trolley pressure regulator was used (from 0 to 1500 psig, then to 1600 psig) before the QA valve was opened, and as mentioned in the user instructions as a note, that rapid pressurization (adiabatic compression) in the filling line is possible for this sequential order, which was the case in this event.
