Air Accident Investigation Sector Accident

- Final Report -

AAIS Case N° AIFN/0020/2014

Loss of Control-Inflight

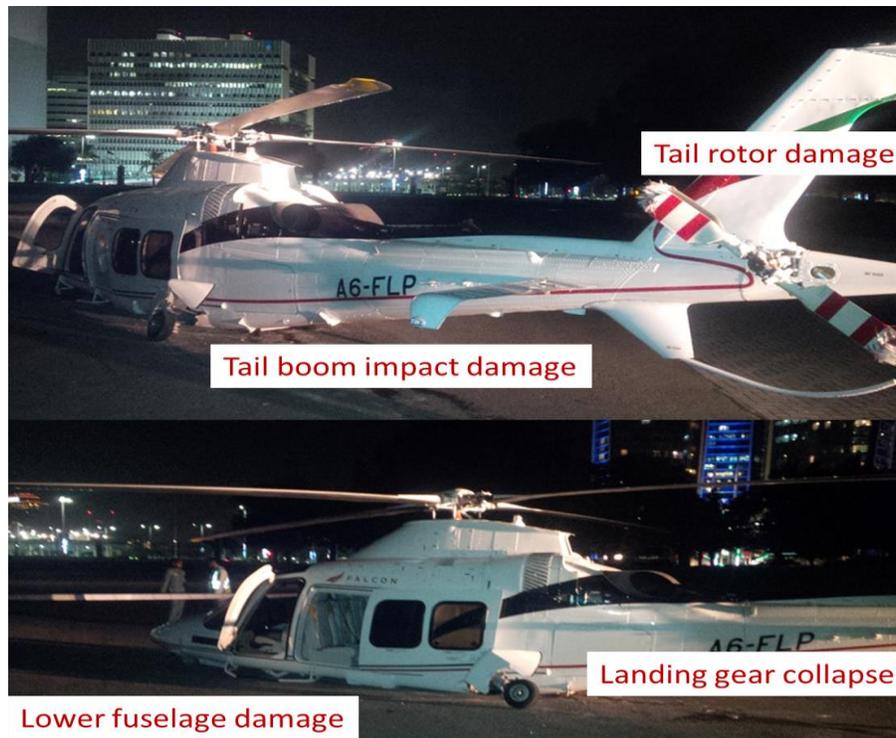
Figure 1. Damage to the Aircraft

The Aircraft sustained significant damaged due to the impact, which caused the undercarriage to collapse. The tail rotor made ground contact and the underside of the Aircraft was substantially damaged.

The Aircraft was substantially damaged, but the main assemblies were in place.
