- Summary Report -

AAIS Case N° AIFN/0011/2018

Inadvertent Opening of Emergency Exit Hatch and Deployment of Slide Ramp

Operator:	Saudia Airlines
Make and Model:	Airbus A320
Nationality and Registration:	Saudi Arabia, HZ-AS55
Place of Occurrence:	Dubai International Airport
State of Occurrence:	The United Arab Emirates
Date of Occurrence:	20 September 2018

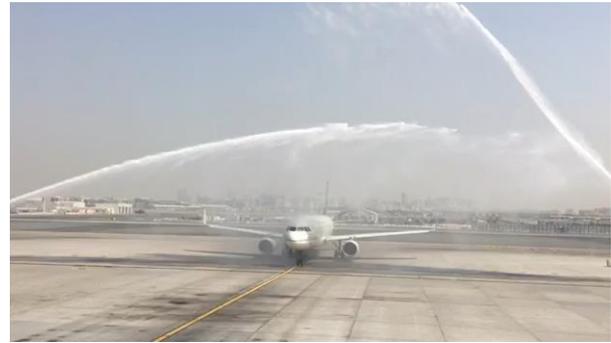
After turning towards the terminal, two fire-fighting vehicles, which were located on either side of the taxiway, started spraying jets of water to welcome the Aircraft with a water salute in celebration of the Saudi Arabia National Day (figure 1). The vehicle turret operators selected a water jet with a high kinetic energy to form a far-reaching arc.

The fire-fighting vehicle positioned on the left side of the Aircraft, FIRE 8, experienced a problem with the roof turret, which ceased to follow the operator's input from the hand controller. The high pressure water jet was suddenly sprayed upwards and then downwards, as the Aircraft passed underneath (figure 2). The Aircraft was struck by the water jet causing the left forward over-wing emergency exit hatch to open. The hatch fell into the cabin. This resulted in the deployment of the left over-wing emergency slide ramp.

Figure 1. Aircraft arrival at gate (start of water turret malfunction)

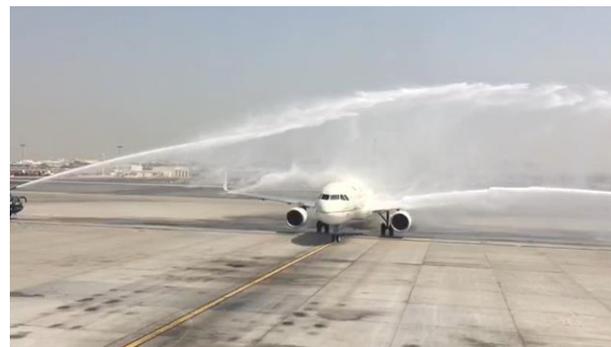
Figure 2. Water jet strikes the over-wing emergency exit hatch

turret mechanism. An AAIS investigator attended the maintenance activity, which identified that the loss of vertical turret control was caused by a fault in the elevation control potentiometer on the control handle.

The Air Accident Investigation Sector determines that the cause of the Incident was the erratic directional movement of the water jet onto the push panel of the left forward over-wing emergency exit hatch, which, when pushed inwards, resulted in the emergency exit hatch opening and falling into the cabin, slightly injuring the passenger seated in the window seat.

The potentiometer was replaced and the turret movement re-calibrated before FIRE 8 returned to service.

Introduce a routine "dry" turret check procedure, to ensure that malfunctioning turrets are identified during maintenance, or prior to their operation with water or foam.
